MASSACHUSETTS INSTITUTE OF TECHNOLOGY
HAYSTACK OBSERVATORY
 WESTFORD, MASSACHUSETTS 01886
 March 20, 2018

To: EDGES Group

From: Alan E.E. Rogers

Subject: Evidence for intermittent antenna S11 for lowband2 data

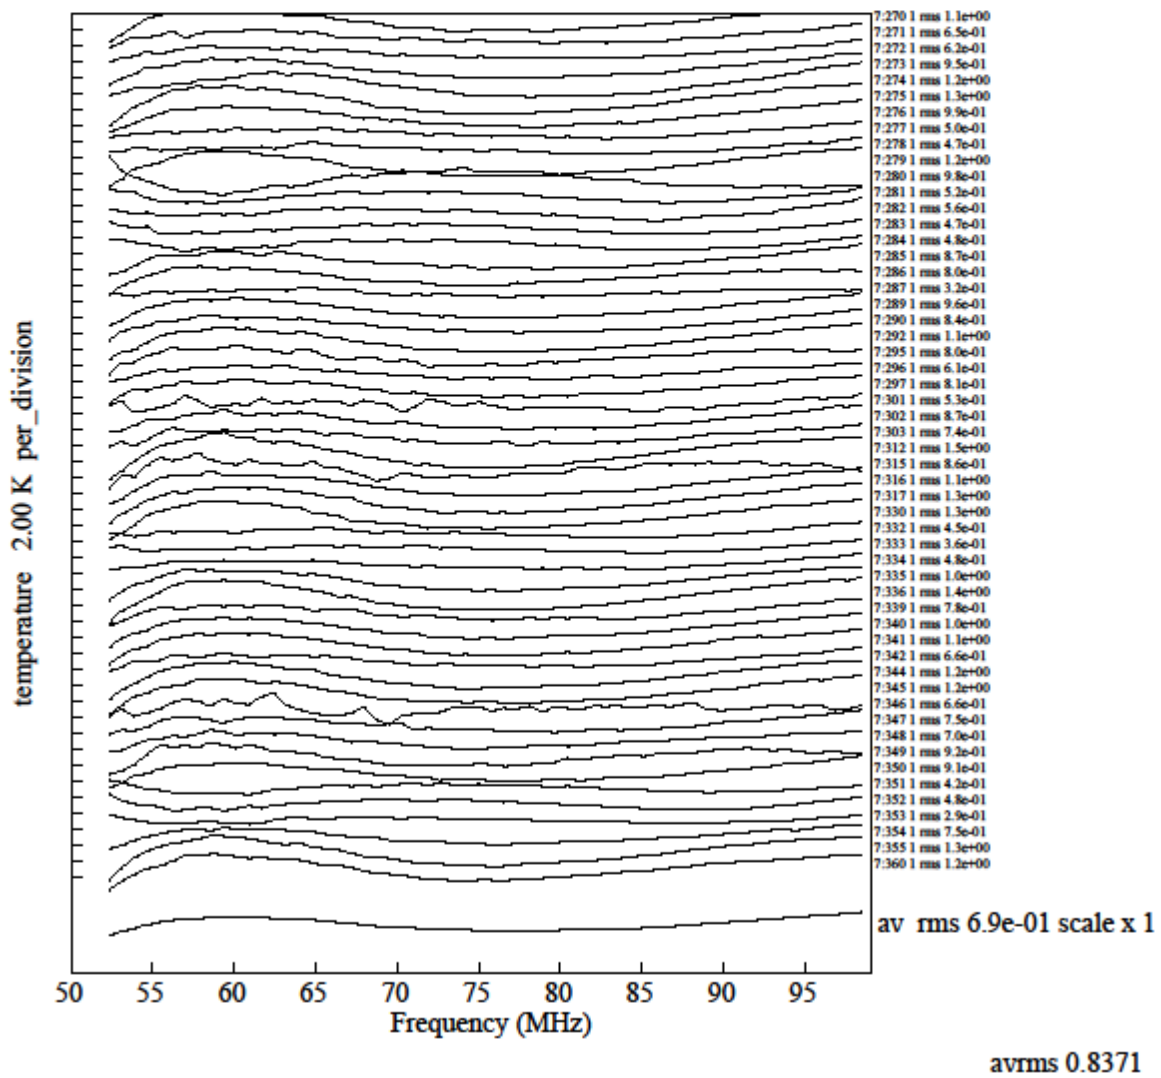
Lowband2 data from 2017_181 to 2018_074 shows evidence of random changes from one state to another. Figure 1 shows the residual spectra with 3 physical terms removed from 2017_270 to 2017_360 processed with S11 from 2018_046. The plots show occasional jumps back and forth from one state to another. Figure 2 shows residuals from simulated data for which

Figure 1. Residuals with 3 physical terms removed using NUM=2 S11.

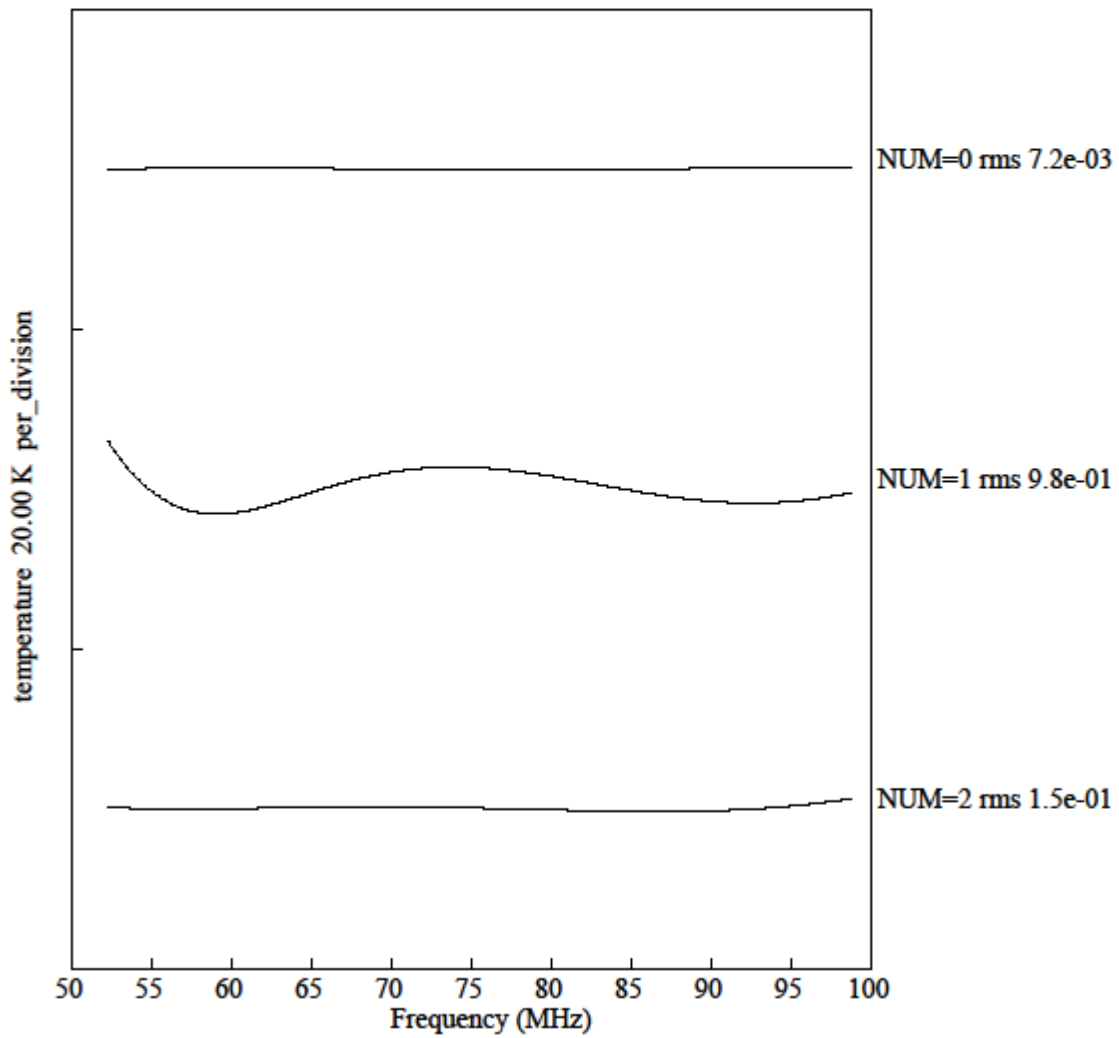
NUM=0 was used as the reference. Note that NUM=0 taken on 2017_291 agrees fairly well with NUM=2 taken on 2018_046 but is quite different than NUM=1 which was taken 15 minutes later than NUM=2. (see email from Raul 22 Feb 2018)

Figure 2. Differences in antenna S11 measurements 0, 1, 2 – see table.

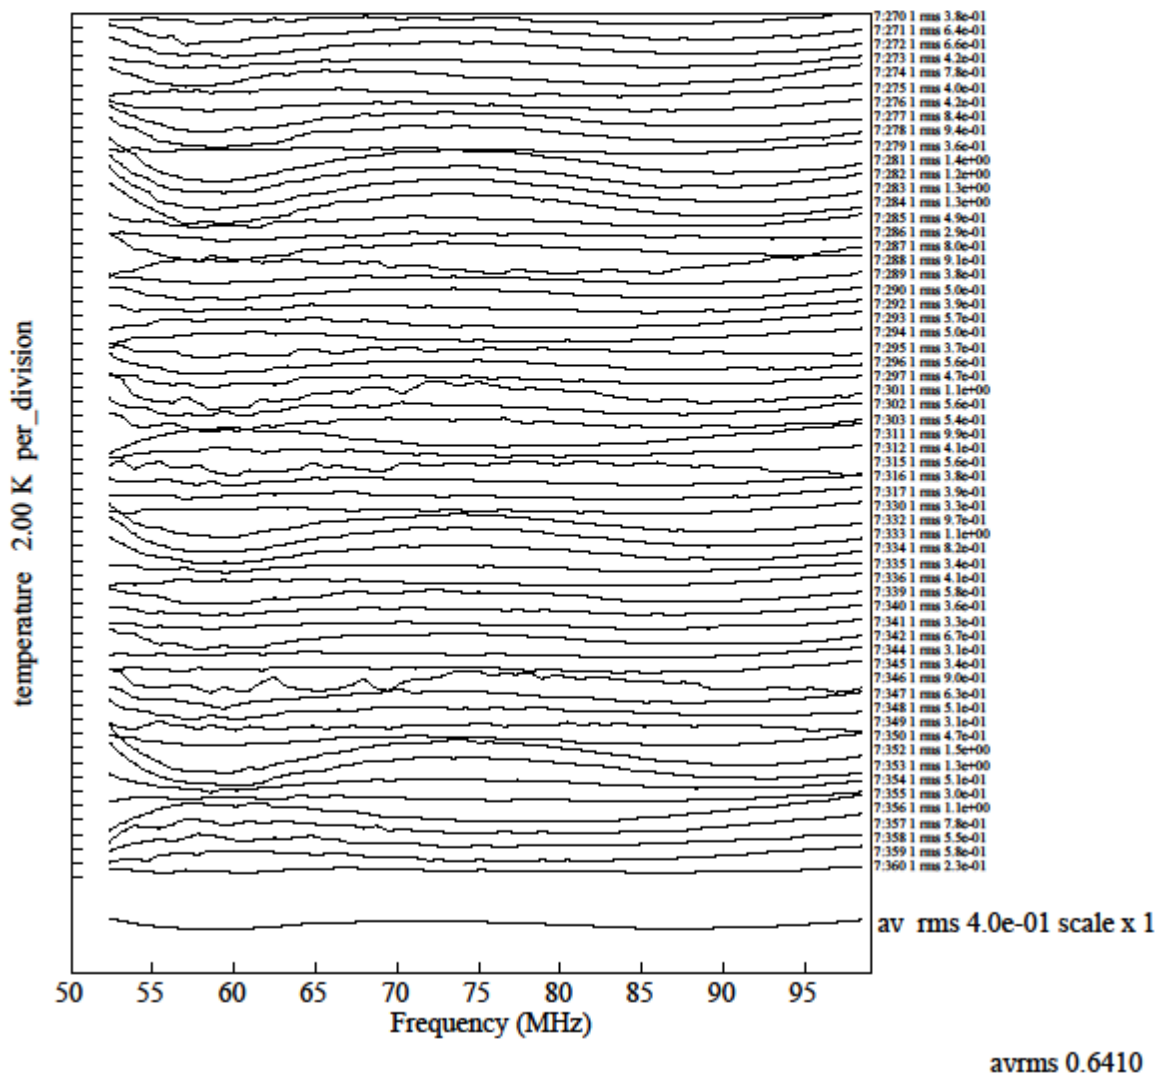
Figure 3 shows the residuals plotted with S11 NUM=1 compared with using NUM=2 for Figure 1. Note that the changes are reversed from which I conclude that whatever caused the change in S11 measured with the build-in VNA measurement also caused the changes in the calibrated spectra. This eliminates the 3-position switch as the cause as it is not in the circuit path of the VNA measurement and leaves the VNA switch on the antenna as the cause of the intermittent changes. An attempt is made to correct the intermittent antenna S11 by processing every day with the following S11 measurements:

Figure 3. Residuals with 3 physical terms removed using NUM=1.

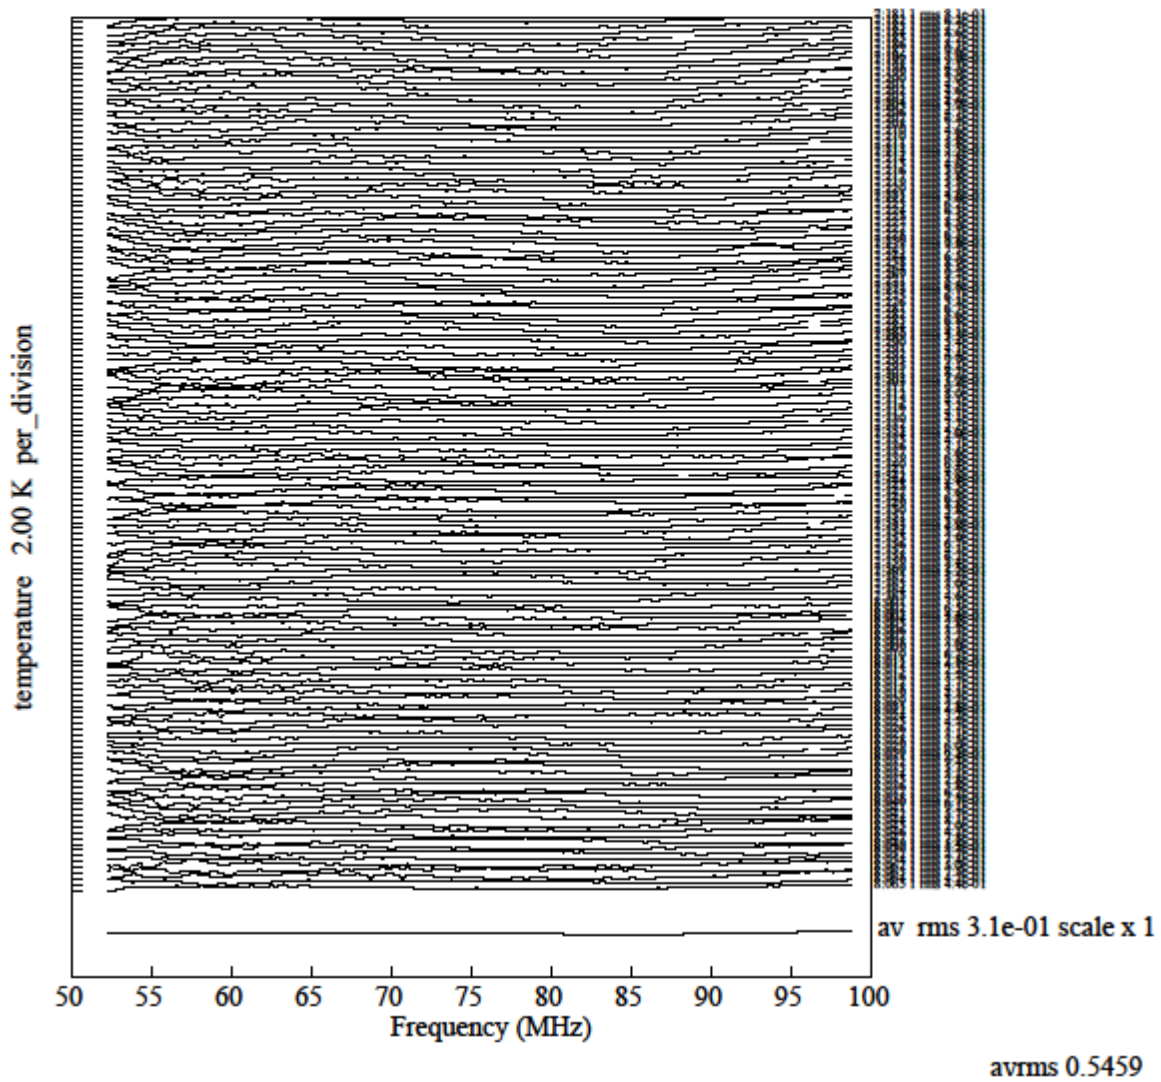
and using the spectrum with lowest rms with 3 physical terms removed. The residuals to these spectra are shown in Figure 4. However, the best data is from 2017_181-2017_245 when there was little if any intermittent change and I find I cannot improve on the analysis of ASU memo 109 and my conclusion is that we need to check and find the source of the intermittent S11. I suspect a loose connection to the receiver, or possible a loose top cap. All mechanical parts need to be checked for tightness. It would be useful to first apply a little force to the antenna with a

Figure 4. Residuals with 3 physical terms removed in which the S11 which gives the lowest rms was selected. Note that the lower average rms is lower than in Figures 1 and 3.

long plastic rod to look for indications of looseness visually and while watching the S11 with a VNA.

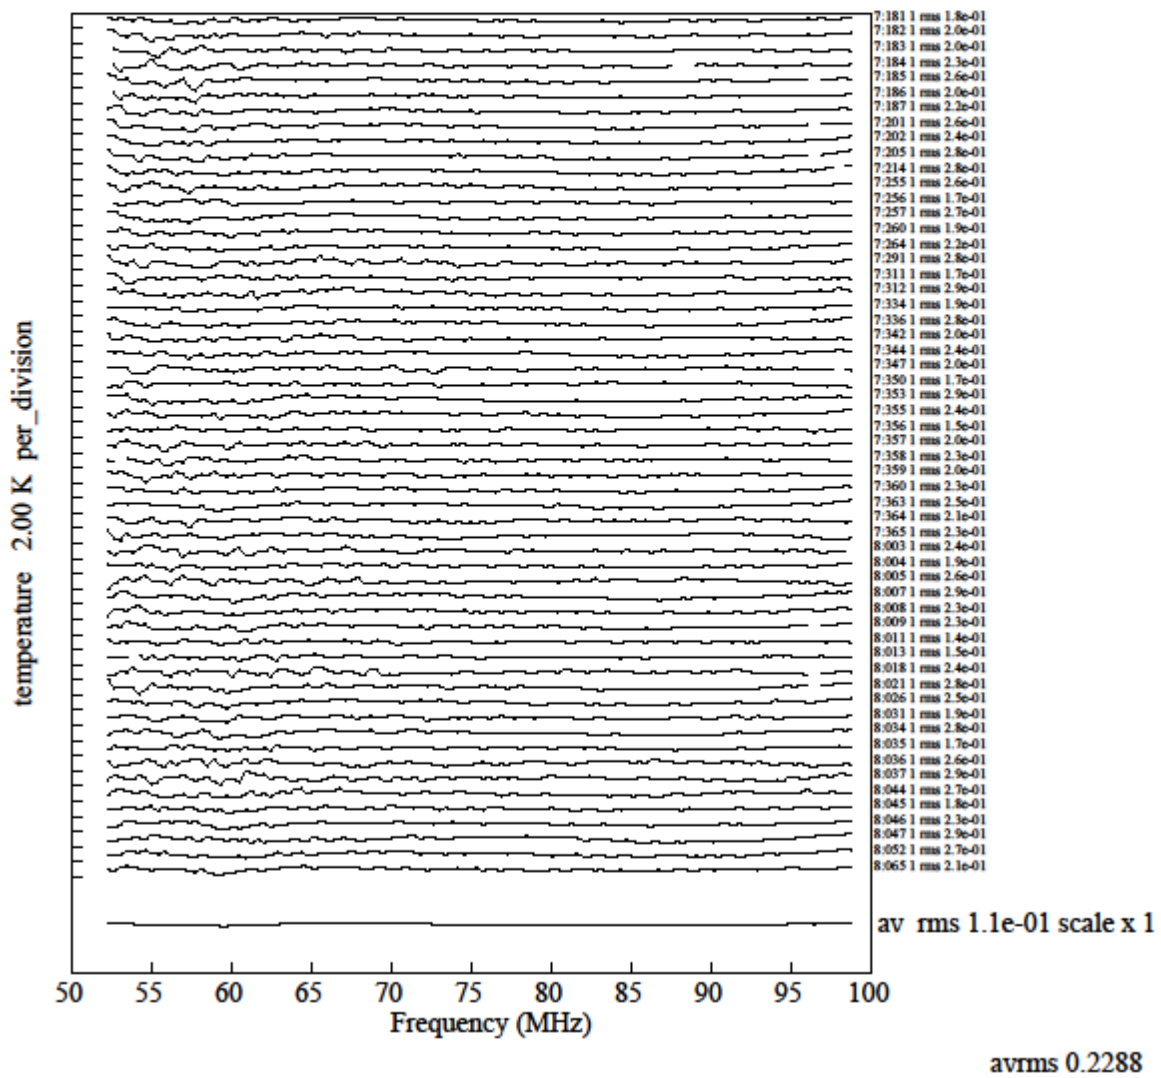
Figure 5 shows the rms residuals with 4 physical terms removed filtered to accept only residuals below 300 mK each day. The resulting bestfit signature parameters are

# terms	center MHz	SNR	amp K	width MHz
4 phys.	82.5	21	0.52	22.4
9 poly	78.9	12	0.45	20.7

Figure 5. The residuals with 4 terms removed for the best data.
