**MASSACHUSETTS INSTITUTE OF TECHNOLOGY**  
**HAYSTACK OBSERVATORY**  
WESTFORD, MASSACHUSETTS 01886  
Updated May 1, 2018

To: EDGES Group  
From: Alan E.E. Rogers  
Subject: Midband results from 2017\_329 to 2018\_043

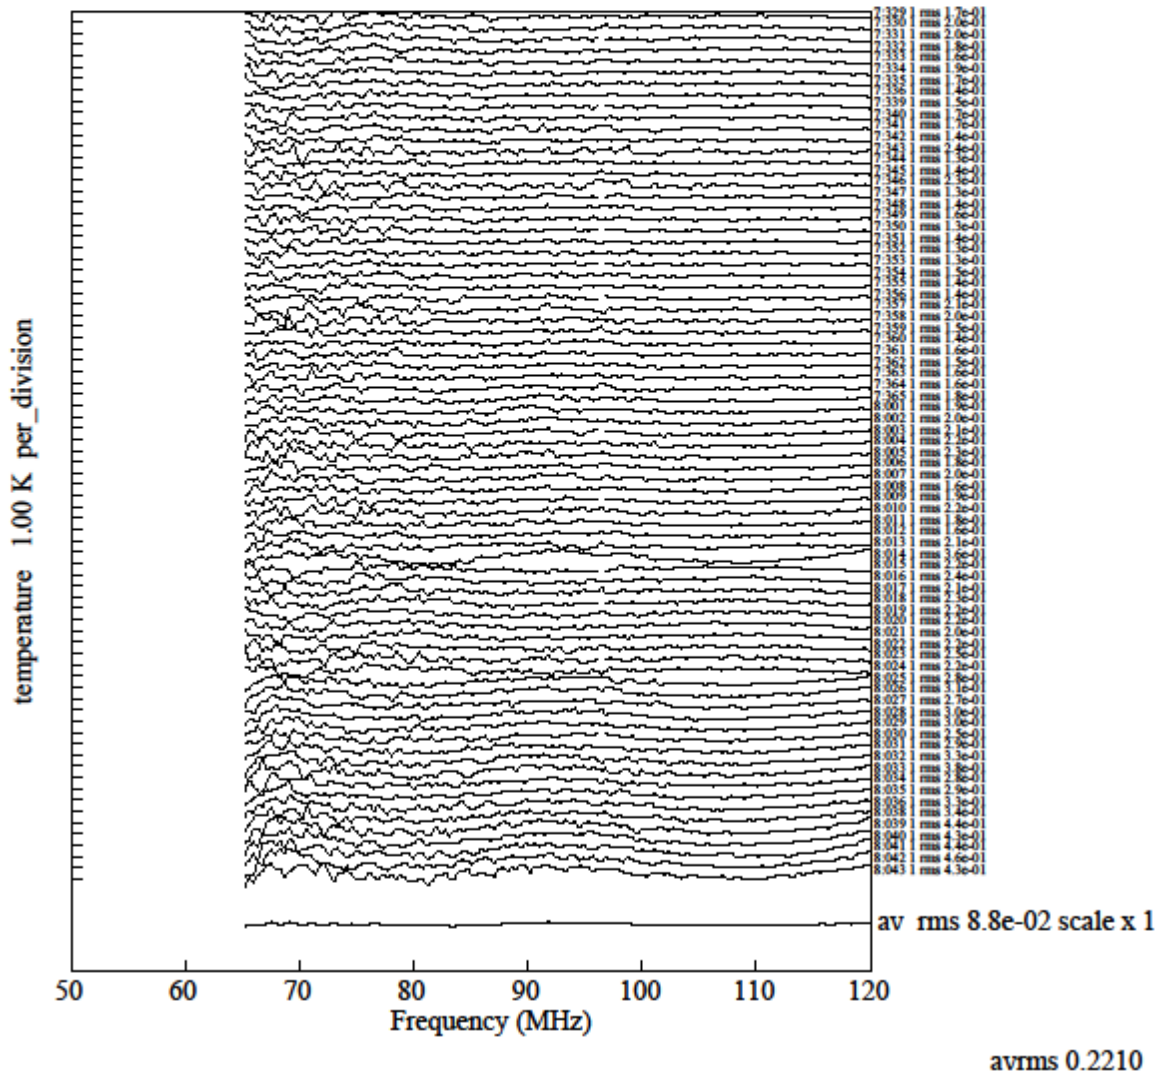
A midband system was deployed at the MRO in November 2017. Unfortunately the strength of the noise source used in the 3-position switching did not provide adequate rejection of the ripples in the 50 m cable to the hut so that these ripples along with a higher noise level are present in the data.

When the receiver was returned to ASU it was discovered that the voltage regulator which provides +12 V in the receiver had inadequate voltage margin to maintain 12 V when the input voltage drops to +16 V when in the antenna position of the switch cycle. The part number should have been LM340T-12 from Texas instruments which has a specific voltage margin of 2 volt so that it should maintain 12 V output for output voltage of more than 14 V. The incorrect voltage regulator was the major cause of the failure of the 3-position switch to cancel out the ripple in the long cable from receiver to the hut.

Figure 1. Midband data residuals from 2017\_329 to 2018\_043 with 5 physical terms removed.

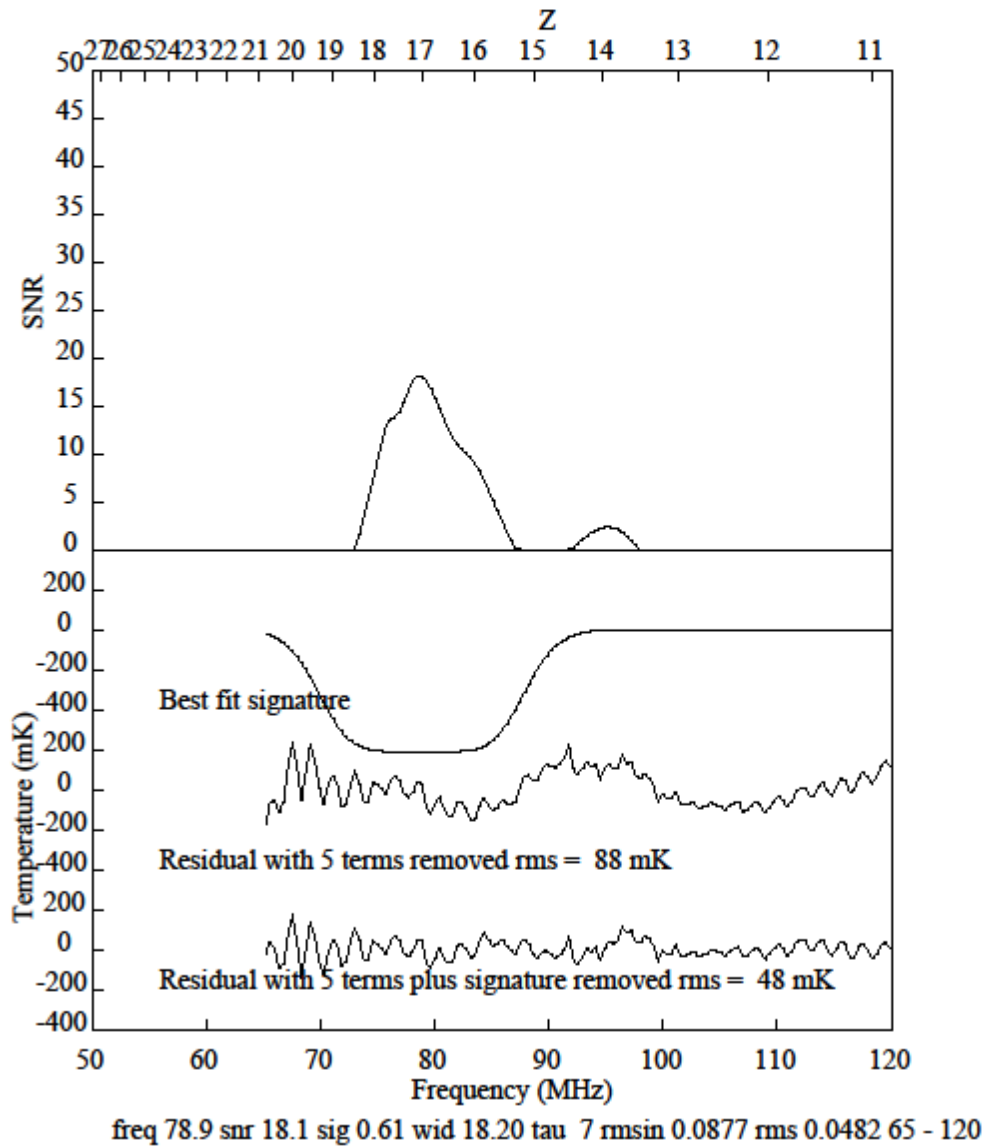
Figure 1 shows the residual spectra with 5 physical terms removed and Figure 2 shows the results of a signature search with 5 physical terms plus a signature with  $\tau = 7$ . Despite the added noise and ripple the best fit signature is close to those obtained in the low band.

Figure 2. Midband signature search using 5 physical terms plus signature with  $\tau=7$ .
