**ARIZONA STATE UNIVERSITY, LOCO LAB
MIT, HAYSTACK OBSERVATORY**

Subject: Boolardy Site Visit Log – February 2020

This is a short memo detailing activities during the February, 2020 visit to the EDGES site at Boolardy station, WA, which will be updated with the activities of each day.

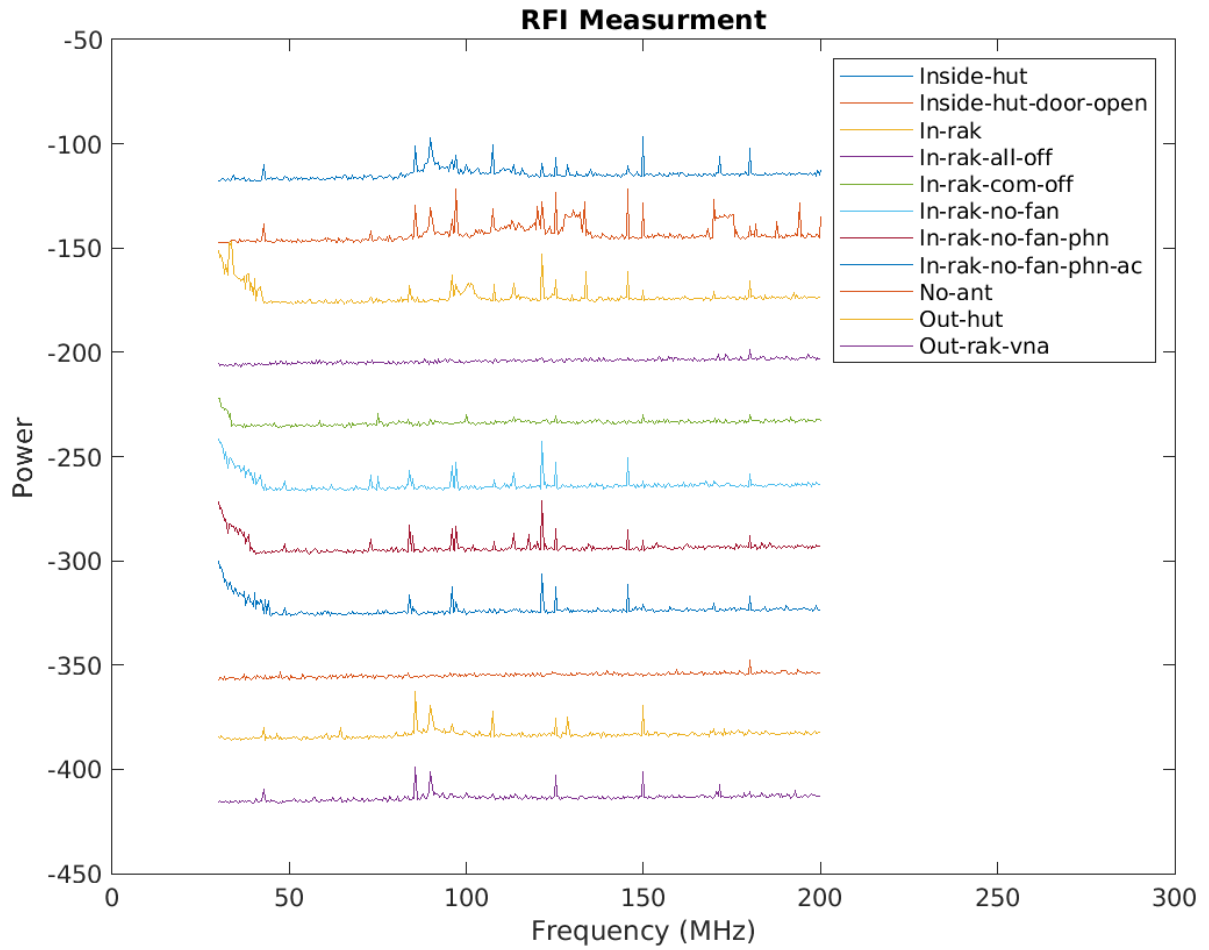
The afternoon of February 18, 2020 a quick RFI survey of the EDGES hut was down using a FieldFox spectrum analyzer coupled to an approximately 2 feet long monopole whip antenna. Table 1 contains a summary of the measurements taken. Unless otherwise specified under the description heading, all measurements were taken with the hut door open. For measurements where the FieldFox was inside the equipment rack cabinet, it was connected to the antenna (inside the hut) via co-ax. cable¹ through the equipment cabinet wall. The FieldFox was set up to generate a spectrum sweep from 30MHz to 200MHz with a spectral resolution of 100Hz. The number of averages for each spectrum measurement was configured to be 150. It should be noted for some measurements the low frequency portion of data may be unreliable as there was no way to introduce a delayed-start to the measurement and for measurements where the spectrum analyzer was inside the equipment cabinet with the door closed, there is some non-zero time between the start of a measurement and when the door was fully closed. We estimate that this affected the first ~ 10 MHz of each measurement. For a rough idea of the setup (with cabinet door open) see figure 2. Note that for measurements A through E, there were two smart phone devices (in airplane mode) inside the hut a few feet from the antenna as well as a handheld UHF radio (not-transmitting) outside the hut. For measurements F and onwards, these devices were switched off and placed inside a car ~ 20 feet away. For all measurements A through F, we also had two car key transponders nearby in the hut, these were removed for measurement G onwards and placed outside the hut about ~ 25 feet away. During measurement G, a vehicle approached and parked about 40 feet away from the hut, so this measurement was repeated. Figure 1 gives a comparison of the RFI survey measurements. From this figure we conclude that there may be some RFI produced by the back-end computers within the equipment rack, the most salient features being the peaks closest to 85, 120, and 145 MHz.

Figure 1: Comparison of RFI survey measurements. The y-axis is relative power in dB, the x-axis is frequency in MHz. The measurement at the top (label: inside-hut) is the associated with the true power scale, whereas each subsequent measurement has offset from the last by -30 dB for clarity.

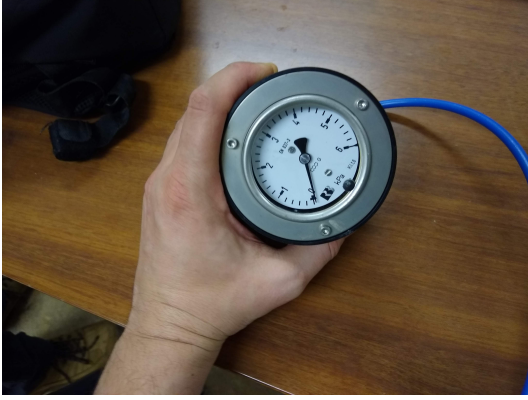
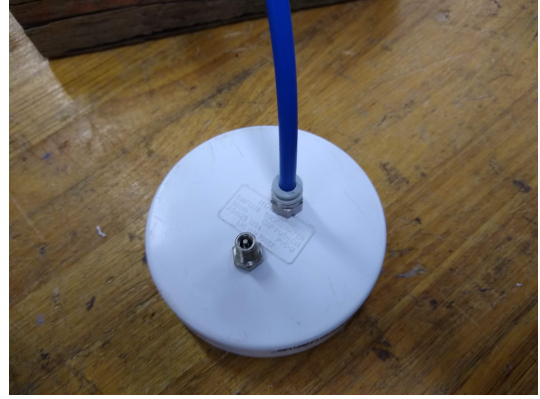
Figure 4: Air pressure test attachments.

During the first test, the cap failed with an air leak from the hole through which the Schrader valve was fit, this may have been due to a crack which formed during free-hand drilling. On the second attempt, a new cap was drilled using a drill press and a drill bit with a hollowed out cutting edge², this resulted in a tighter seal and no cracks in the PVC cap. However there was still some leakage though the valve stem threads so teflon tape was applied, which improved the seal and seems to have resulted in no leaks from the valve/gauge ports.

(a) The 6kPa pressure gauge.

(b) The 90mm PVC pipe cap with Schrader valve and press-fit coupling used to charge the line

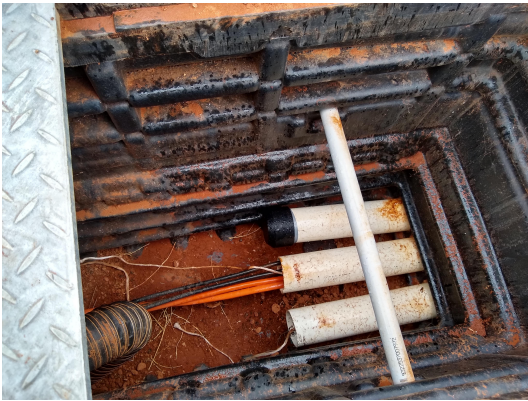
(a) Black ABS cap fitted to far end of conduit in pit.

the primary leak was due to a poor seal between the ABS cap and the PVC pipe. However, the rubber gasket material used to seal the end with the valved cap appears to fit tightly with no leaks. Tomorrow we plan to seal both ends with 90mm caps equipped with rubber gaskets (as shown in 5b).

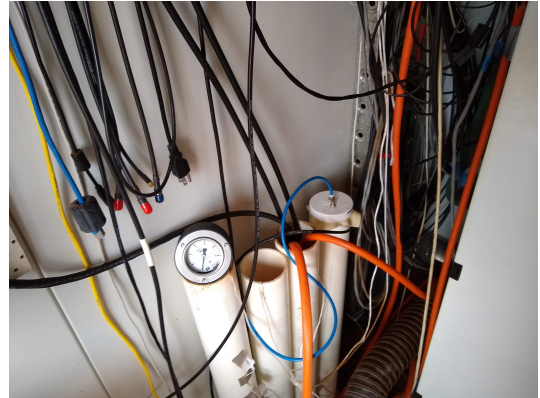
(b) PVC cap fitted to conduit in hut, sealed with rubber gasket material.

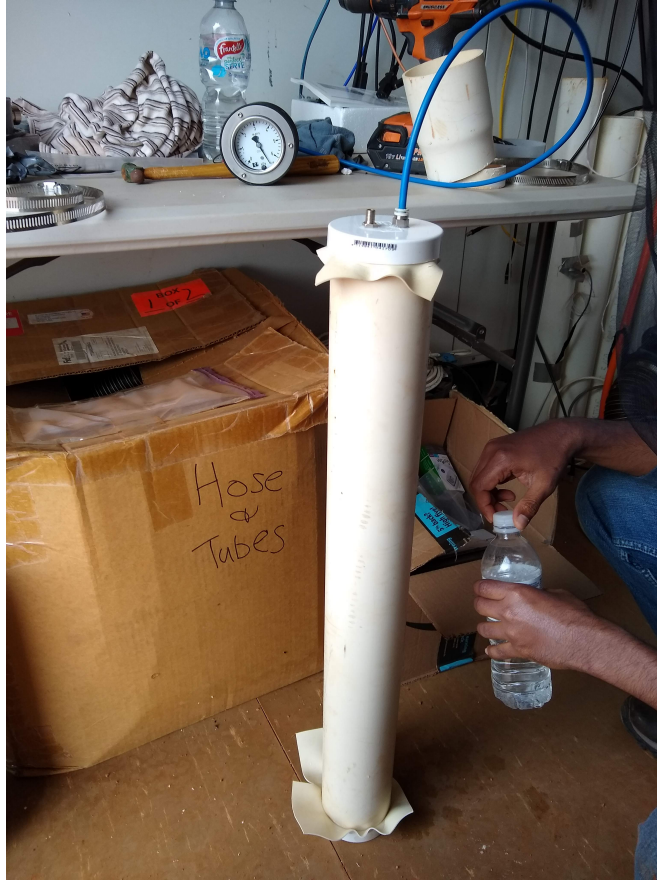
Overnight it rained about 20mm so the roads were a little soft this morning and pad-3 pit had some water, but we otherwise had fairly clear skies today. Upon arrival at the site we first tested the air-tightness of the caps we devised the day before on a short section of pipe, as shown in figure 6. This scheme held about 6 kPa of pressure for several minutes with no signs of leaks, giving us a fair degree of confidence that the end-caps should be able to hold enough pressure to check the conduit for leaks.

Figure 6: Test chamber used to test end-cap seal before testing the conduit.

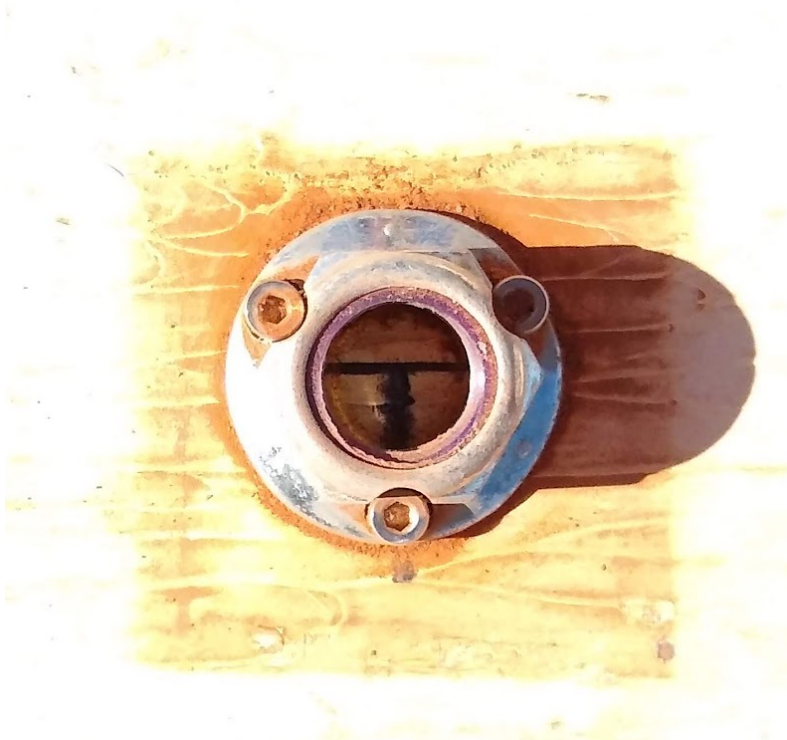
We decided early on to rotate the low-band antenna on pad-4 by 45 degrees. To do this we removed the antenna and then marked the new locations for the flanged nuts according to table 3, and then drilled and re-mounted the nuts. Figure 7 shows the type of nut used to attached the threaded nylon rods. Note that each nut has had 3 through-holes added around its perimeter to permit size M4 screws to pass through to the base-plate, and the nylon lock-washer present inside the nut has been tapped-out to allow the 3/4"-10 threaded rod to pass through. The approximate diameter of the outer flange is about 1.3". For EDGES-3 we may want to consider a mounting scheme along these lines since it is much easier to deal with than mounting through the base-plate.

Figure 7: The modified flanged nuts use to attach the threaded nylon rods (withing the fiberglass support legs) to the base-plate.

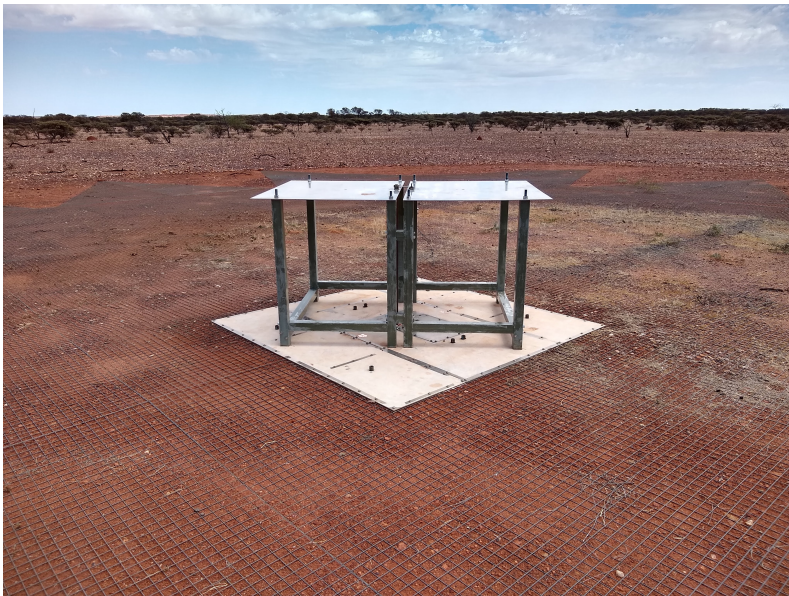
Afterwards we surveyed the low-2 and mid-band antennas. The orientation (directed along the long edge of the antenna panels) of the low-2 antenna on pad-4 was measured with a compass and was found to be roughly 42° to the East of due (magnetic) North. Figure 8 shows the antenna position relative to the base plate. We also measured the degree to which the low and mid-band antennas were out of level. For the low-band antenna, we measured the gap between the two dipole halves was 1.85 inches, and the height of the top-cap above the antenna was 0.65 inches. Figure 9 shows the relative positioning of the low-2 antenna panels. For the mid-band antenna (which was not moved or otherwise modified on this trip) we measured the gap to be 50mm (1.96"). However, we did not remove the plastic cap to measure the top-cap height. The original dimensions (measured Nov. 25, 2017) of the mid-band antenna were $\sim 1.9''$ for the gap spacing and $\sim 0.75''$ for the top-cap height above panels.

Figure 8: The low-2 antenna rotated roughly $\sim 45^\circ$ relative to the base plane.

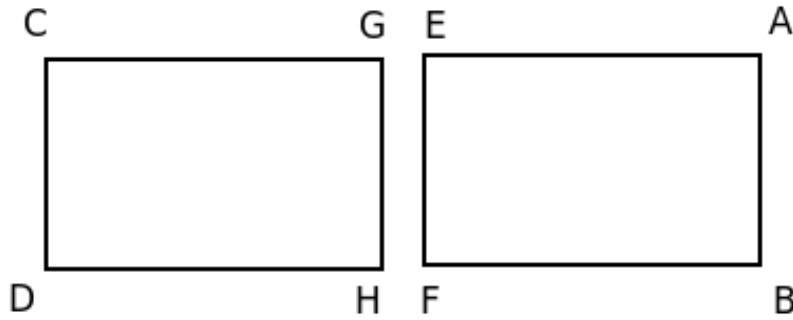
Figure 9: Rough survey of low-2 antenna panels, view from top down. Side CD is the South-West side, while side AB is the North-East side. Using a level we measured side GH to be 8mm lower than the outside edge CD, while side AB is 3mm lower than EF. In the perpendicular direction, side CG is 5mm lower than DH, while side AE is 4mm lower than BF.

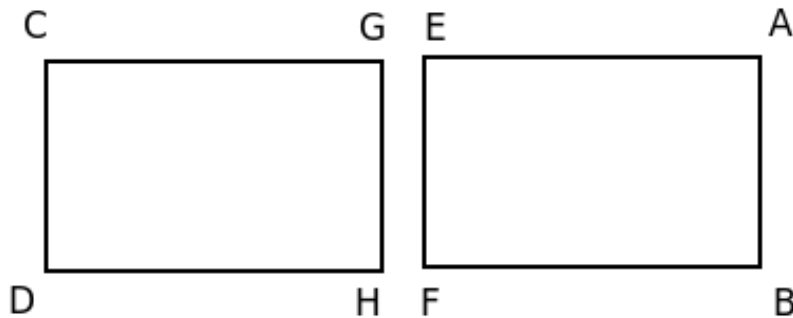
Figure 10 shows the relative positioning of the mid-band antenna panels. The orientation of the mid-band antenna was found to be 82° to the East of due (magnetic) North. Note that the low-2 receiver was connected to back-end D (in the rack) while the mid-band receiver was connected to back-end B.

Figure 10: Rough survey of mid-band antenna panels, view from top down. Side CD is the West side, while side AB is the East side. Using a level we measured side AB to be 5mm lower than the central edge EF, while side GH is 6mm lower than CD. In the perpendicular direction, side CG is 7mm lower than DH, while side AE is 5mm lower than BF.
