UVLBI Memo #031

**MASSACHUSETTS INSTITUTE OF TECHNOLOGY  
HAYSTACK OBSERVATORY**

To: UVLBI Group  
From: G. B. Crew and V. Fish  
Subject: SMTO 2012 EHT Observing Campaign Report

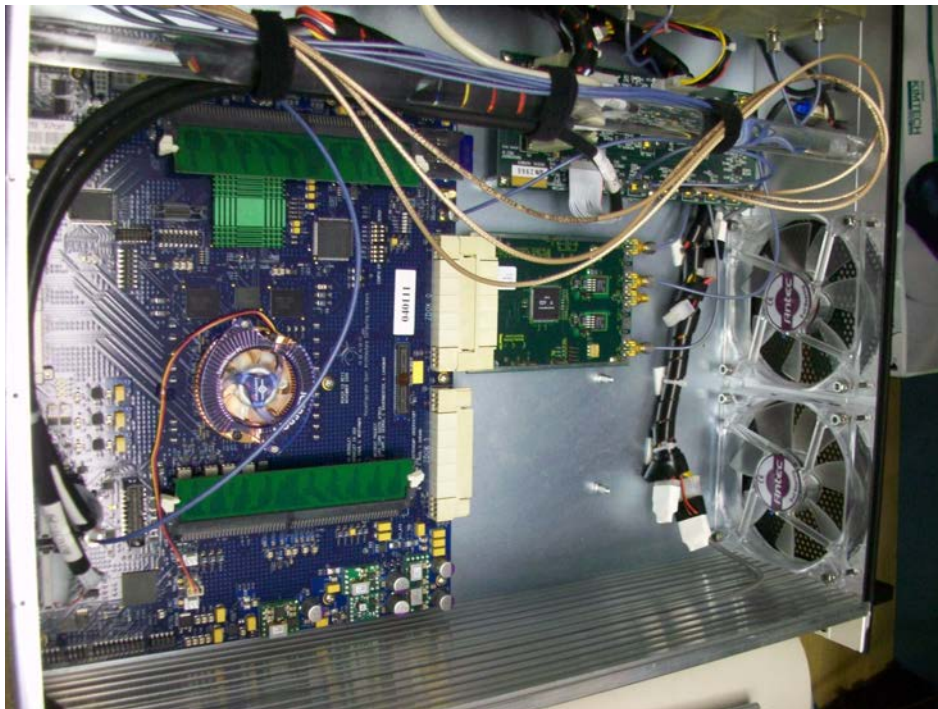
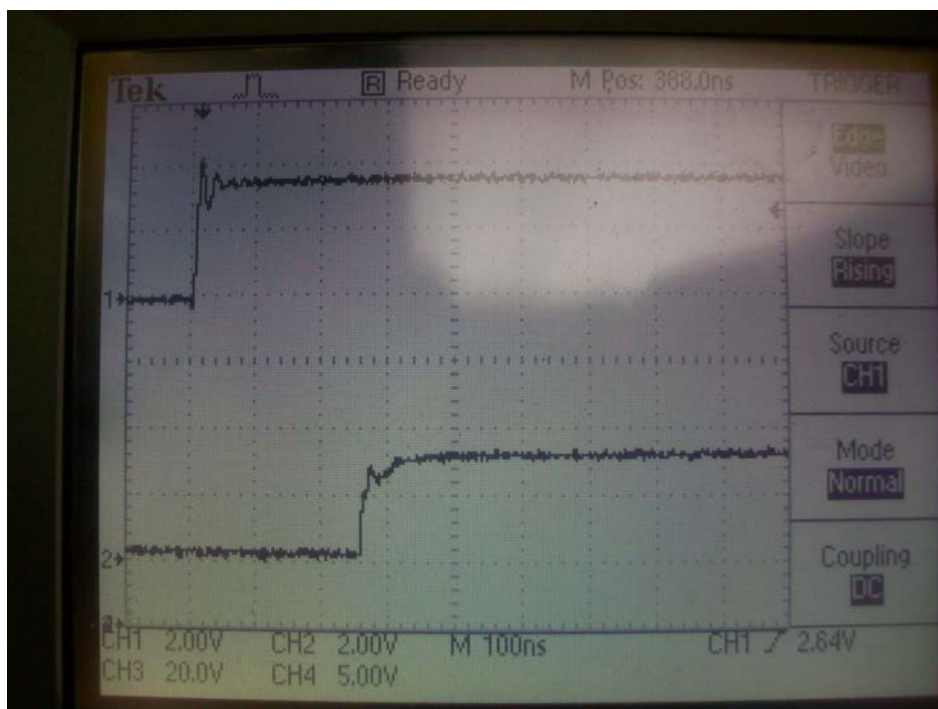
Two of the RDBE-H units had 3 additional cables installed to allow the regenerated PPS to be passed from the NRAO synthesizer board to the outside so that one RDBE-H unit could supply the PPS to all units. (See [Figure 5](#).) However, it was not clear that the voltage levels of this output (1.6 - 2.0 V) were adequate to drive the PPS inputs (0 - 1.5 V). To be safe, we daisy-chained the four units (“stations” A1, A2, A3 and A4):

Figure 5: The inside of one RDBE-H with 3 extra PPS cables (copper-colored) from the NRAO synthesizer board is shown. In the event, the 4 units were daisy-chained and the maser tick and dotmon output of the final unit were monitored by scope to be less than 260 ns.

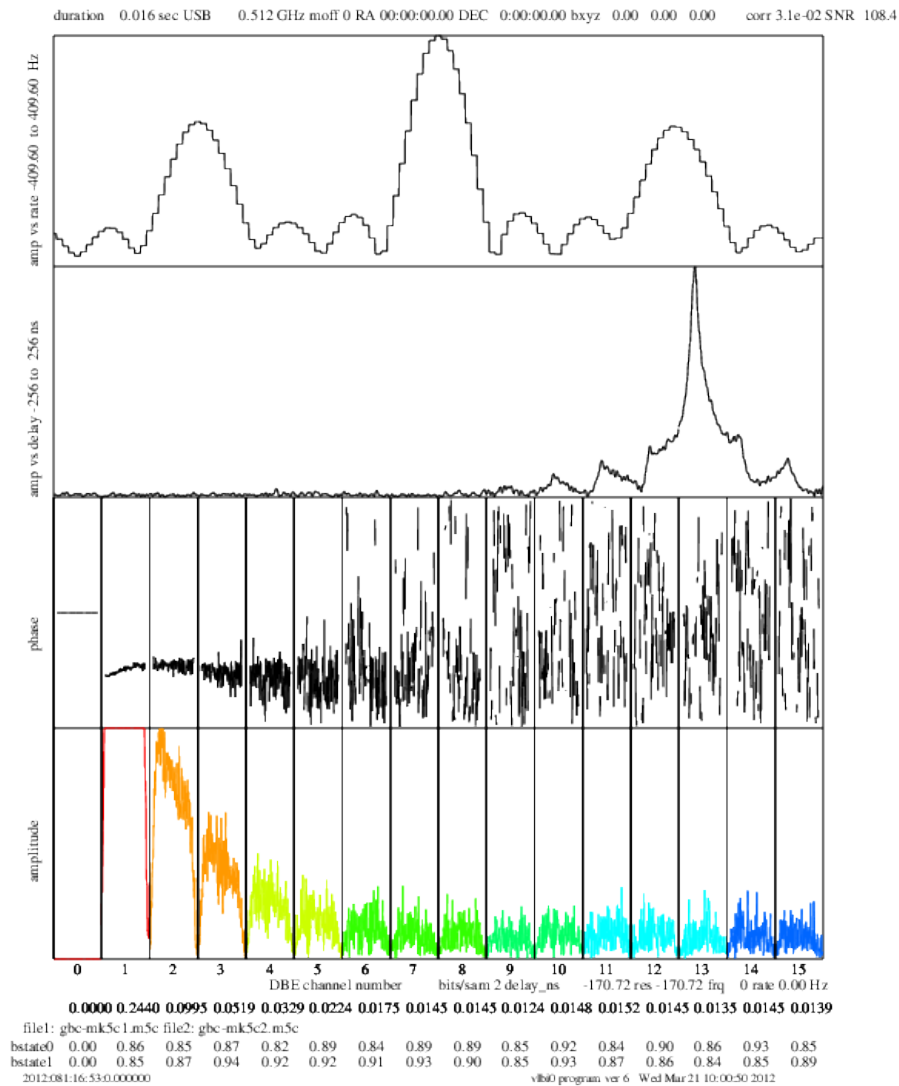
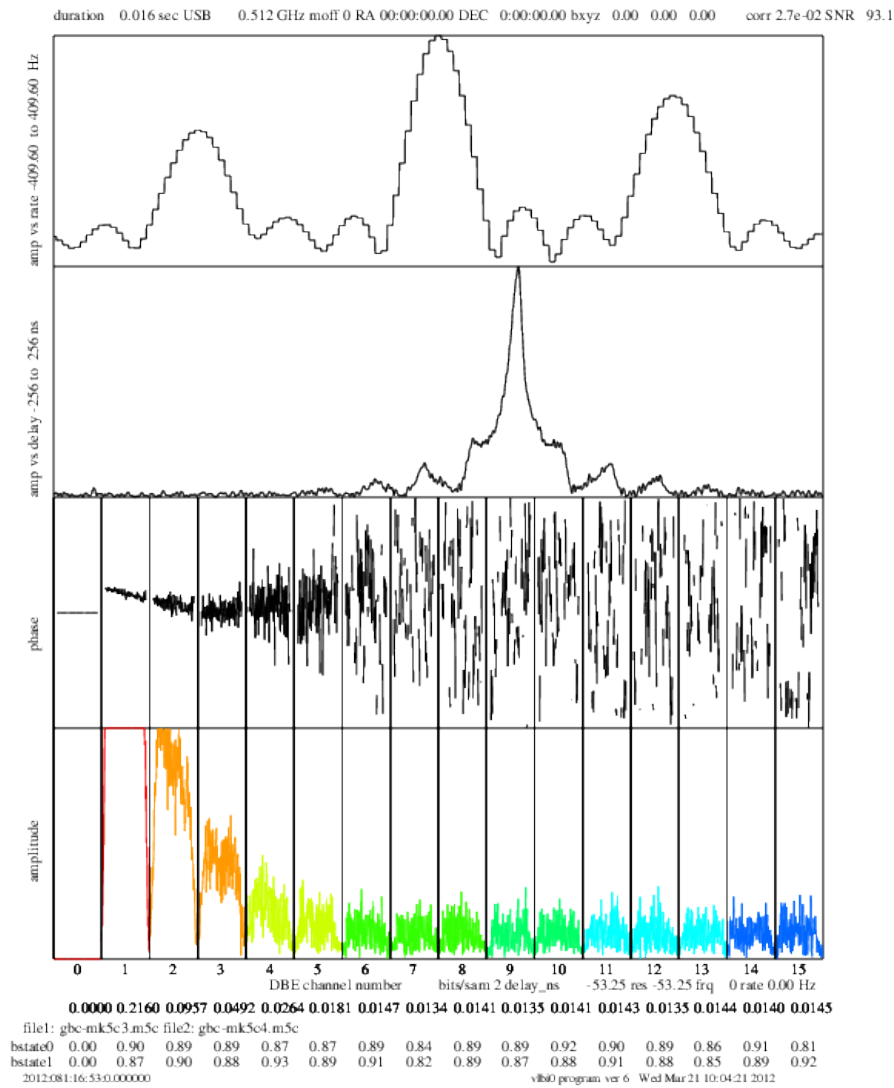
From time to time we did try correlating 1000-frame samples from the 4 recorder chains with *vlbi0*. Representative samples are shown in Figure 8 through Figure 13. The upper/lower sideband pairs (Figure 8 and Figure 13) were found to be highly correlated (25%) at the DC edge. This is presumably due to a broader width to the bandwidth filters than one might suppose. (I.e. signals bleeding into the adjacent Nyquist zone.)

Figure 8: Sample correlation of A1 (LCP Lower) with A2 (LCP Upper).

Figure 13: Sample correlation of A3 (RCP Lower) with A4 (RCP Upper).

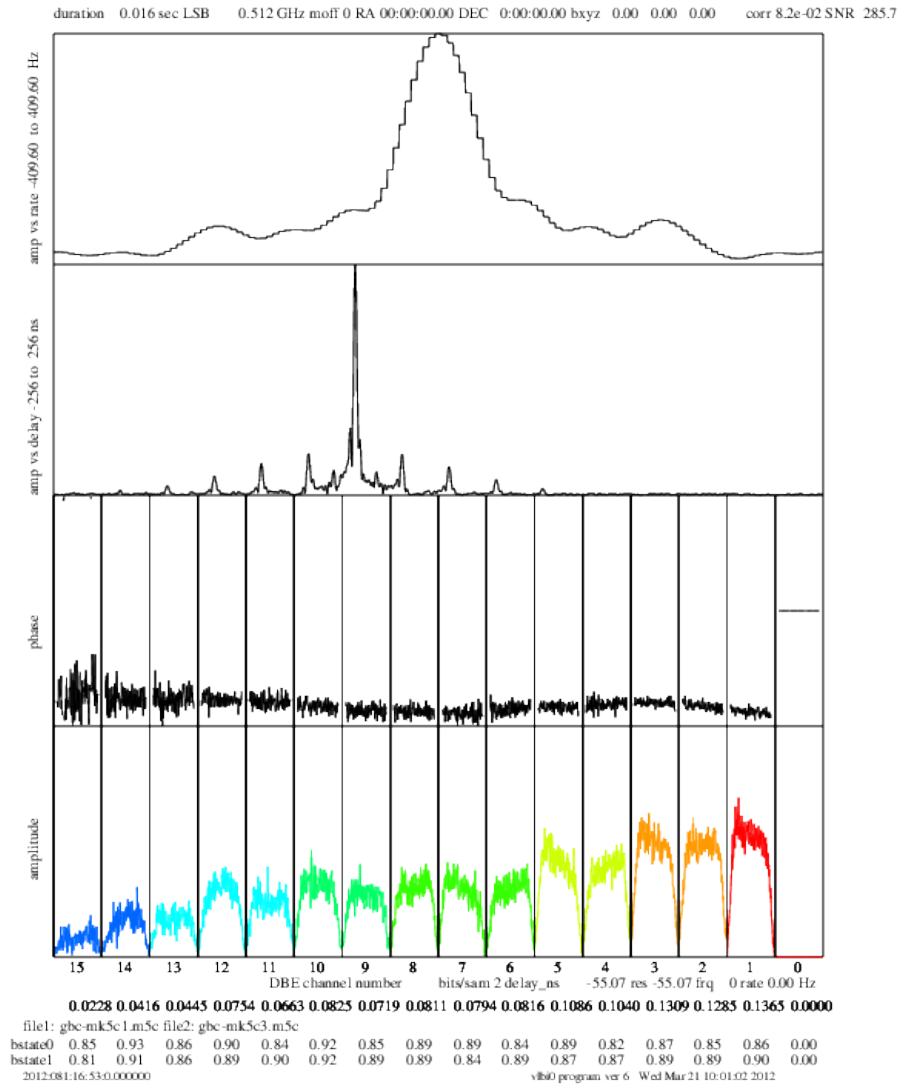
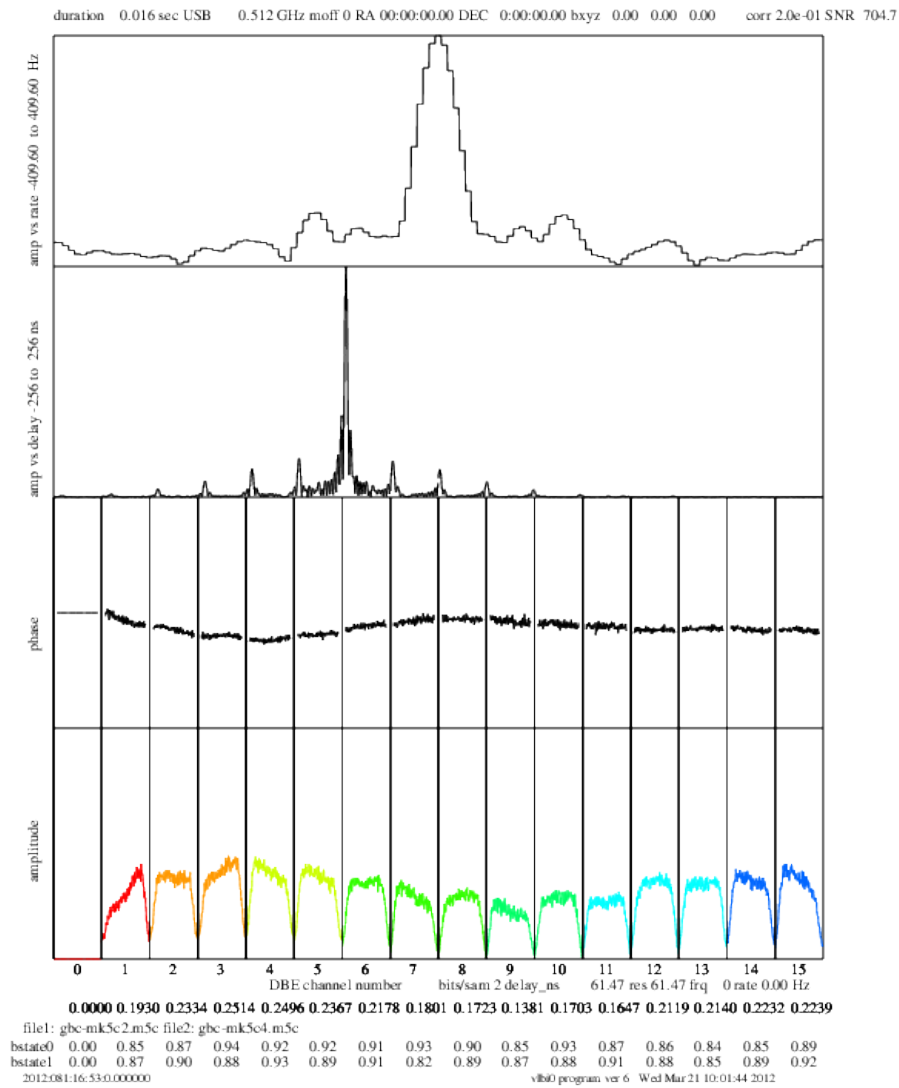
The in-band cross-hand pairs (Figure 9 and Figure 12) show a somewhat larger correlation amplitude than was seen last year (2% [LSB] to 25% [USB]). The cause of this is not known.

Figure 9: Sample correlation of A1 (LCP Lower) with A3 (RCP Lower).

Figure 12: Sample correlation of A2 (LCP Upper) with A4 (RCP Upper).

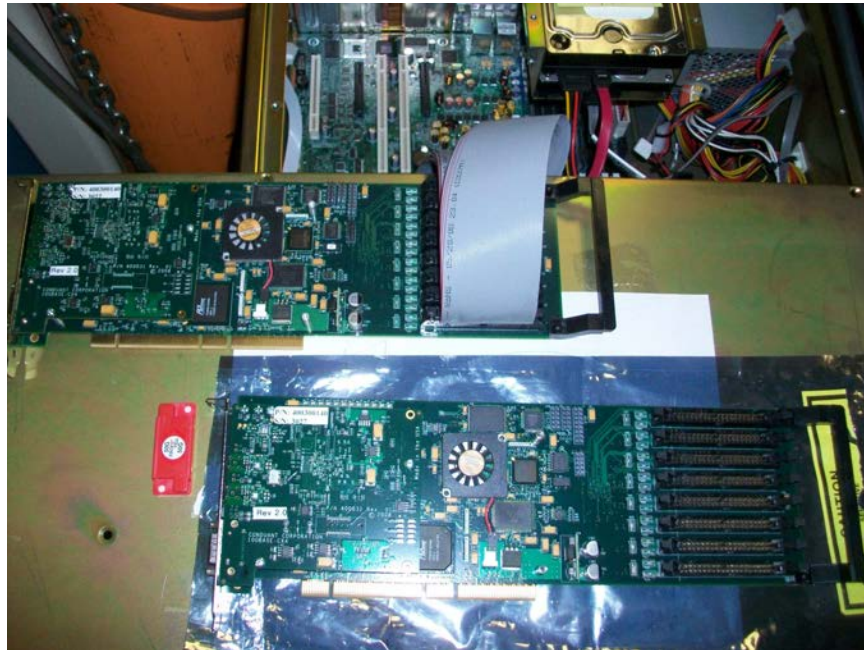
The receiver and equipment racks are shown in [Figure 2](#). As in previous years, the units not fitting into the rack were piled on a table. (See [Figure 3](#).) This was fortuitous as the Amazon/10GbE daughter card from the recorder on the lower left was faulty and needed to be replaced. There was sufficient slack in the cables that we were able to stack the 3 RDBE-H units atop the other recorder in order to gain access.

Figure 16: The faulty amazon card (still cabled) and the replacement (uncabled) are shown. The IDE cables were swapped from the old to the new card and operability was restored.

A replacement Amazon card arrived just in time to be swapped in prior to the second night of observing. (See Figure 16)

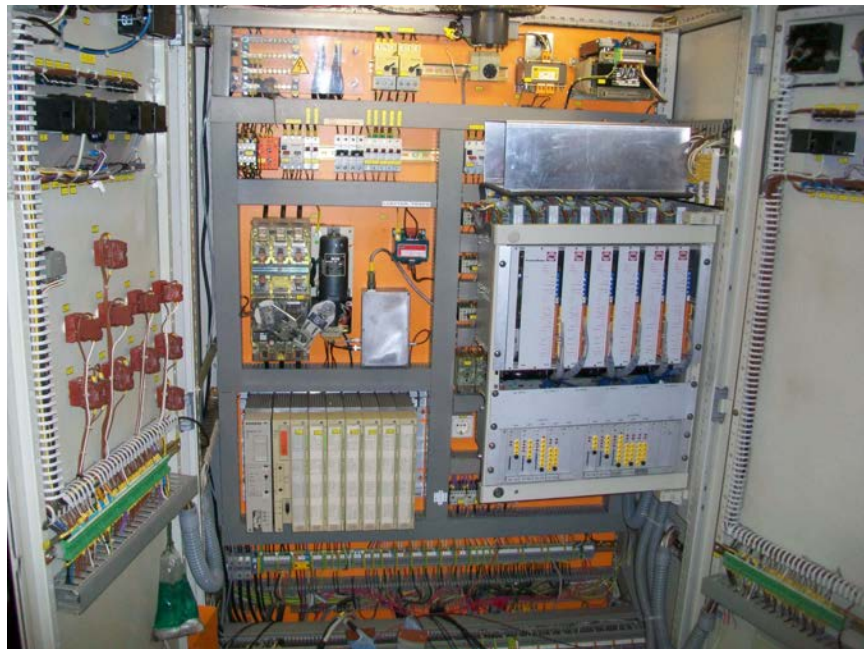
At the start of the VLBI session, tau was very good, but snow was still falling, so Patrick (the operator) was doing hourly assessments of when it would be safe to open. It wasn't until the 080-0800 UT scan that conditions allowed us to start. However, when the drive system was activated, there were immediate faults in the azimuthal drive system.

The more obvious fault was in the part of the system that controls the relative movement of the antenna and the building. (The antenna gets pointed, and the building rotates so that the antenna doesn't hit the building.) This problem has been seen occasionally, and appears to be a warm-up issue (after power-off or line glitches in the Azimuth drive system). The symptom is that the building and antenna cross limits and the drive shuts down, requiring resets/restarts (a pretty complicated dance). Eventually that component warmed up enough that we were only hitting soft limits rather than hard limits, so the azimuth slew would just stop.

At that point it became clear that the Azimuth control had a mind of its own with regard to where the antenna should be pointing—*i.e.* it was slewing elsewhere than its commanded destination. We eventually locked out the computer control and found that manual commanding at the azimuth drive controls took us full speed towards the hard stop. (This system can rotate 1 deg/sec when it wants to.) A servo fault indicator indicated a problem, but not what the problem was, and we were stuck 6 deg from the hard-stop, shut everything down state. I invited the other operator (John) to the party 3 hours before his shift was due to start to get an additional brain on the problem with the drive system. (See [Figure 17](#)) It eventually (by the time of the 080-1100 scan) became very clear that someone (Dave Forbes/Bob Freund) with knowledge of the drive system was required on site to diagnose the fault.

Figure 17: The Azimuth drive electronics exhibited a fault that was beyond our immediate ability to repair.

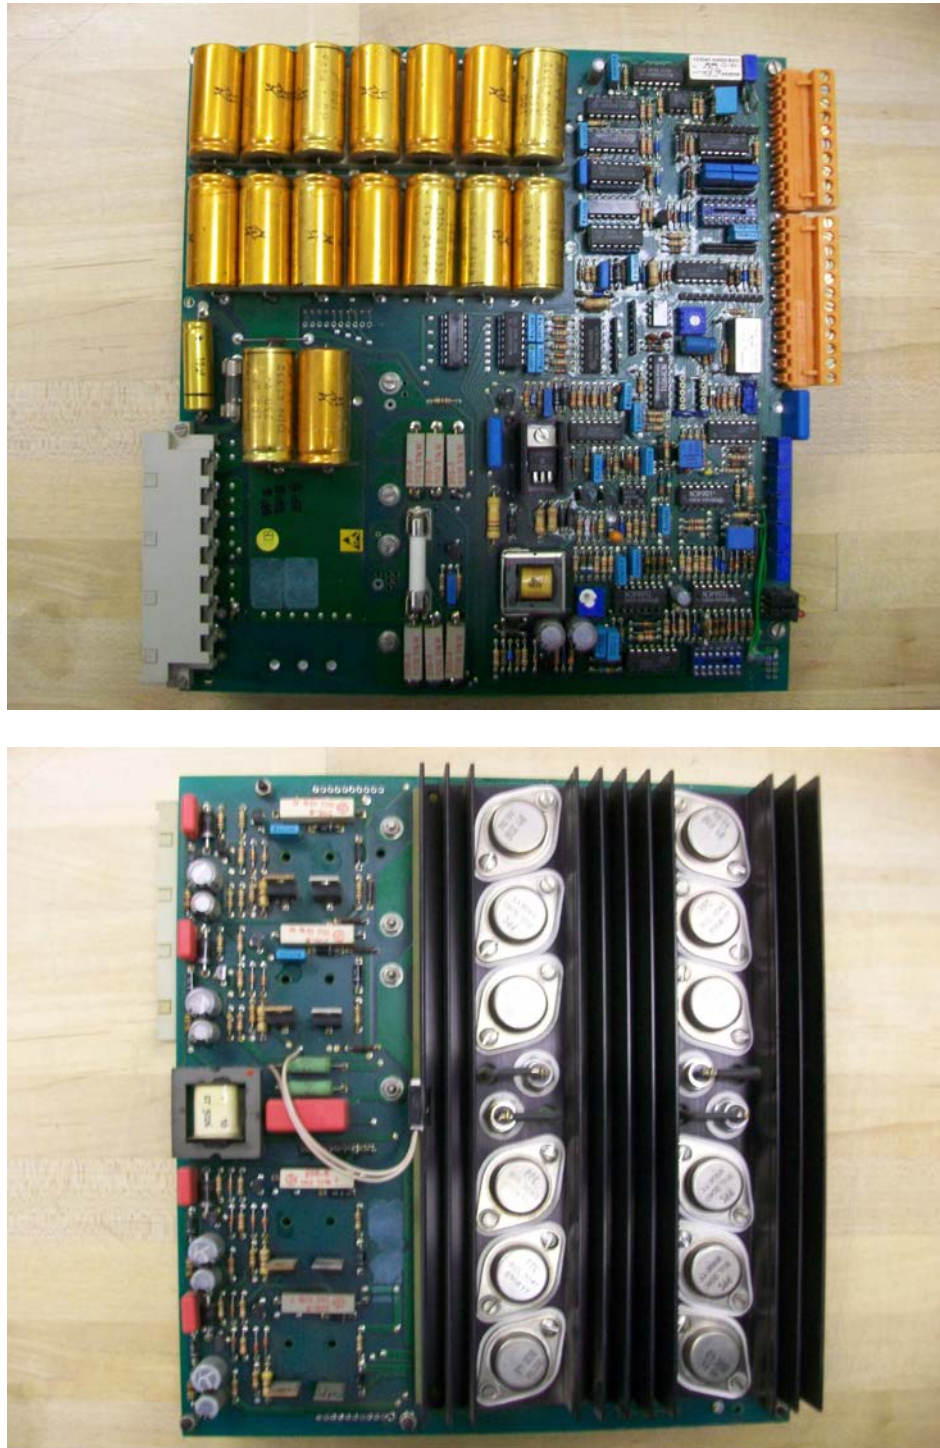
Figure 18: Ultimately the fault was traced to this servo board, and operations were restored after a suitable spare was located and installed.

Dave & Bob came up this morning and found that one of the server boards (See [Figure 18](#)) had an overcurrent protection trip, and *fortunately* a spare board of the same type was available on-site. We are now running with the spare board and full functionality appears to have been restored. The antenna has been exercised this this afternoon, and it appears to be able to point to sources as commanded. However, the pointing model appears to be a bit off. (Not enough to be a serious issue, but off nevertheless.) A new pointing model usually requires several days of observations in line mode (*i.e.* not the mode we operate in for VLBI), so it's not fixable tonight. Fortunately Patrick is the operator who builds the pointing model, and he's on duty most of this session, so he should be on top of the situation. (I'll be watching too, of course.)
