**MASSACHUSETTS INSTITUTE OF TECHNOLOGY
HAYSTACK OBSERVATORY
WESTFORD, MASSACHUSETTS 01886**

August 22, 2016

To: Space Geodesy Project
From: Ganesh Rajagopalan and Chris Eckert
Subject: Failure and repair of the GGAO broadband cryogenics and receiver

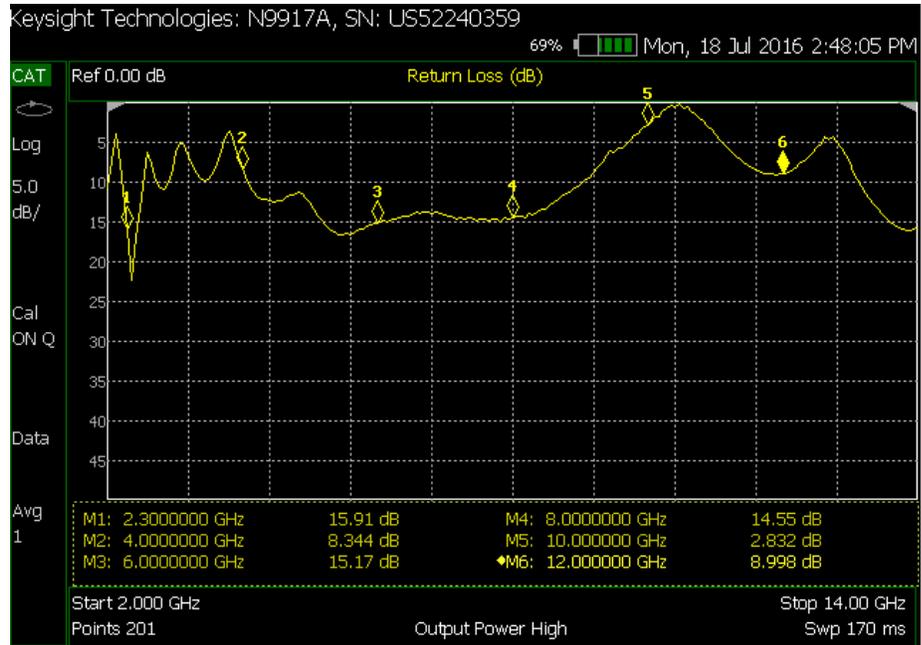
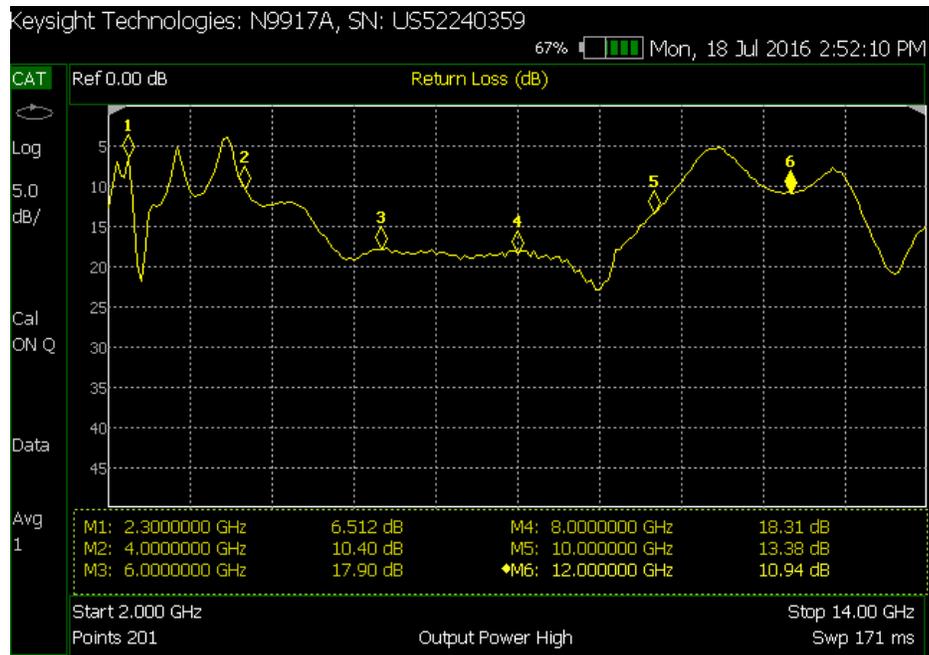
The Dewar was opened and the feed brought inside the trailer for further analysis. Using a network analyzer it was quickly evident that there were large impedance mismatches in both the vertical (V) and horizontal (H) polarization channels. Figure 1 indicates mismatch (i.e., poor return loss) across the (2-14 GHz) broadband in both polarizations.

Figure 1 Return loss in the QRFH feed for (top) vertical and (bottom) horizontal polarization before tuning.

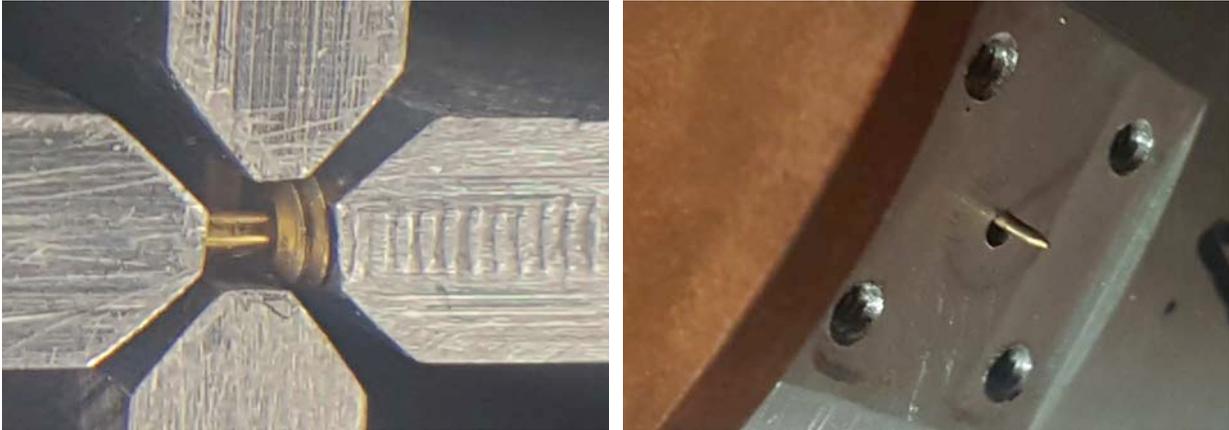
Visual inspection found positioning misalignment on the receiver probes. Figure 2 is a zoom into the receiver probes to illustrate positioning misalignment.

Figure 2 Close-up view of (left) probe and set screw, showing misalignment, and (right) end of the probe connector, showing over extension.

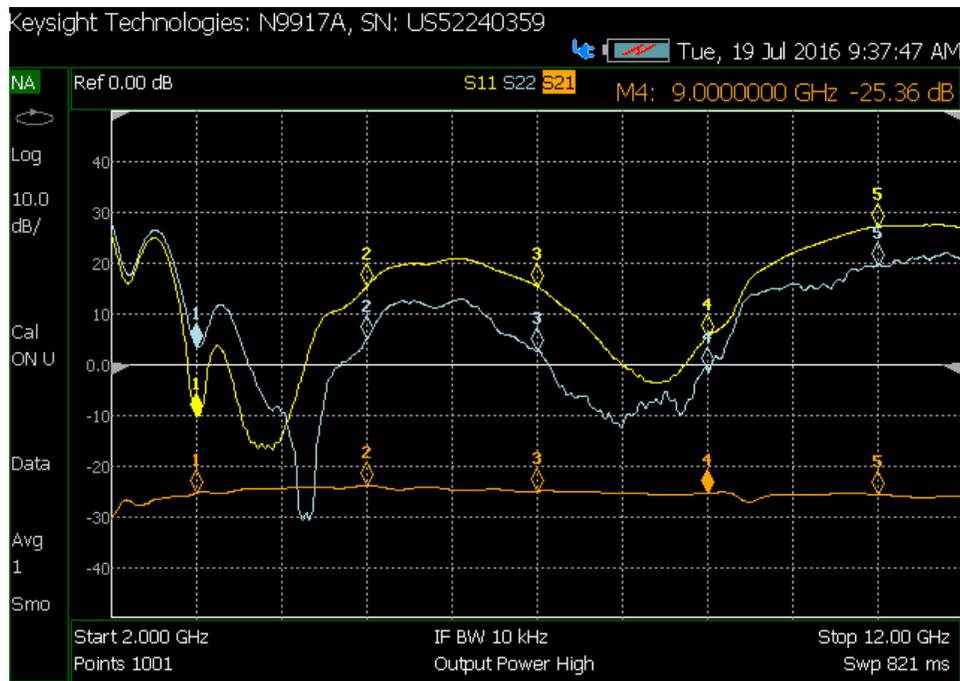
Figure 3 Post-tuning performance of (yellow) the V- and (blue) H-polarization channels.

Retuning of the probes was initiated and the results (Figure 3) show very good broadband match over the entire band after re-tuning the probes for proper positioning. (No part of the set screw should show up inside the waveguide cavity.) It was also noted that the second set of jam screws that lock the set screw with the probes were initially loose leading to the inward movement of the probe during multiple vacuum cycles contributing to the problem.

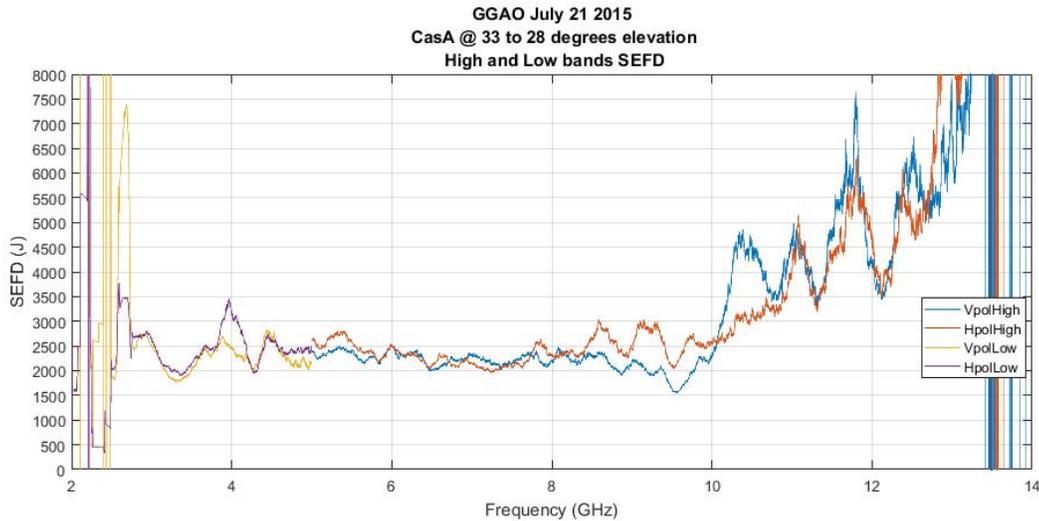
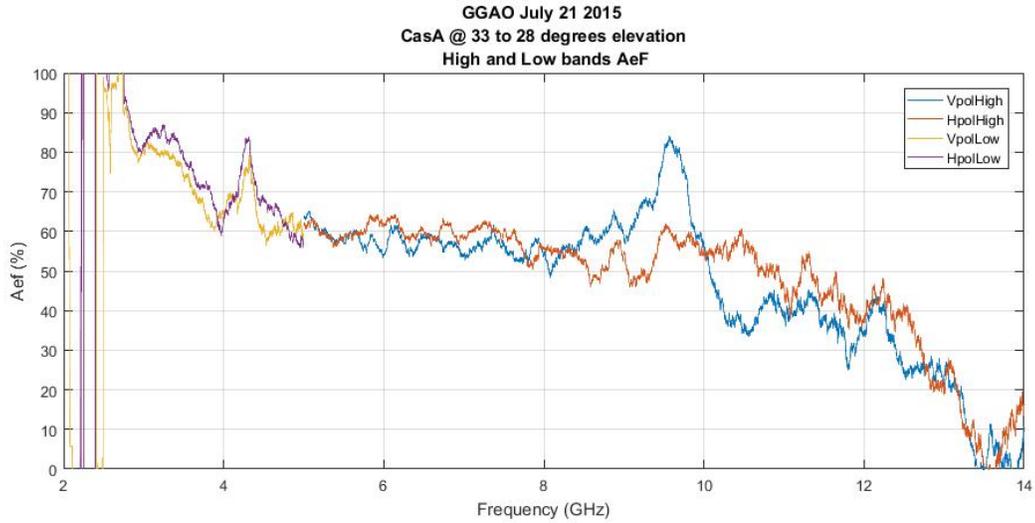
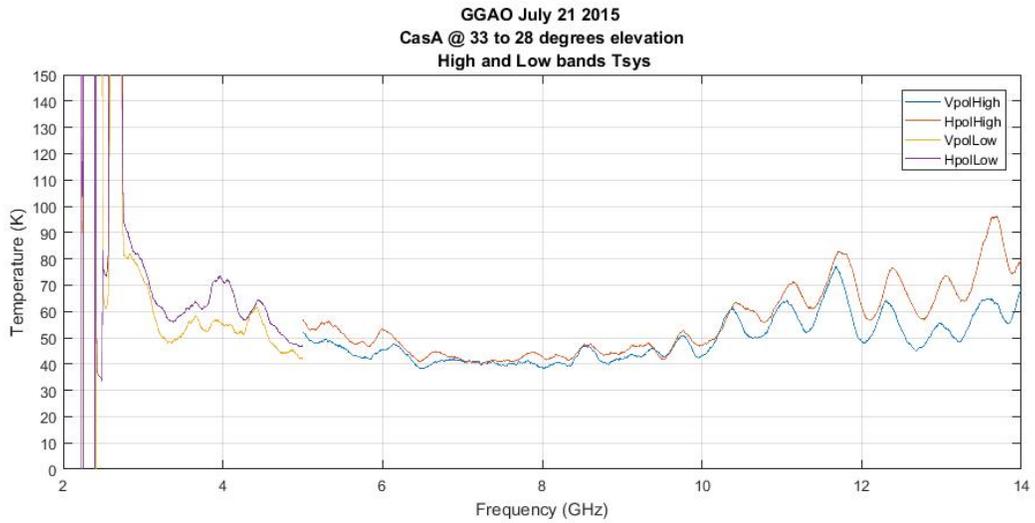
Figures 4 and 5 show SEFD, aperture efficiency, and system temperature of GGAO to compare performance between (pre-failure) February and (post-repair) July 2016. The overall improvement in flat performance up to 10 GHz can clearly be seen.

Figure 4 GGAO post-repair (top) SEFD, (middle) antenna efficiency, and (bottom) system temperature measured on CasA on 21 July 2016 (note typo in the title year).

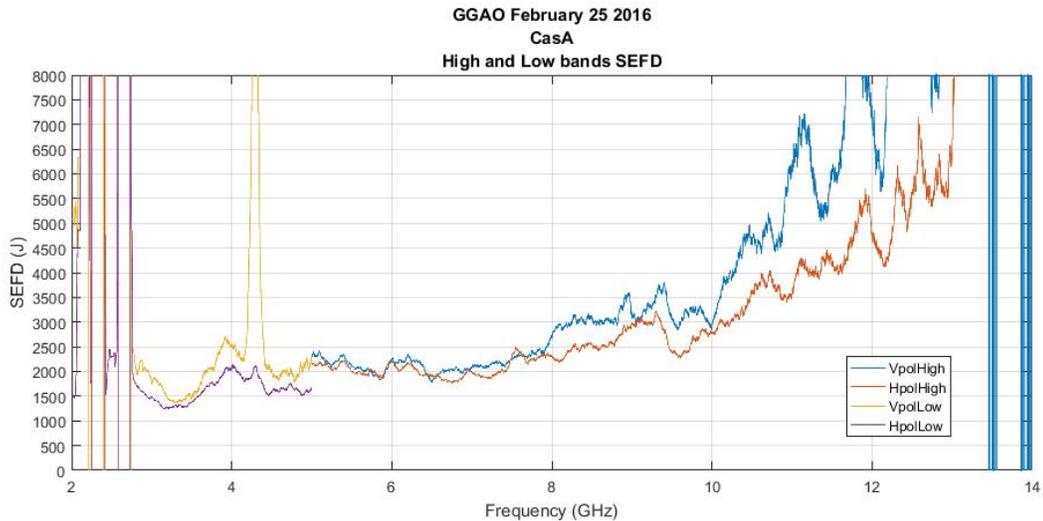
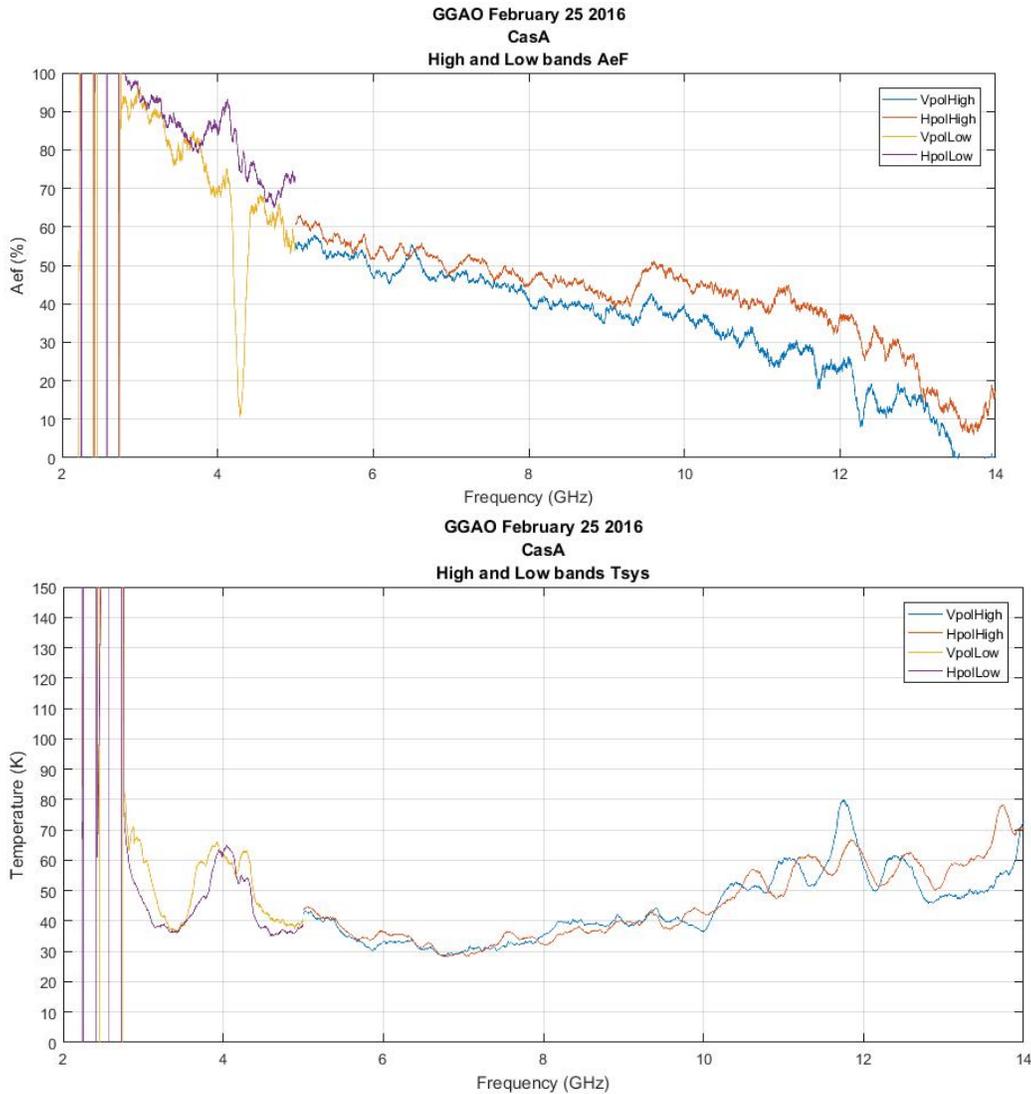
Figure 5 Same as Figure 4 but here on (pre-failure) 25 February 2016.
