HAYSTACK OBSERVATORY

Subject: Optimum illumination of Haystack

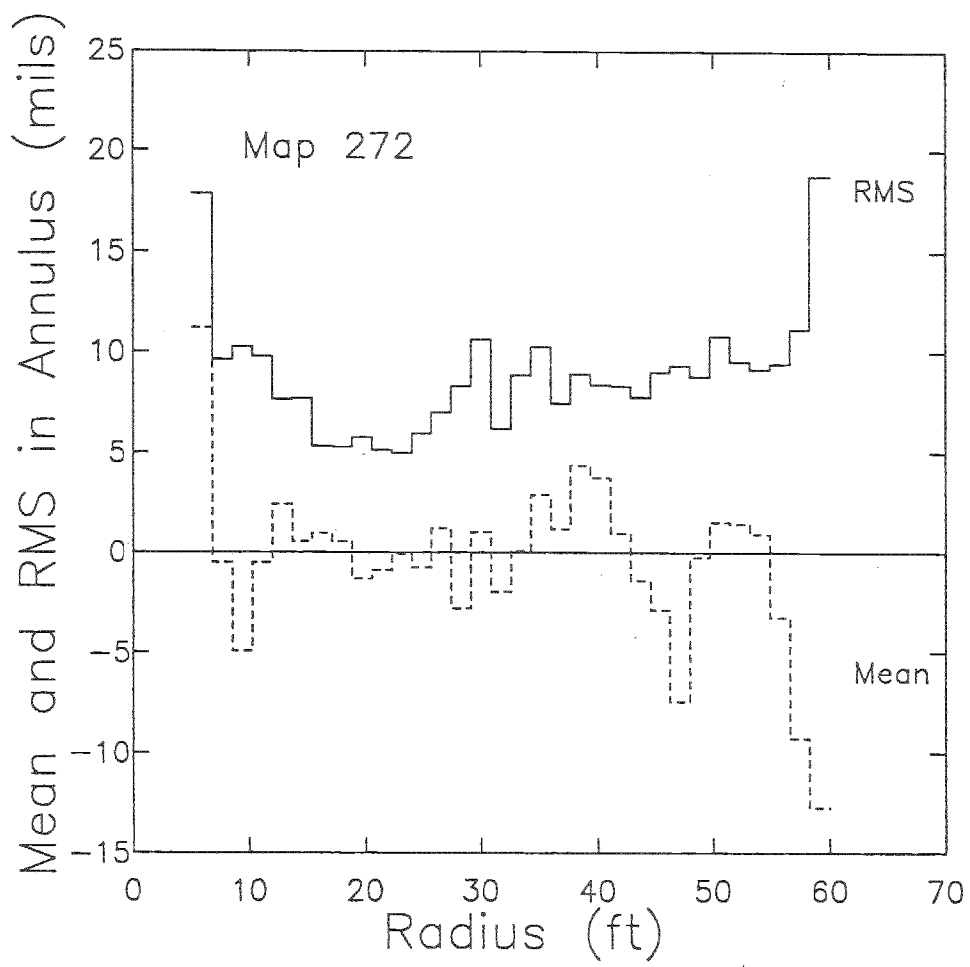
The larger than expected beamwidth (see memo dated 22 April 1993), the holographic data (see attached plot made by Rich for map 272), and the sun scans (see memo dated 24 April 1992), all suggest that the small scale rms increases rapidly towards the edge of the dish. The SGH panel survey (5 September 1989) only went out to a radius of 45 feet and found an 8 mil rms at that radius. Reading the monthly reports of North American Aviation (NAA) (see attached page), it appears that NAA had considerable difficulty with the "large ends" of the outer panels and, therefore, it wouldn't be surprising if the rms increases rapidly towards the edge of the dish. If this is in fact the case, then there is probably more advantage in under-illumination than previously thought. Rich's study of the optimum illumination used only the variation of rms with radius determined by holography. While Rich concluded, on this basis, that under-illumination would not significantly increase the efficiency, a sharp increase of small scale rms at the edge of the dish could change this conclusion. If the rms at the outer part of the antenna increases quadratically from 6 mils at the splice plate to 12 mils at a radius of 45' to 30 mils at the edge then the aperture efficiency at 115 GHz will increase from 11% with the standard 10 dB taper to 13% with a 17 dB taper. [The beam efficiency is increased by an even larger amount.] Tests using the curved mirror on the offset beam could help determine whether under-illumination is advantageous.
