**MIT, HAYSTACK OBSERVATORY**

To: EDGES Group

From: J. Barrett, R. Cappallo J. Soohoo

Subject: Devon Island Deployment Log – August 2022

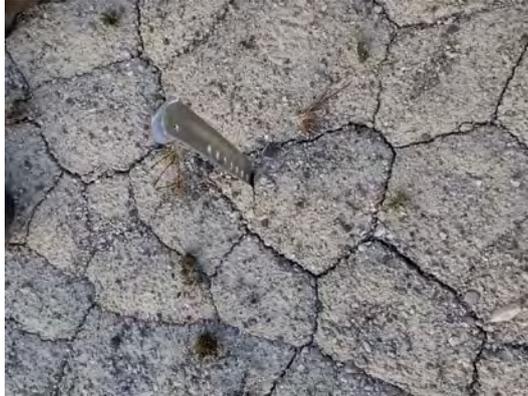
amount of vegetation on the surface. However, the ground there is much more bumpy, the surface is covered with cracks and small mounds (about 6 inches to 1 foot in diameter) that undulate about 5-7cm from peak to trough as shown in figure 2. The ground is also prone to cracking into chunks which appears to make the stakes used to secure the ground plane less stable against much wire tension (if for example it is necessary to tension the wires enough distortion from the undulations). The trail to into the crate to reach the Drill hill location is significantly rougher than Site 1, and might pose a larger risk of vibration damage to the antenna electronics.

Figure 2: The ground condition at Site 2 (Drill Hill), showing the localized mounds and cracking.

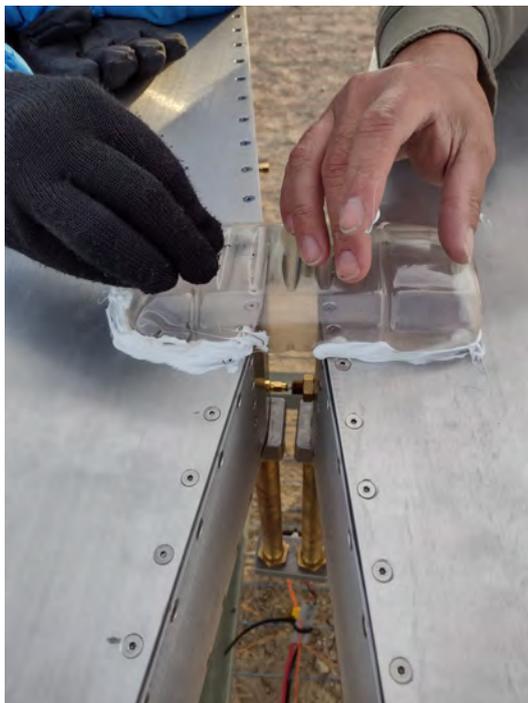
box at 30C and a script to perform the VNA calibration measurements was launched. At 9:00PM (CDT) a fresh battery was brought out and the spectrum calibration measurement script was launched to run overnight. In addition, the plastic rain cover (from juice bottle) was attached with caulk to protect the central connector from direct precipitation as shown in figure 8.

Figure 8: Rain cover attachment.

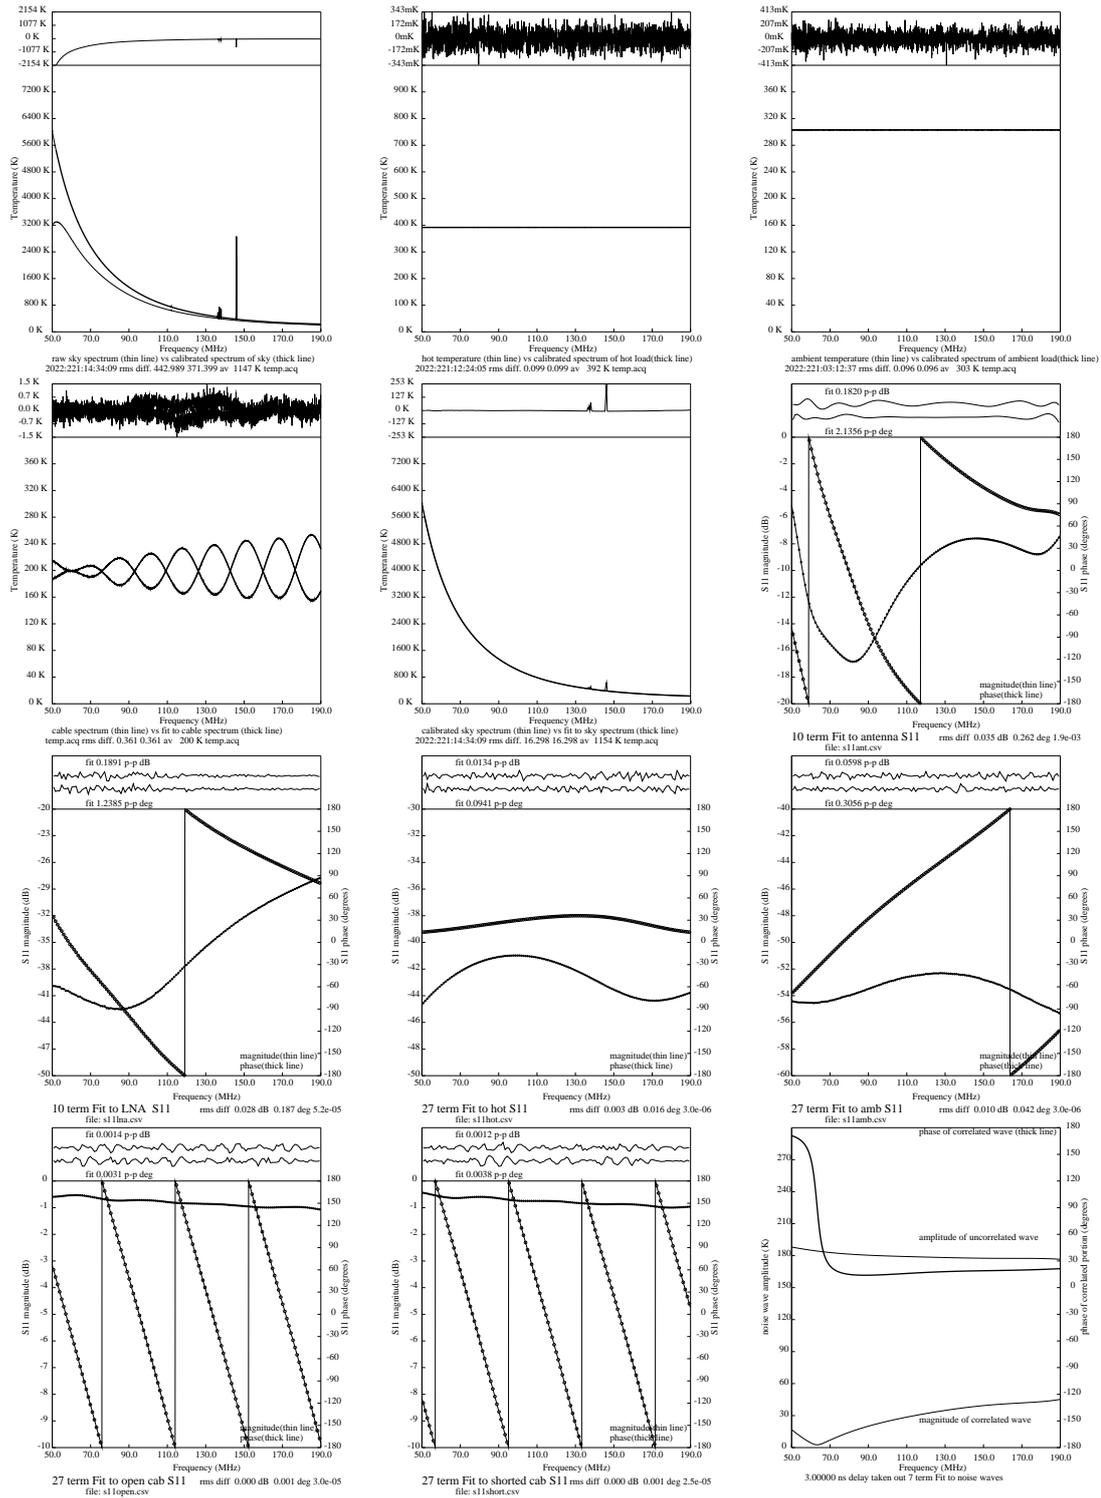
At 9:00AM we returned to swap in a fresh battery, and launch a script to acquire sky data until 9:00PM. At this point the front-end box was still configured to run at 30C. However, in consultation with Alan (upon viewing the spec-cal data), it was discovered that the system was having difficulty maintaining a temperature of 30C, often dipping as low as 27C. This was determined from the large residuals on the open/shorted cable fit, as shown in figure 9.

Figure 9: The initial calibrated spectrum (poorly maintained 30C front-end temperature, with 15 minutes of sky-data). Note the large residuals in the plot of the cable spectrum (left, 2nd from top).

At 9:00PM we returned to swap in a fresh battery. We reconfigured the system thermal control to keep the front-end electronics box at 20C. We then configured an overnight script to run the VNA-cal process and then spec-cal process.

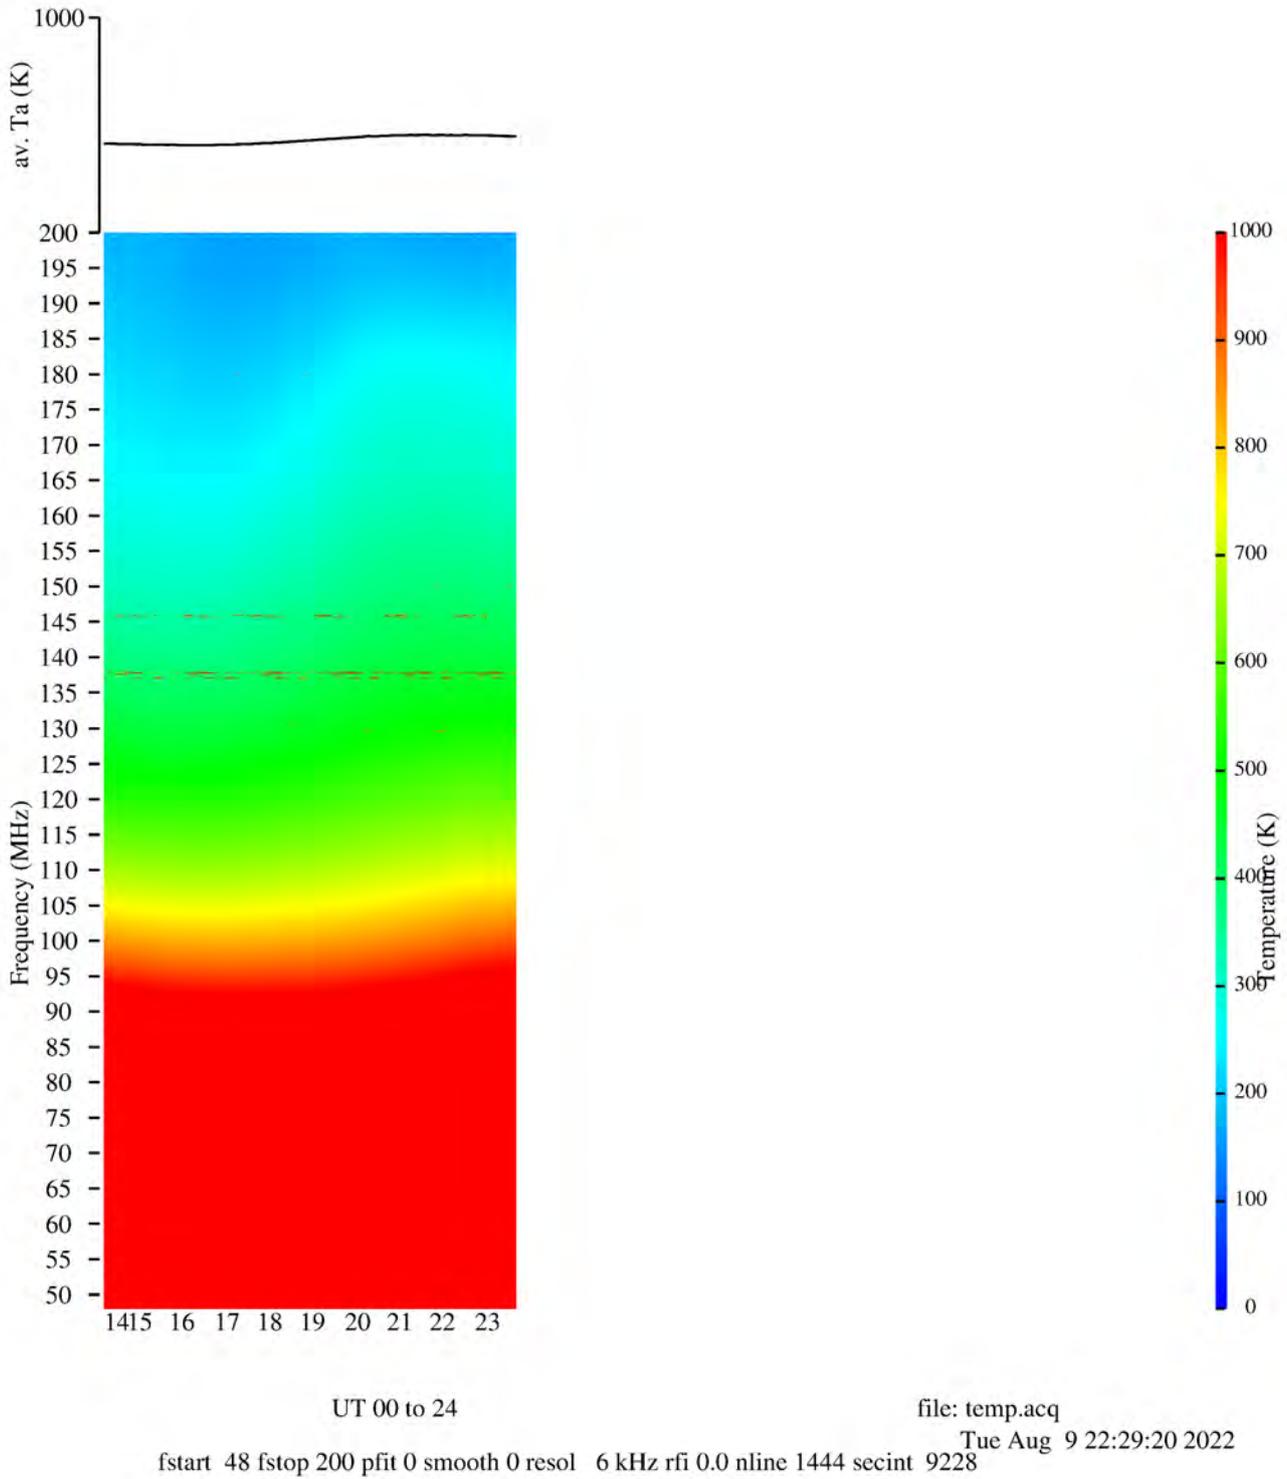
only a minor amount of meteor scatter in the EDGES observing band. A waterfall plot from 50 to 190 MHz is shown in figure 10. The signals near 137 and 145 MHz appear to be satellites.

Figure 10: Water-fall plot of roughly 12 hours of spectrum observed by the EDGES instrument.

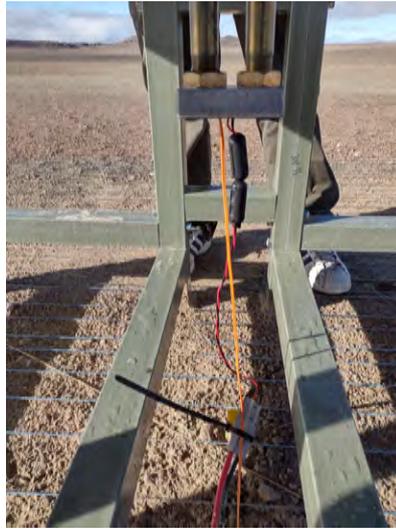
Today around 7:30PM we added an additional ferrite on the DC input line at the base of the antenna, as shown in figure 14.

Figure 14: Additional ferrite at DC input.

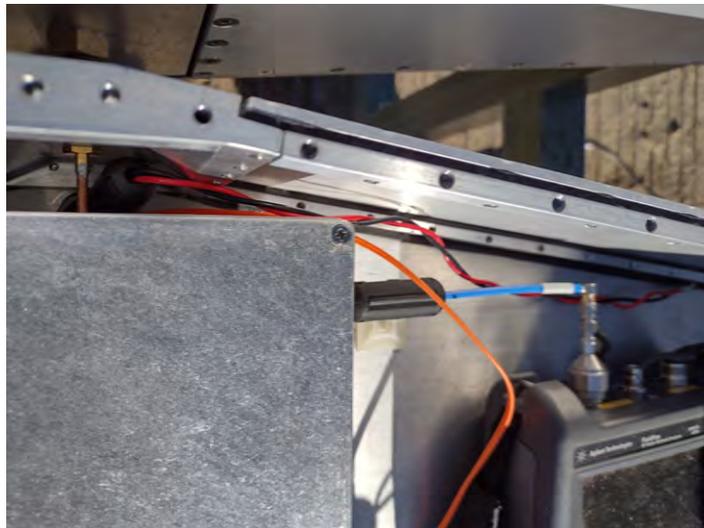
Today at 3:00PM after consulting with Alan we opened up the antenna in order to add an additional ferrite to the DC input line at the pipe opening as shown in figure 15. We added an additional ferrite on the DC input line just after the terminal block as well for good measure.

Figure 15: Internal ferrite at the DC input inside of the antenna.

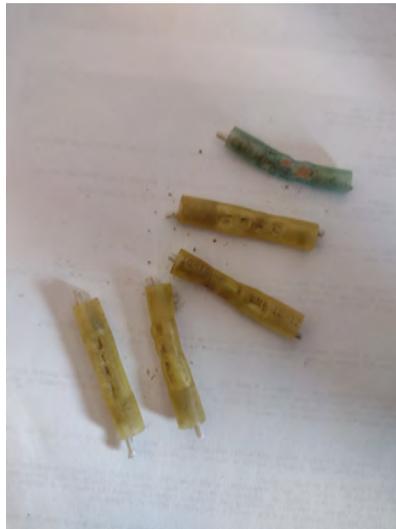
Today after talking with Alan, we returned to check the ground plane electrical continuity. While the ground plane was examined to physically continuous, we discovered that there were several electrical breaks in western most 5 meter section of the ground plane. These disconnects were due to poor electrical connections formed by the crimp-style butt connectors used in this (earliest assembled) section, as shown in figure 18. The locations (wire, as numbered from west, starting with #1) of the disconnects are listed below, the distance specified is the length measured from the south side of the ground plane, all discontinuities discovered were in the outermost 25cm spaced section. These breaks were repaired, and the resistance between the South-East corner of the ground plan and opposite North-West corner was measured to be 176 Ohms, while the resistance between the South-East Corner to the approximate mid-point was 90 Ohms.

1. Wire #3, @ 3.65m
2. Wire #6, @ 42.5m
3. Wire #9, @ 12m
4. Wire #12, @ 33.6m
5. Wire #15, @ 16.45m
6. Wire #18, @ 33.15m
7. Wire #21, @ 17.3m

Figure 18: The bad crimp style butt connectors (avoid in future deployments).
