### MASSACHUSETTS INSTITUTE OF TECHNOLOGY HAYSTACK OBSERVATORY WESTFORD, MASSACHUSETTS 01886 March 26, 2025

To: EDGES group From: Rigel C. Cappallo Subject: EDGES-3 repair trip to Adak, AK, March 2025

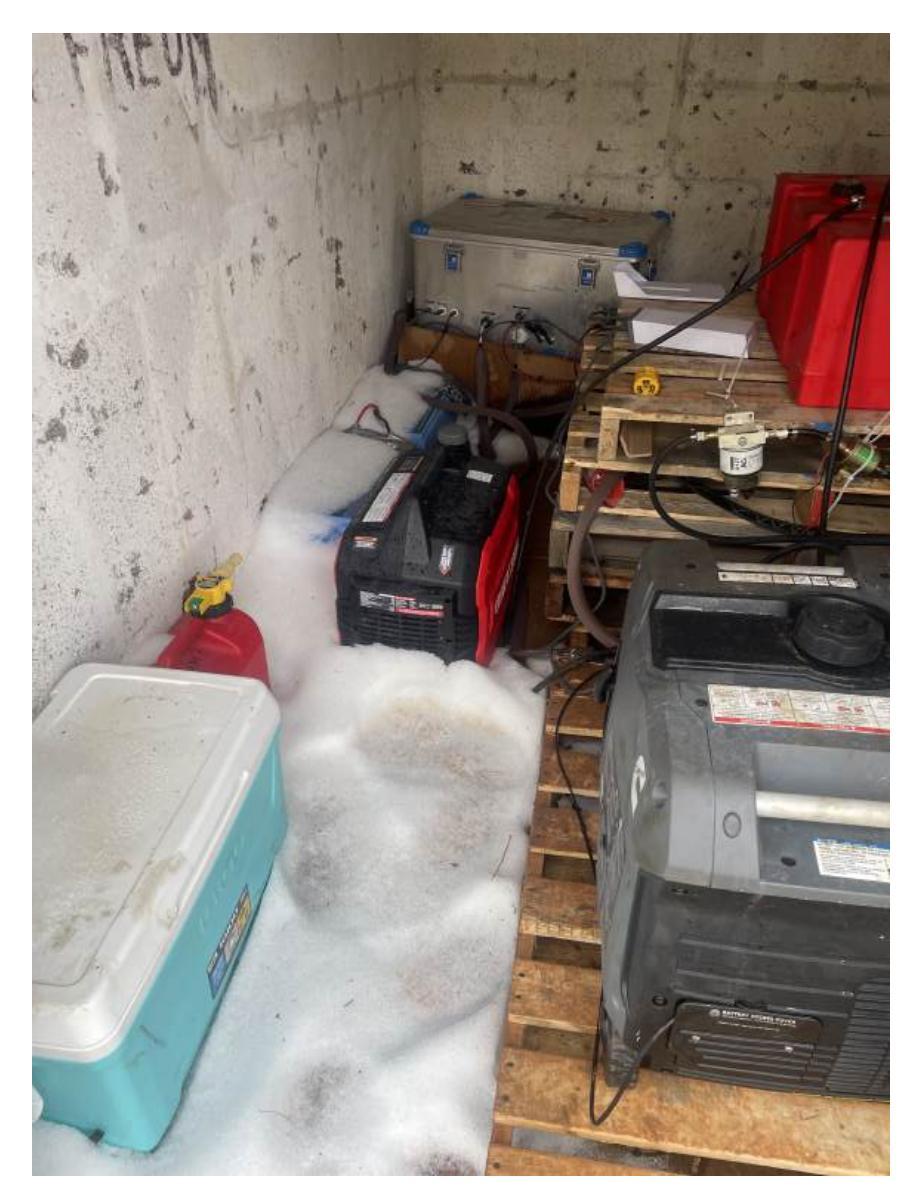
Figure 1: The electronics hut upon arrival to the site. Snow had drifted clear to the back of the hut, covering the batteries in the process.

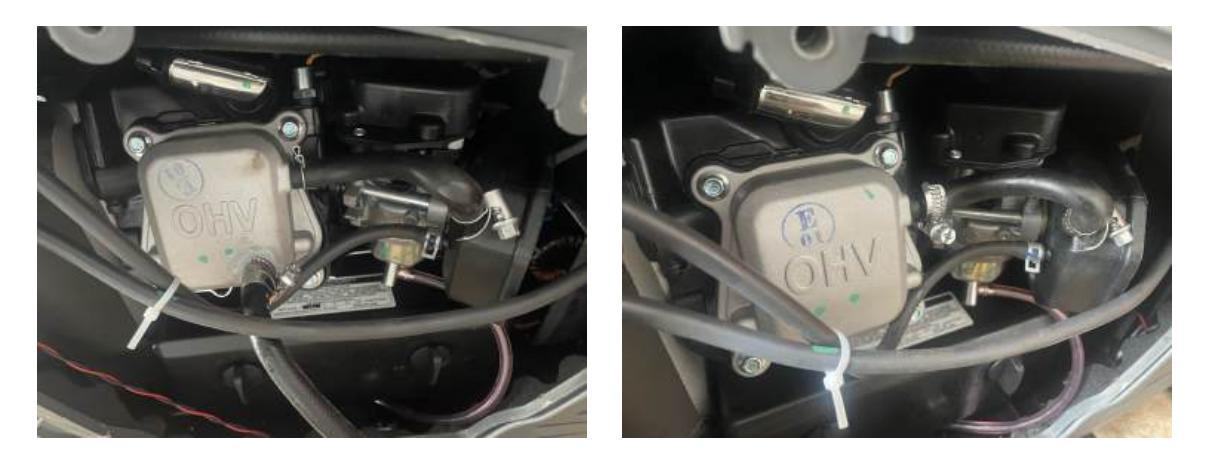
Figure 2: *left:* The previous valve cover with the alteration to allow a second fuel line. *right:* The new valve cover, without the post-production alteration.

After some general housekeeping and plugging things into their proper places, I opened up the generator and replaced the altered valve cover with the brand new one I had cannibalized from the back-up generator at Haystack (Fig. 2). Everything in the electronics box was still functioning nominally. I started up the generator and left it to run for  $\sim$  five hours in order to fully recharge the batteries. After that it was set to shut off, with an antenna S11 and then sky data to be taken overnight.

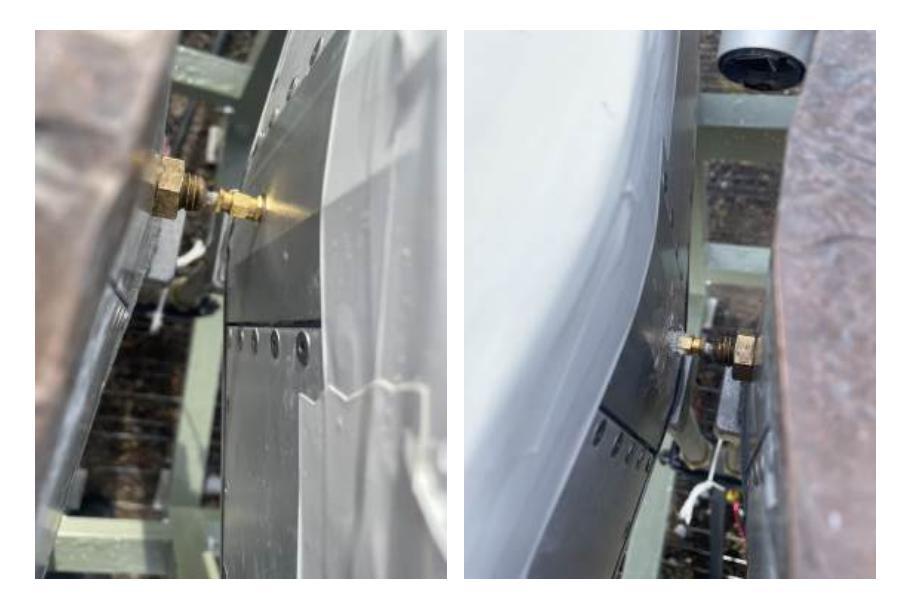
Fortunately, around noon there was a break in the snow and I decided it was the best time to attempt the antenna repair. Once I removed the shielding and the grease, I saw that the brass nut was loose (i.e. I could easily turn it with the tip of my finger, left panel of Fig. 3). I also noticed that most of the dielectric grease had leaked out of the SMA connection covering and run down the side of the antenna, ultimately resting upon the top of the small aluminum box above the pipe.

Figure 3: *left:* The connection after removing the covers and grease. *right:* The connection after the epoxy was applied, being cured by the heat gun just visible in the top of the photo.

I cleaned both surfaces with Q-tips and alcohol, applied polish to abrade the surfaces, covered the area with conductive epoxy, and tightened the brass bolt. Then with a heat gun I kept the area at 150 °F for two hours to cure the epoxy (Fig. 3, right panel). Once cured, I applied more dielectric grease to the connection and re-covered it, this time leaving the opening slit on the inner SMA connection cover facing the sky, in hopes of ameliorating the leaky grease issue (Fig. 4).

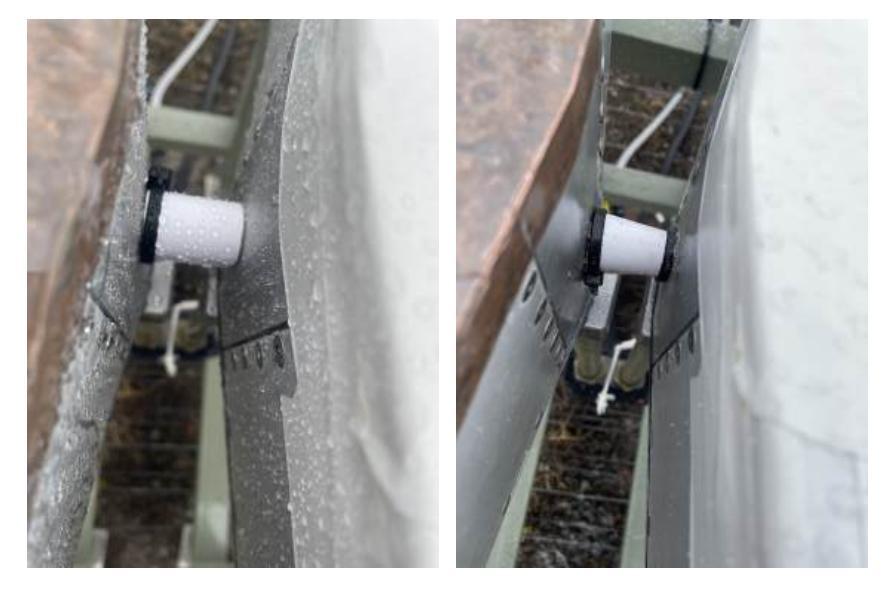
Figure 4: *left:* The connection between antenna boxes before the repair was performed. *right:* The connection in its final state after the repair.

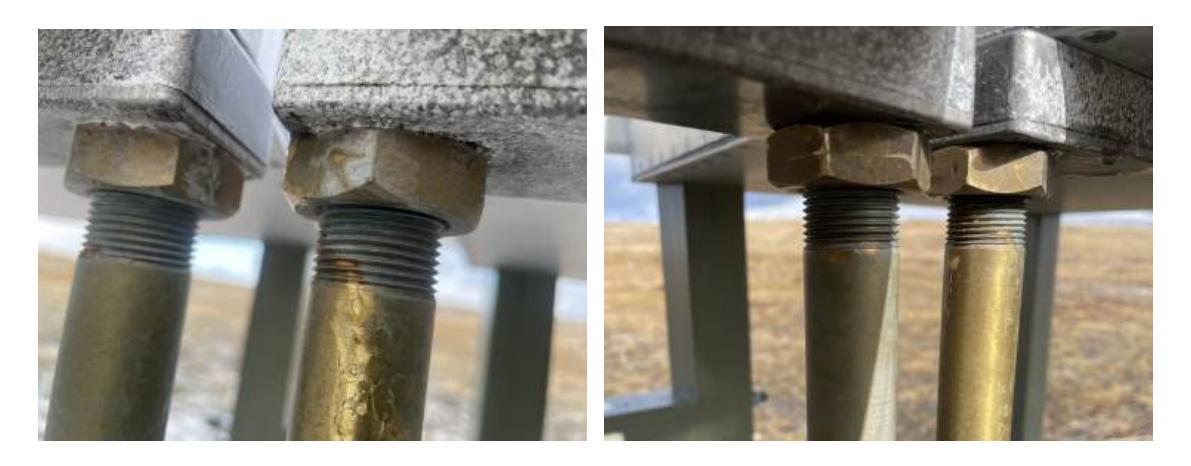
Rogers met virtually to discuss other possibilities. We decided to check the continuity between the two antenna boxes via the brass pipes. I found there was a break between the top of the brass pipe and the little aluminum box under the electronics half of the antenna, with a DC resistance of  $\sim 15,000 \ \Omega$ . The corrosion was extensive, as brass and aluminum are far apart on the galvanic scale, and the sea is on the order of hundreds of meters away (Fig. 5, left panel). To fix the connection, I loosened the brass bolts and cleared away the corrosion, first with the blade of a knife and then by cleaning and polishing (Fig. 5, right panel).

Figure 5: *left:* Corrosion visible at the interface between the top of the brass pipes and the small aluminum boxes. *right:* The same area after polishing and cleaning.

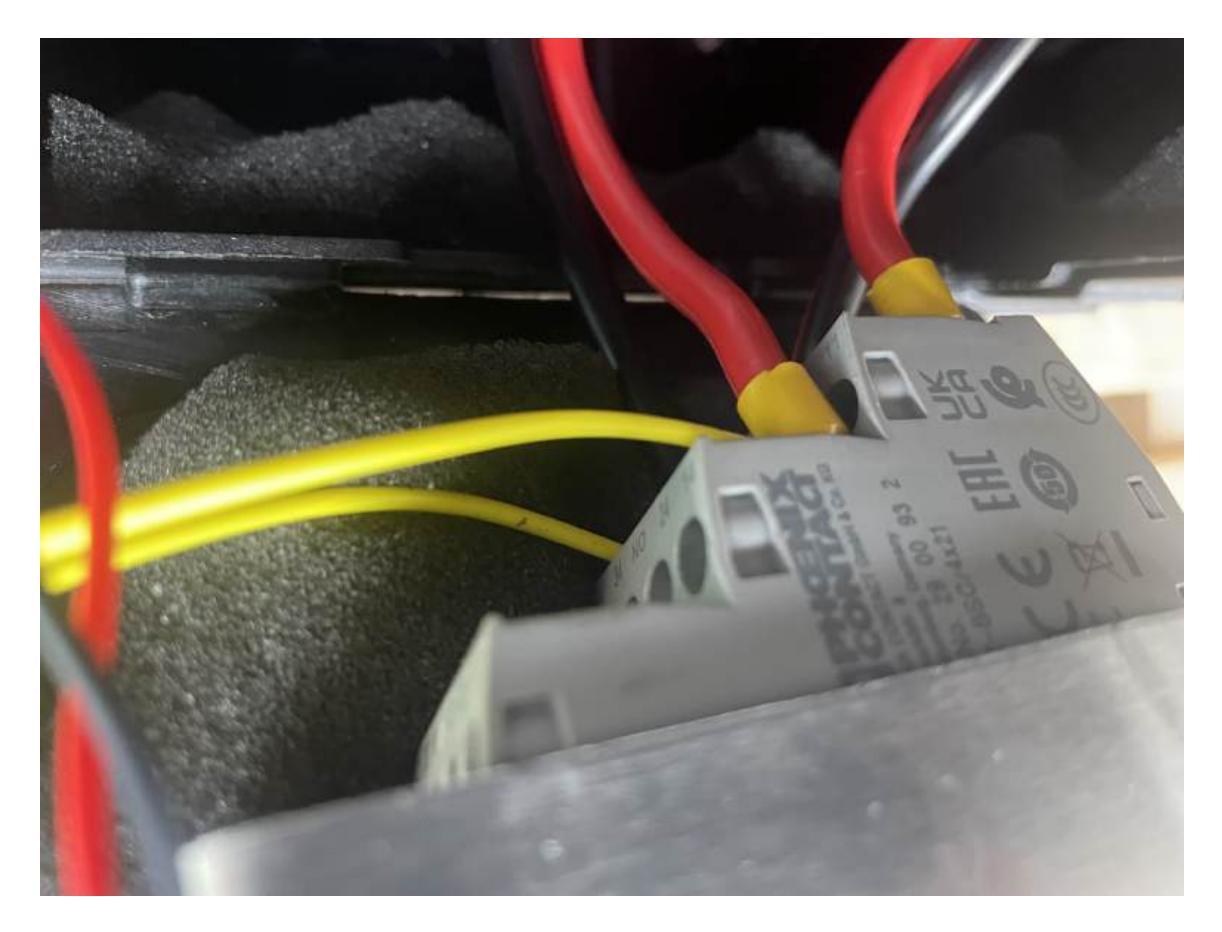
Figure 6: The rewiring for the external fuel pump. Now the power comes directly from the 12 V battery, via the relay (yellow wires).

Turning my attention to the generator, I rewired the external fuel pump to be powered directly from the 12 V generator battery (though still controlled by the Arduino), removing the potentially faulty converter (Fig. 6). For the task I used leftover 18 aug copper wire from the ground plane.

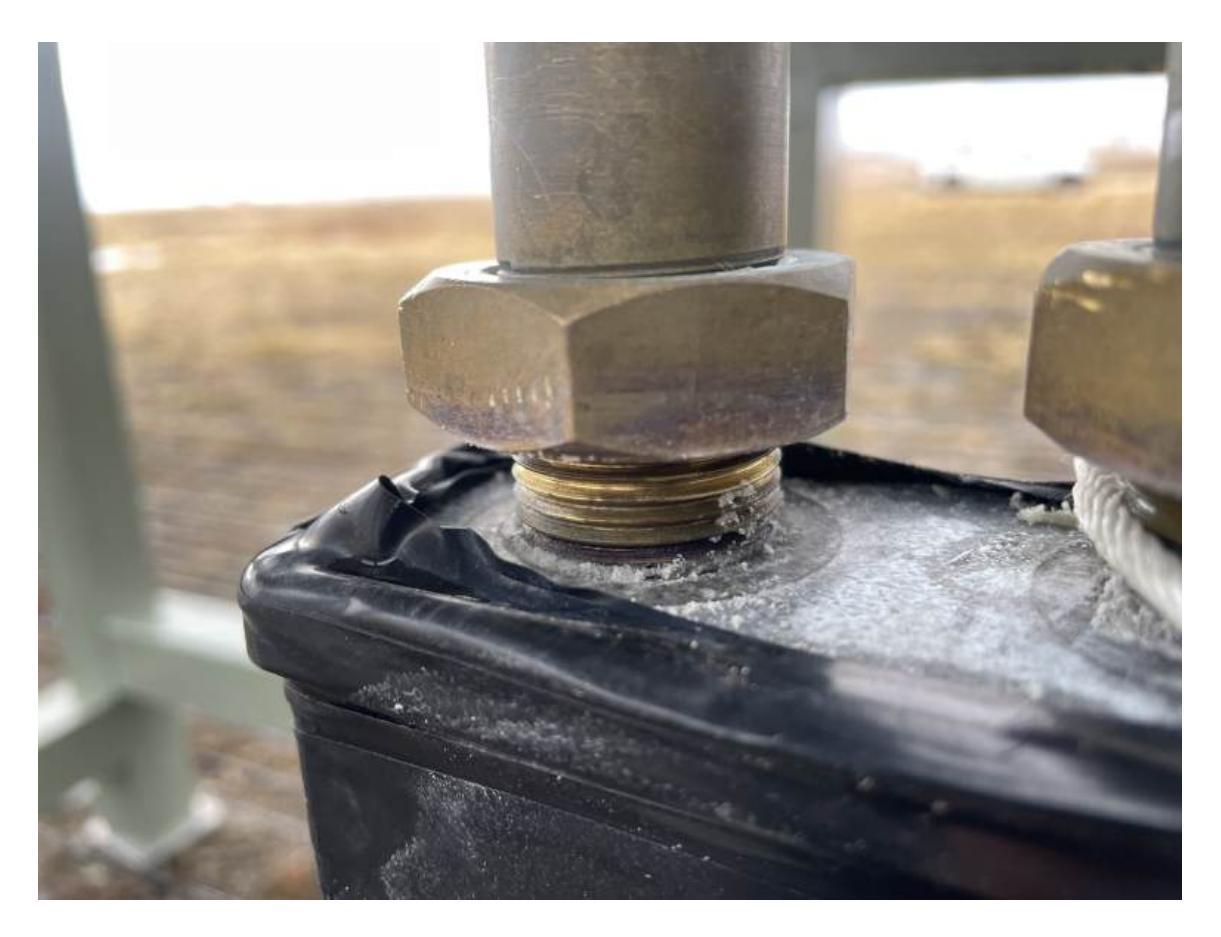
The conduit for electricity from one box to the other, through the brass pipes, has six interfaces where corrosion can build, three per side: the point where the bottom panel of the box meets the small aluminum box, the point where the bottom of the aluminum box meets the top of the brass pipes, and then the point where the bottom of the brass pipes meets the aluminum of the black box (Fig. 7). Using a multi-meter, I found there was still resistance in that circuit of the order 10  $\Omega$ , specifically where top of the small aluminum box meets the bottom panel of the empty antenna box. This was more difficult to fix, as the nut that tightens that connection cannot be accessed without removing the top panel of the antenna box, which I did not have time to do. I cleaned and polished the area, and then applied some of the conductive epoxy remaining from the earlier repair. It was not cured, as the weather was not amenable to that, but the thinking was that even uncured, it would still conduct. After all six connections were cleaned and polished thoroughly, the resistance between the two boxes returned to zero. This failure mode is bound to recur, given the environment, but the hope is that it will not happen before the end of the observing season, which is April  $23^{\rm rd}$ .

Figure 7: The corrosion in the screw threads of the interface between the bottom of the brass pipes and the black box.

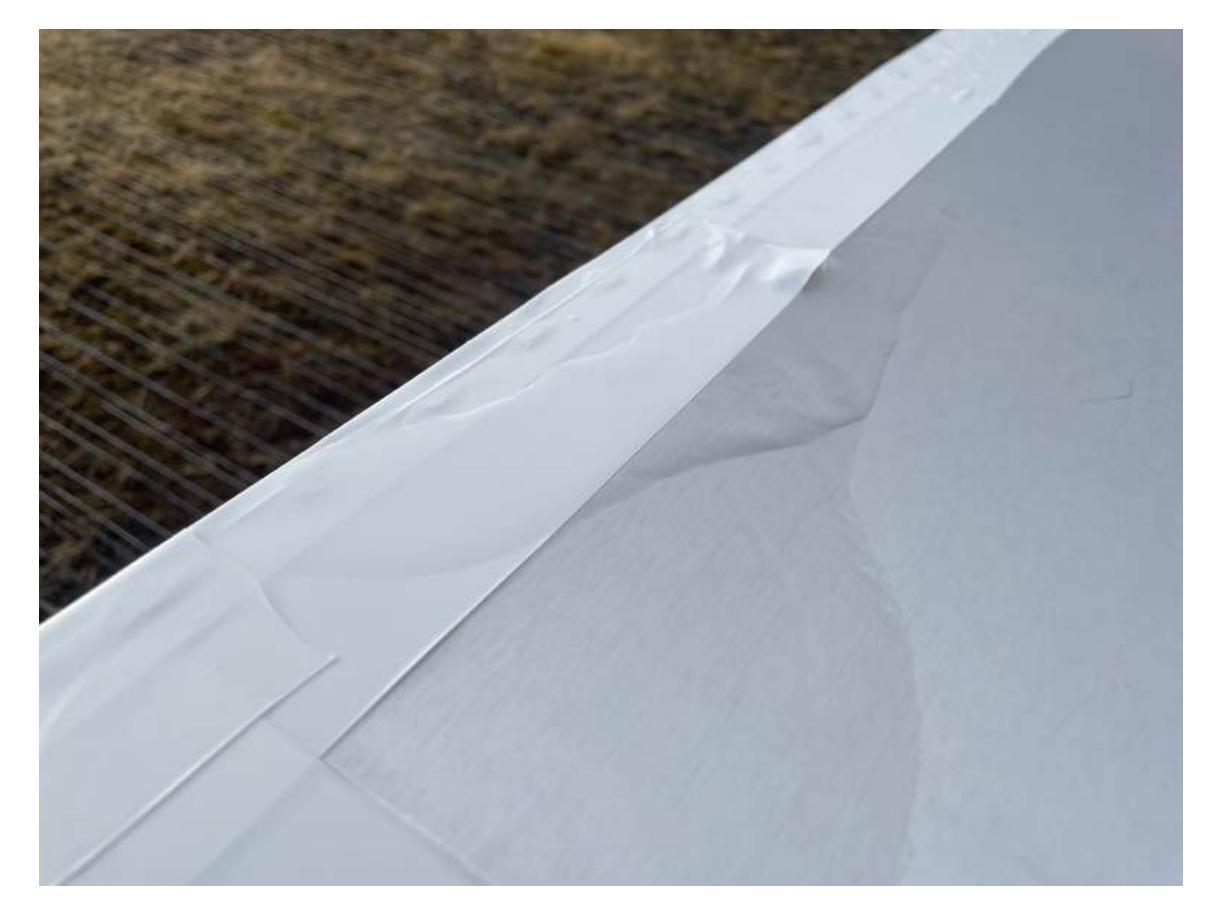
likely damage it. I noticed that water tended to pool on top of the antenna boxes, even from the previous day (Fig. 8), thus it seems possible that it may have found its way into the box. There was no solution to this problem that didn't involve removing the antenna panels, and was thus not addressed. Any future data from this deployment will have to be calibrated using files obtained prior to this malfunction.

Figure 8: Water pooled on the top of the antenna box. This water remained from the previous day's rain. The white weatherproofing tape may not be adequate in a windy, perpetually damp environment such as Adak.

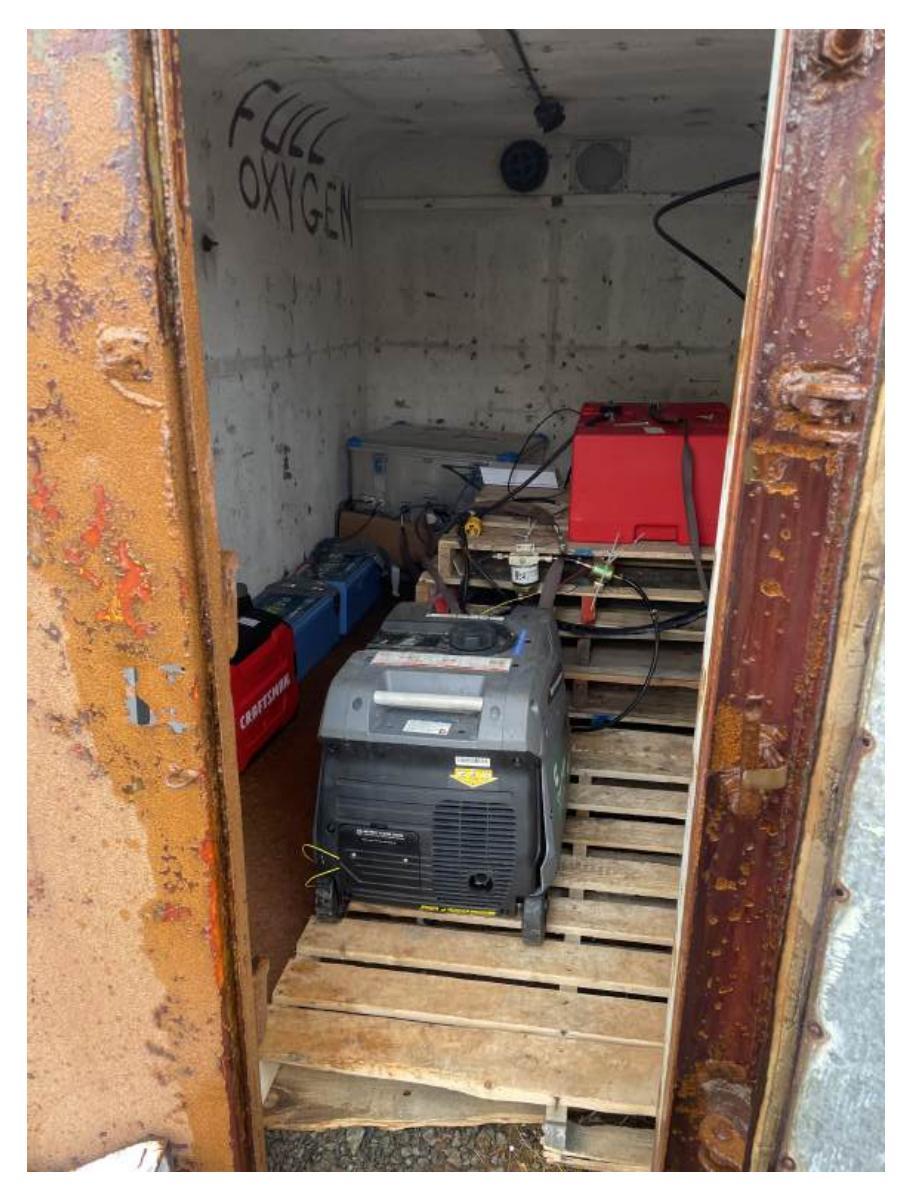
Figure 9: The state of the electronics hut upon departure from Adak.
