**MASSACHUSETTS INSTITUTE OF TECHNOLOGY
HAYSTACK OBSERVATORY
WESTFORD, MASSACHUSETTS 01886**

December 18, 2014

Subject: Changes to EDGES antenna to minimize frequency dependence of beam

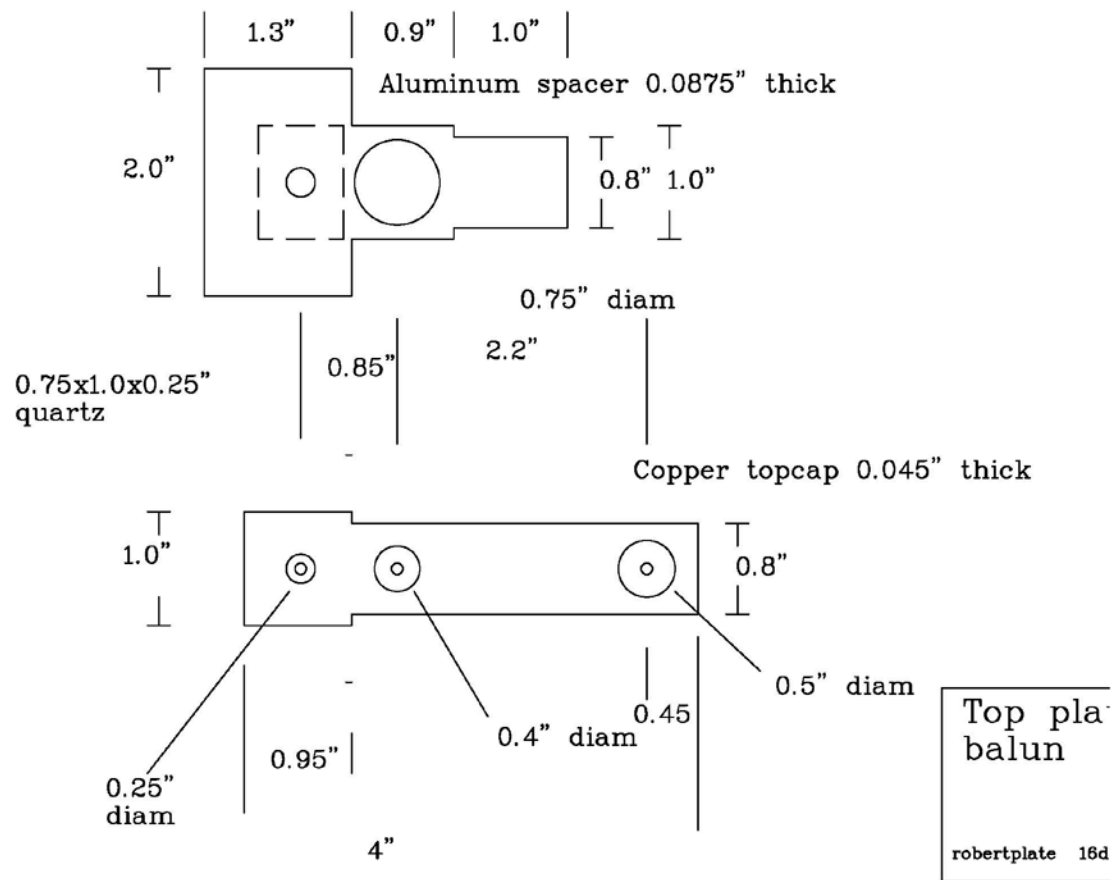
Figure 2. Revised top plate design

- a) Tip capacitance set by $1 \times 0.75 \times 0.35$ " quartz set to maximum.
- b) Top cap design modified as per the drawing in Figure 2 using $1 \times 0.75 \times 0.25$ " quartz set to minimum and located 0.26 m from the base plate.

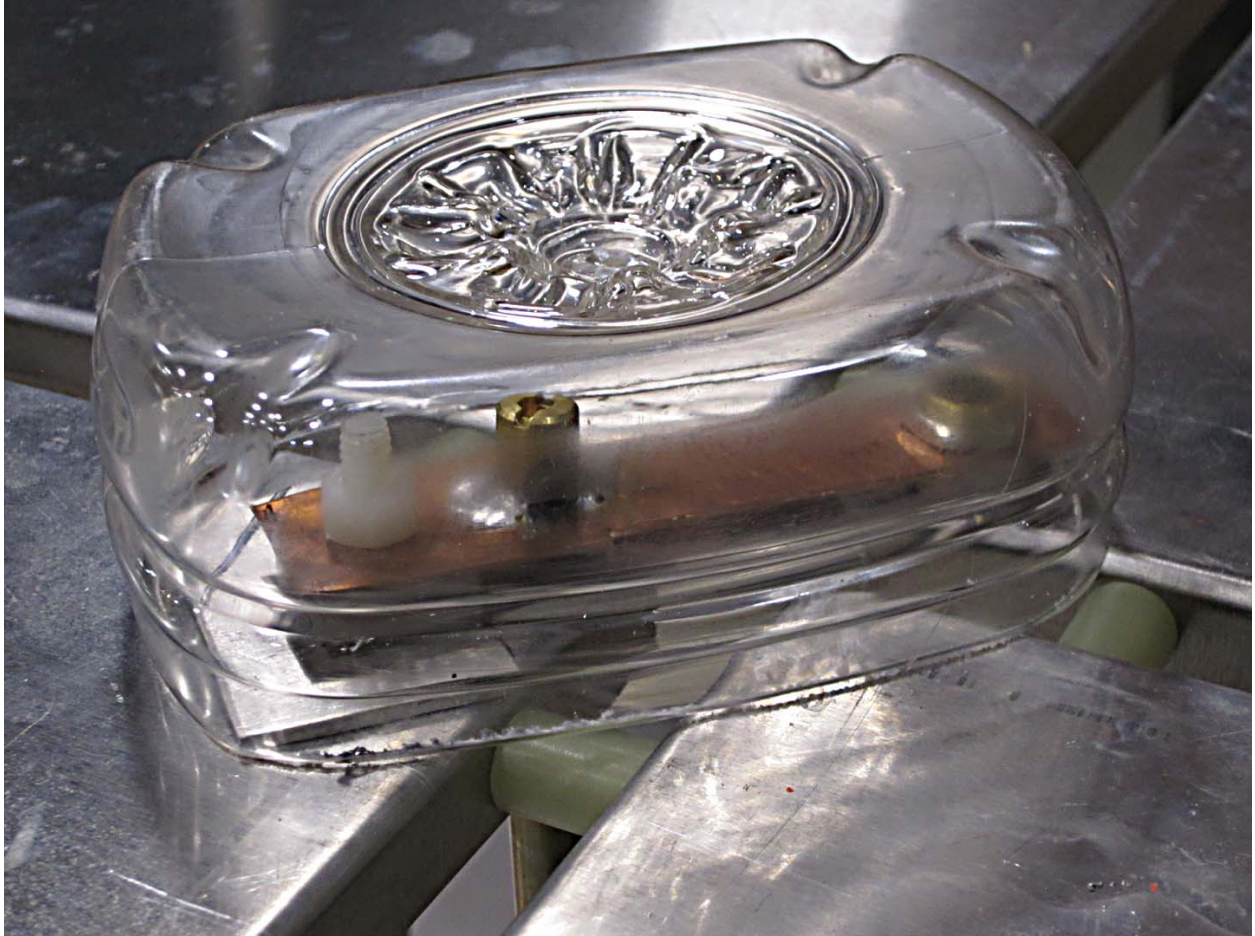
Figure 5. PET rain cover for top plate.

- 2) Recently large changes in S11 were observed in the EDGES antenna at the MRO following rain. These changes took more than a day to recover. The addition of a rain cover as shown in Figure 5 should prevent a slow recover from rain.
