**MASSACHUSETTS INSTITUTE OF TECHNOLOGY  
HAYSTACK OBSERVATORY  
WESTFORD, MASSACHUSETTS 01886**

To: EDGES Group  
From: Alan E.E. Rogers  
Subject: Second low band antenna and balun tests

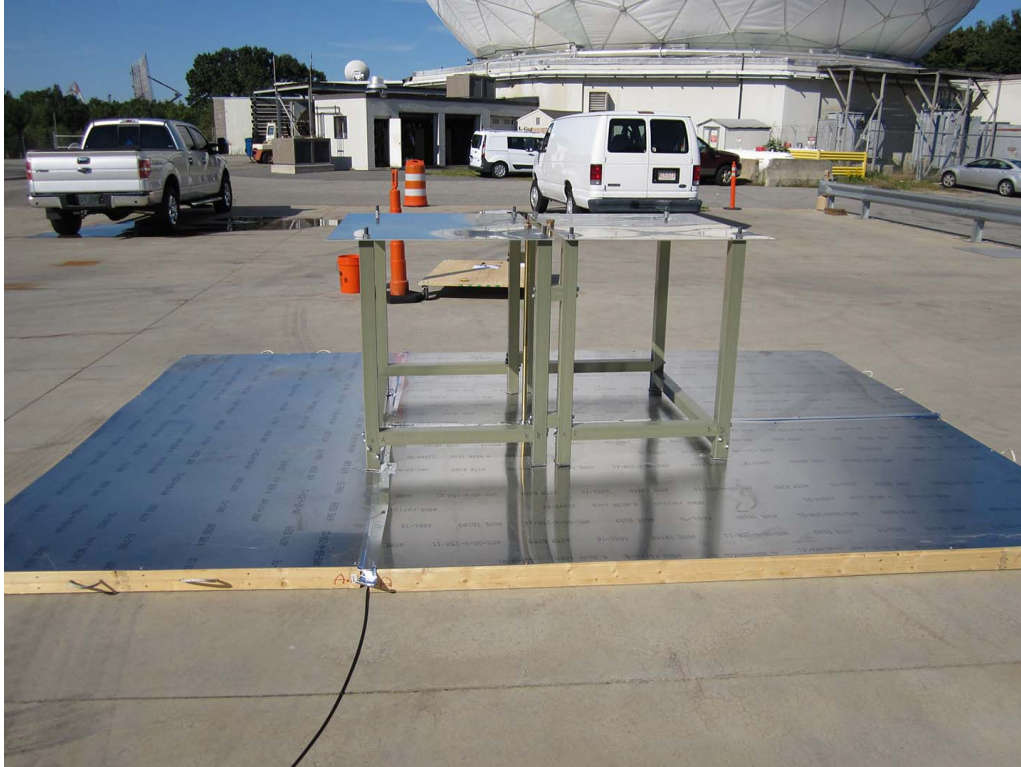
Figure 1. Second low band antenna under test at Haystack.

Figure 1 shows the second low band antenna on small metal ground plane for an initial test at Haystack. The top cap plate height and panel gap were adjusted to the value of the low band blade antenna currently in operation at the MRO as shown in Figure 2.

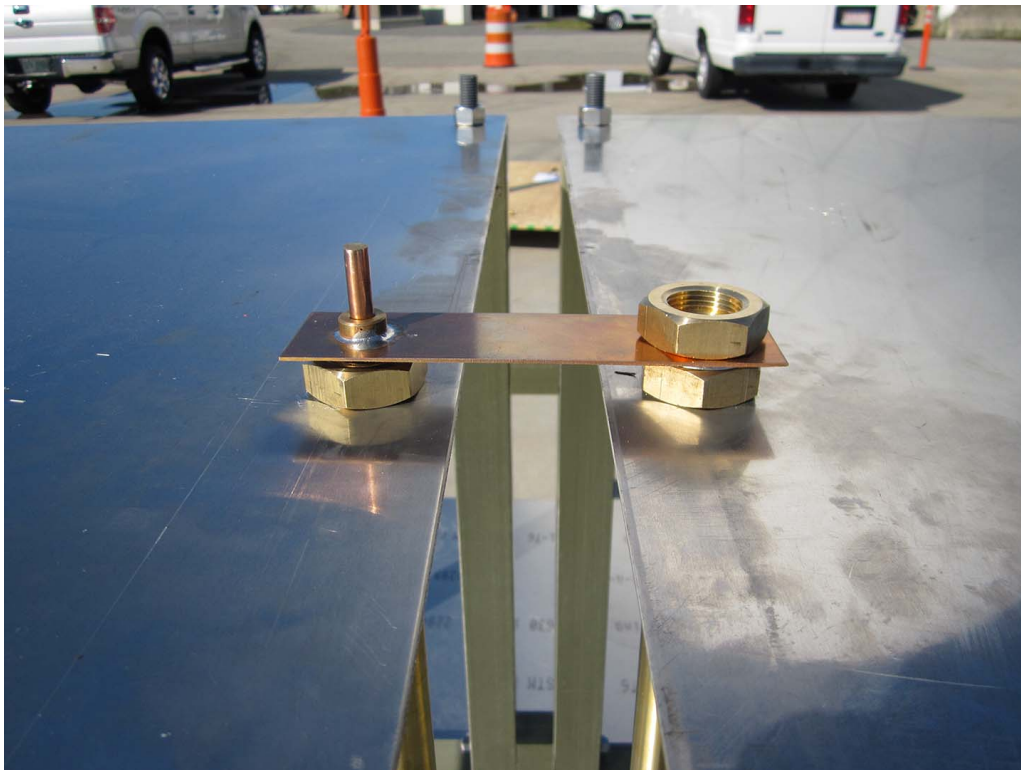
Figure 2. Top cap plate adjusted to 0.61" from panel set to gap of 1.955".

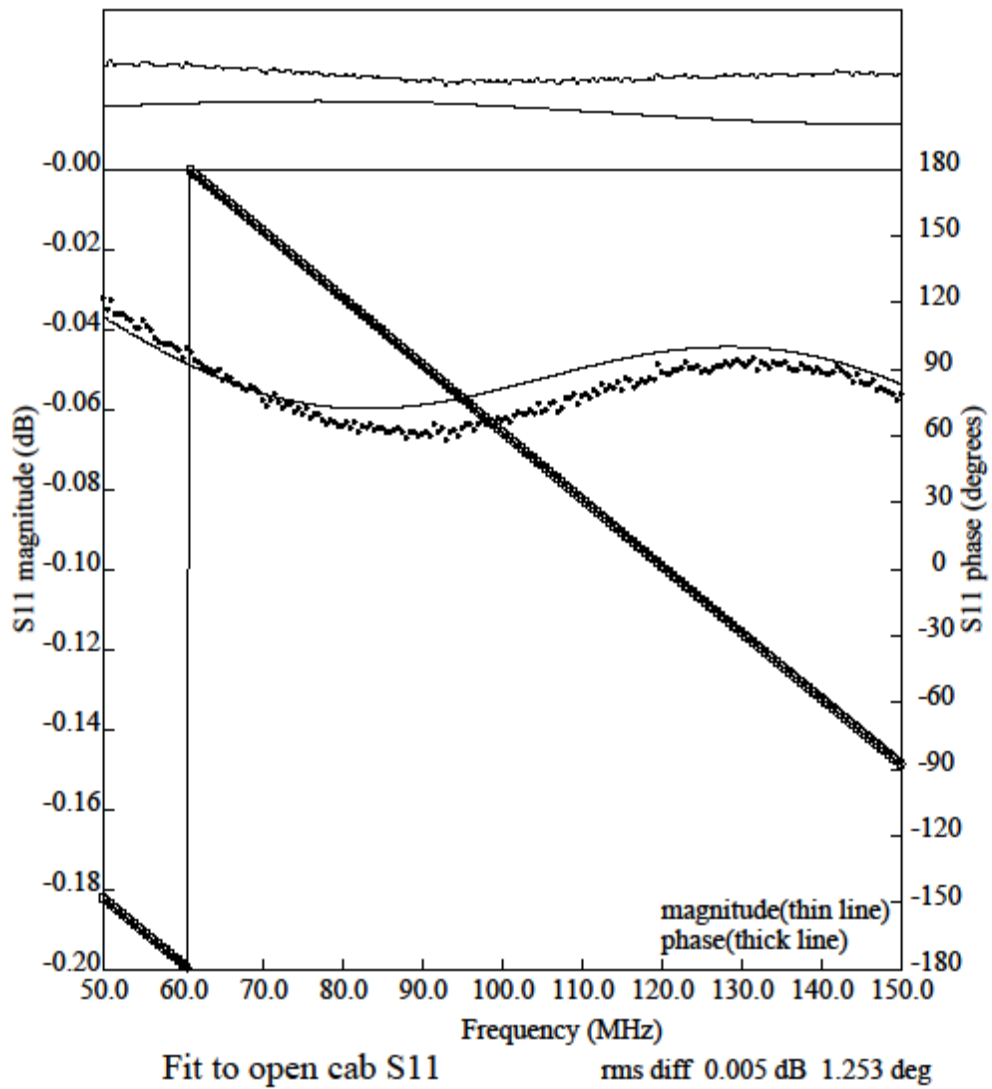
Figure 6. Balun S11 measured with open end.

The loss was measured on the bench with the end open but covered with an extension to the tube and shorted as shown in Figure 8. The S11 open and short results are shown in Figures 6 and 7 respectively and are close to the measurements made on a “test” balun reported in memo 181. It is suggested that balun open and short measurements be made in the field during antenna and receiver installation.
