MASSACHUSETTS INSTITUTE OF TECHNOLOGY  
HAYSTACK OBSERVATORY  
WESTFORD, MASSACHUSETTS 01886  
January 24, 2025

To: EDGES group  
From: Rigel C. Cappallo, John P. Barrett  
Subject: EDGES-3 deployment in Adak, AK, December 2024

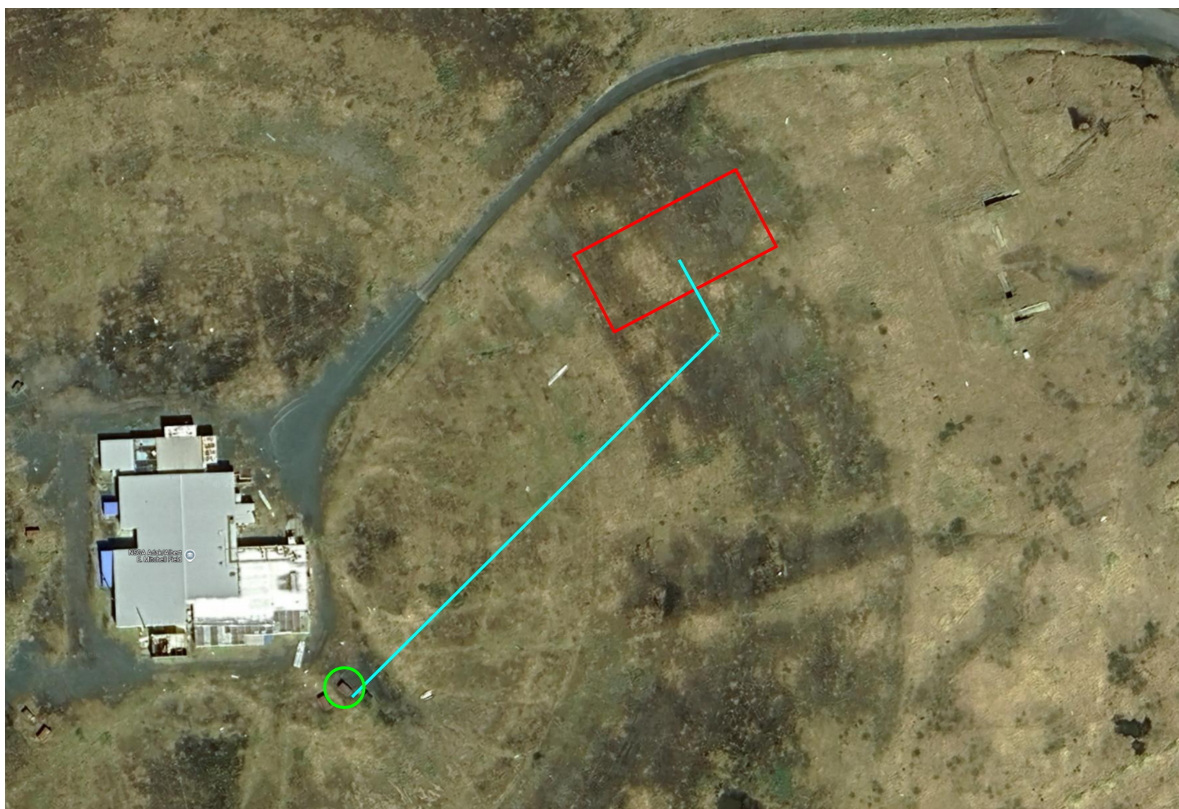
Figure 1: A satellite view of the EDGES-3 deployment site on Adak Island, AK. The red rectangle denotes the outline of the ground plane, the green circle is centered on the power/communications hut, and the cyan line represents the path of the power cable and fiber from the hut to the antenna. Vertical corresponds to north.

The team arrived on Adak at  $\sim 15:00$  local time, upon which we secured our baggage and were shown our accommodations. After this we were able to briefly visit the site to determine the placement of the equipment prior to sunset (Fig. 1). The antenna is located at 51.9433 N, 176.5988 W.

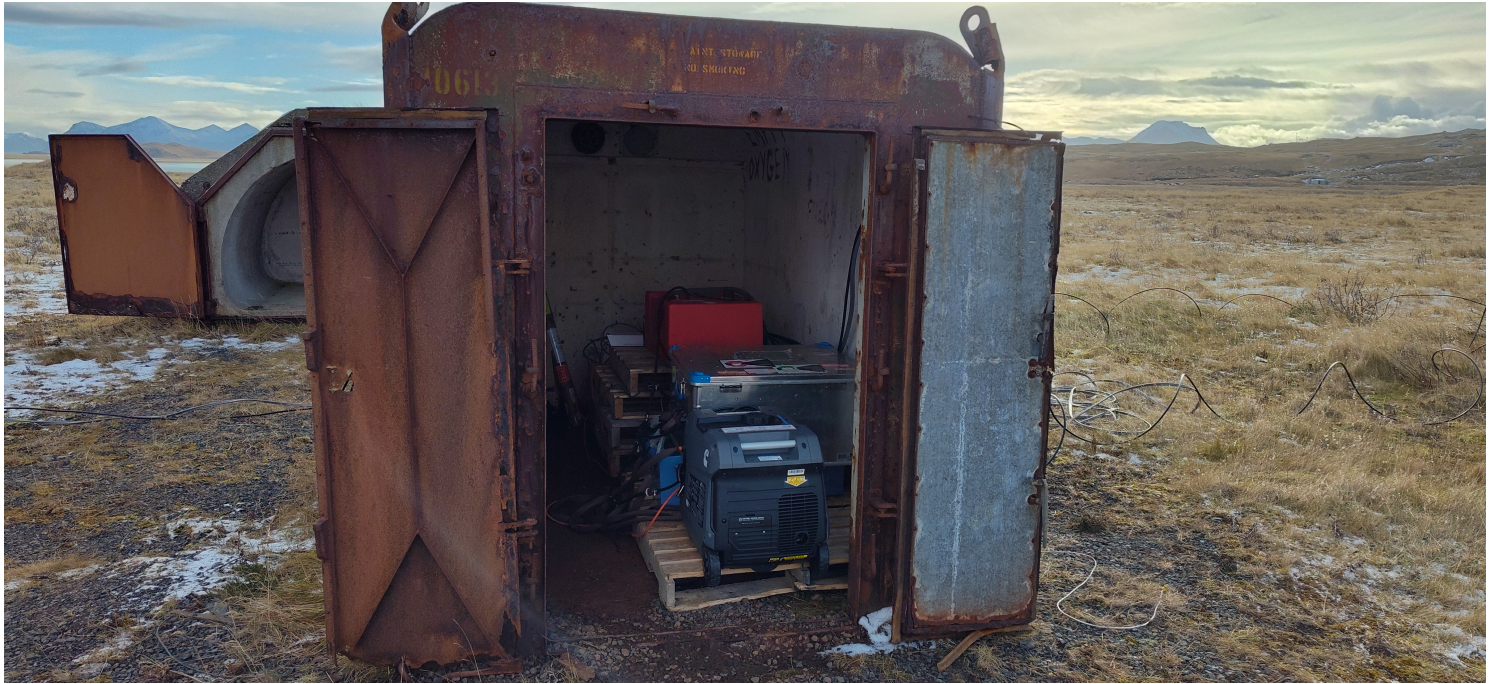
Figure 2: The electronics hut, with the generator, electronics box, batteries, and red fuel tank installed.

The antenna frame was assembled, and the 6 awg copper power line was run from the center of the ground plane to the electronics hut. Before shipment from Haystack, the power line was split into four lengths  $\sim 50$  m each. Two-pole Anderson power connectors were placed at the breaks. However, some of the connectors failed in the field (the clips fell off of the wire), and so we had to fabricate connections by wrapping smaller gauge wire between the pieces and sealing it with shrinkwrap. For the electronics hut itself we chose a metal container roughly  $2 \times 2 \times 3$  meters with a semi-functional door on the front (Fig. 2). It stands roughly 170 meters due south west of the antenna.

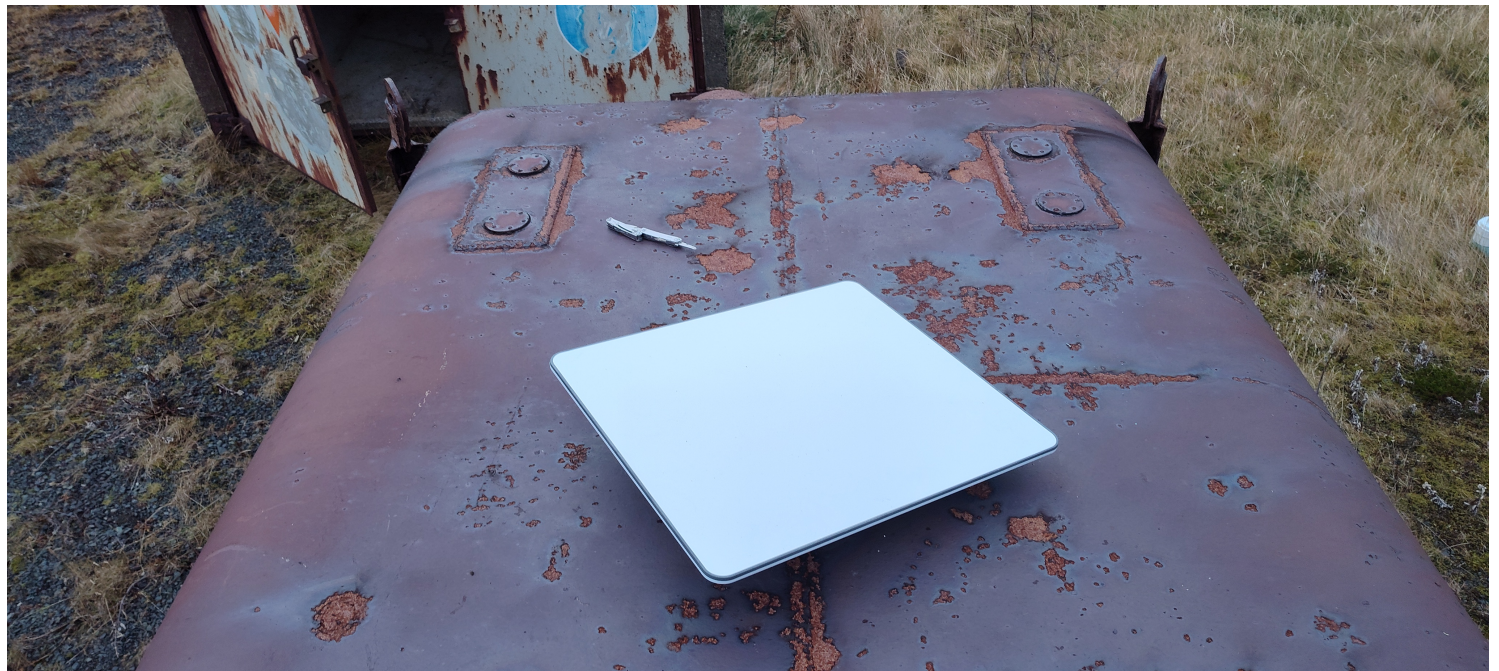
Figure 5: The flat high-performance Starlink antenna after installation on the hut roof. The antenna is oriented to face south, as that is the direction of the highest satellite concentration.

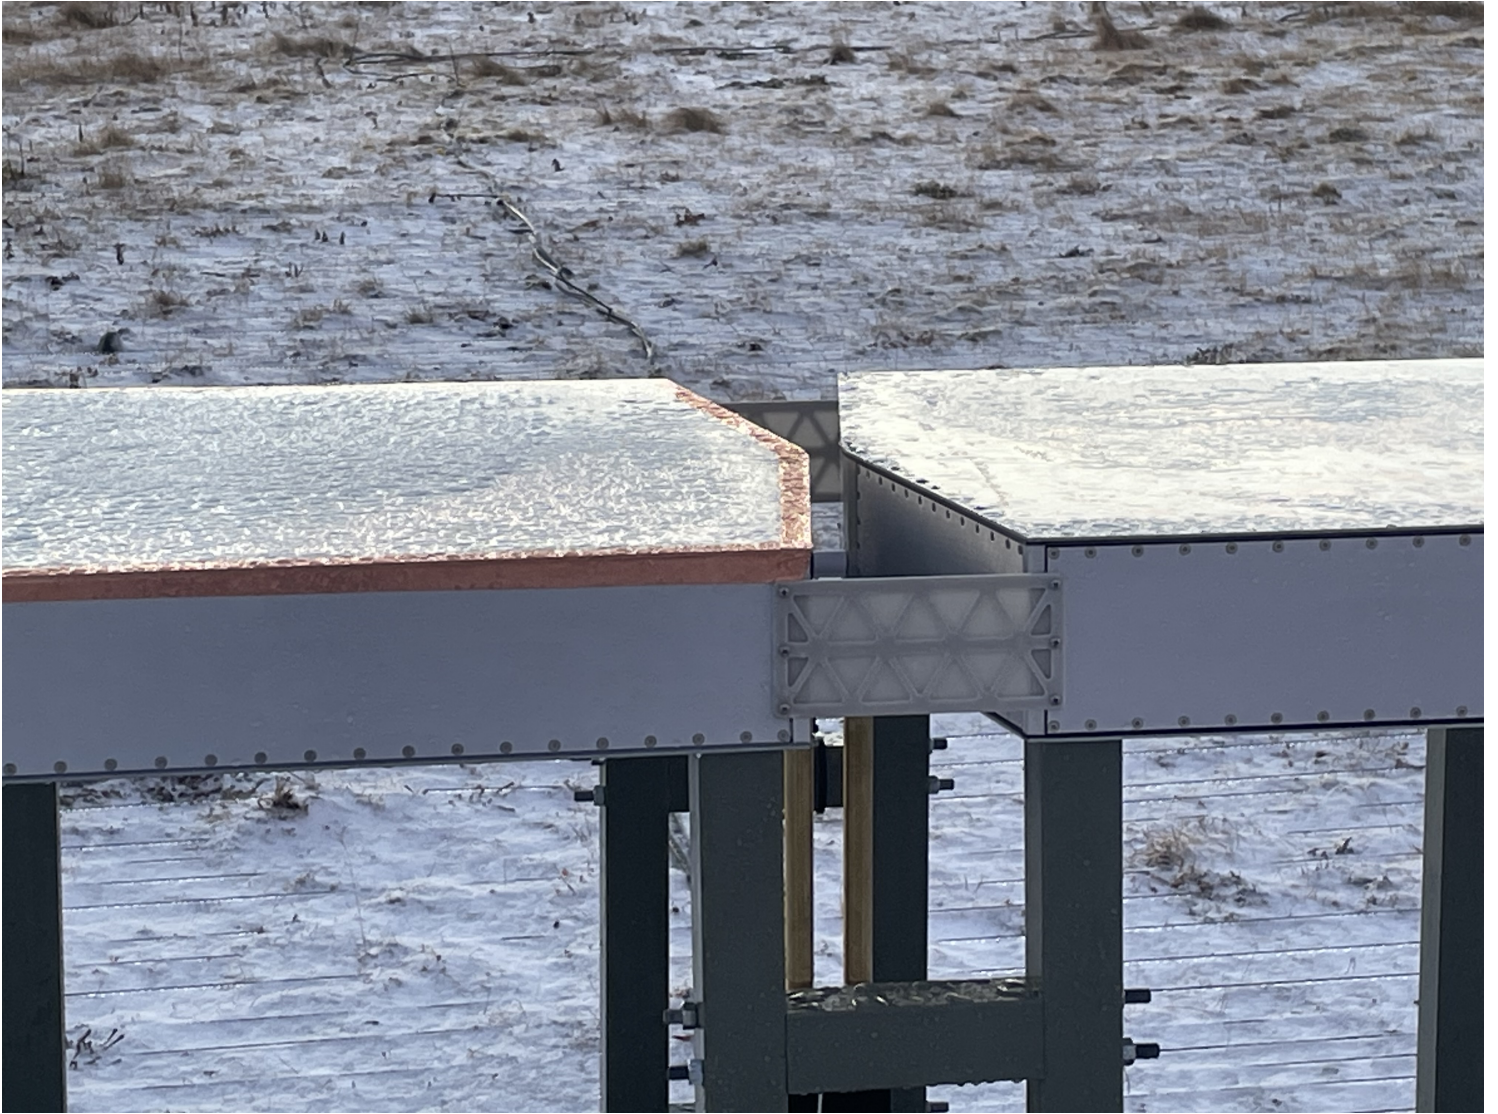
Figure 8: The surface of the antenna after the first night of observations. Ice had accumulated on the panels overnight, but melted away within a few hours of sunrise.

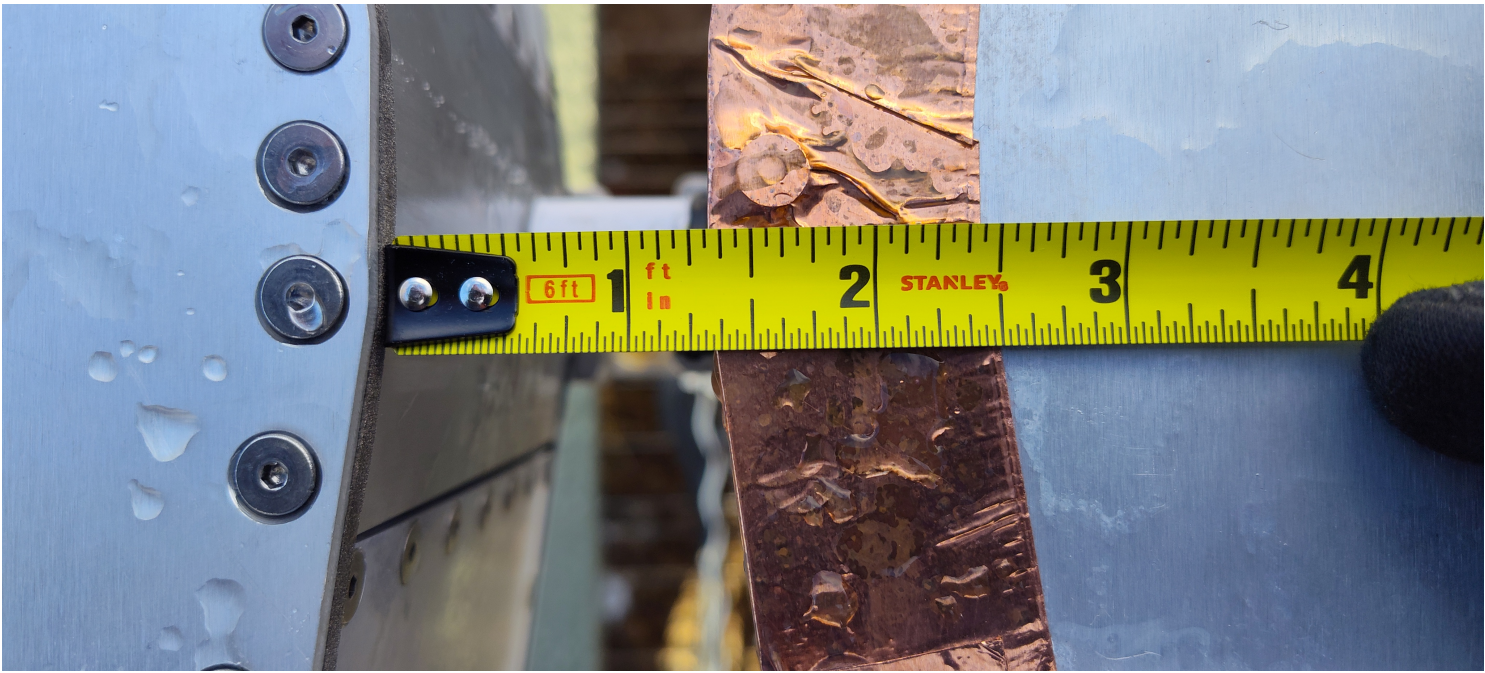
Figure 9: The spacing between the two antenna boxes.
