**ARIZONA STATE UNIVERSITY, LOCO LAB
MIT, HAYSTACK OBSERVATORY**

Subject: Boolardy Site Visit Log – February 2020

This is a short memo detailing activities during the February, 2020 visit to the EDGES site at Boolardy station, WA, which will be updated with the activities of each day.

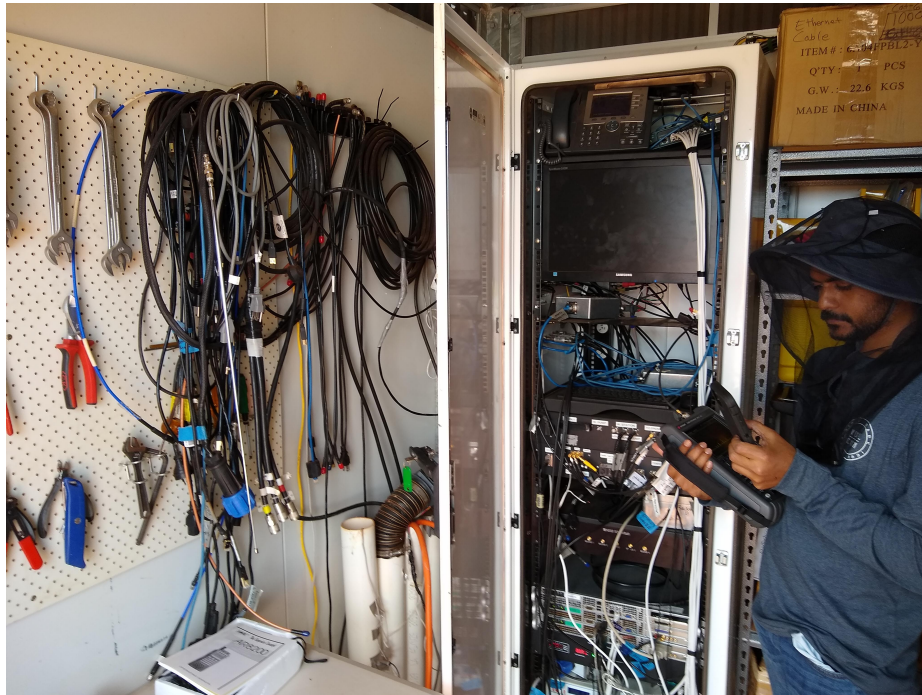
The afternoon of February 18, 2020 a quick RFI survey of the EDGES hut was down using a FieldFox spectrum analyzer coupled to an approximately 2 feet long monopole whip antenna. Table 1 contains a summary of the measurements taken. Unless otherwise specified under the description heading, all measurements were taken with the hut door open. For measurements where the FieldFox was inside the equipment rack cabinet, it was connected to the antenna (inside the hut) via co-ax. cable¹ through the equipment cabinet wall. The FieldFox was set up to generate a spectrum sweep from 30MHz to 200MHz with a spectral resolution of 100Hz. The number of averages for each spectrum measurement was configured to be 150. It should be noted for some measurements the low frequency portion of data may be unreliable as there was no way to introduce a delayed-start to the measurement and for measurements where the spectrum analyzer was inside the equipment cabinet with the door closed, there is some non-zero time between the start of a measurement and when the door was fully closed. We estimate that this affected the first ~ 10 MHz of each measurement. For a rough idea of the setup (with cabinet door open) see figure 2. Note that for measurements A through E, there were two smart phone devices (in airplane mode) inside the hut a few feet from the antenna as well as a handheld UHF radio (not-transmitting) outside the hut. For measurements F and onwards, these devices were switched off and placed inside a car ~ 20 feet away. For all measurements A through F, we also had two car key transponders nearby in the hut, these were removed for measurement G onwards and placed outside the hut about ~ 25 feet away. During measurement G, a vehicle approached and parked about 40 feet away from the hut, so this measurement was repeated. Figure 1 gives a comparison of the RFI survey measurements. From this figure we conclude that there may be some RFI produced by the back-end computers within the equipment rack, the most salient features being the peaks closest to 85, 120, and 145 MHz.

Figure 2: Position of antenna with respect to equipment cabinet during quick RFI survey. Antenna is visible in front of the collection of cables hanging on the hut wall.

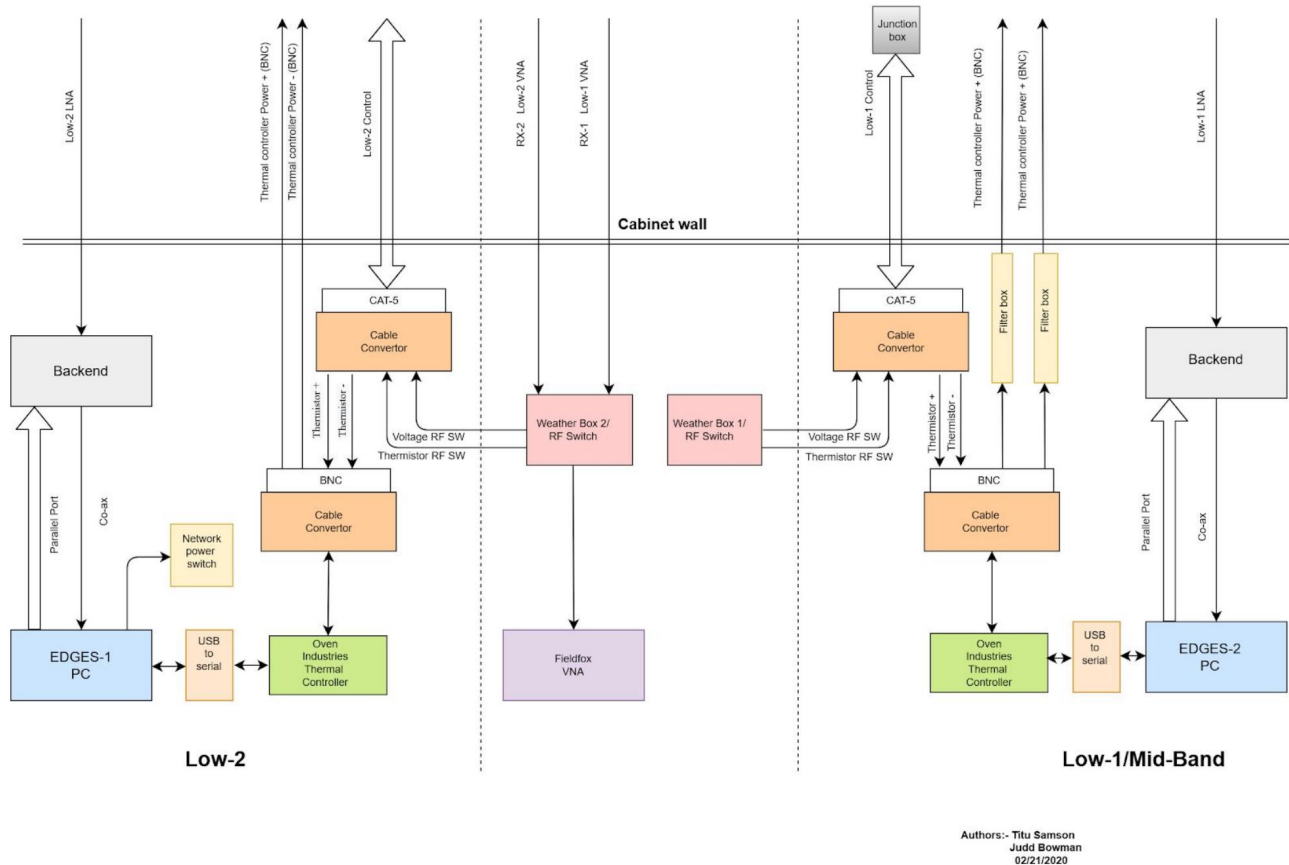
Work during the day was constrained to be inside the hut because of rain and the presence of lightning in the area. The interior cabling for the low-2 and mid-band receivers (to be installed) was reconfigured according to the diagram in figure 3. Some small metal break-out boxes for the receiver control wires (over ethernet cable) were machined to replace the small plastic boxes currently in use.

Figure 3: Wiring scheme of the equipment cabinet wiring scheme for low-2 and mid-band receivers, from T. Samson and J. Bowman.
