**MIT, HAYSTACK OBSERVATORY**

To: EDGES Group

From: J. Barrett, R. Cappallo J. Soohoo

Subject: Devon Island Deployment Log – August 2022

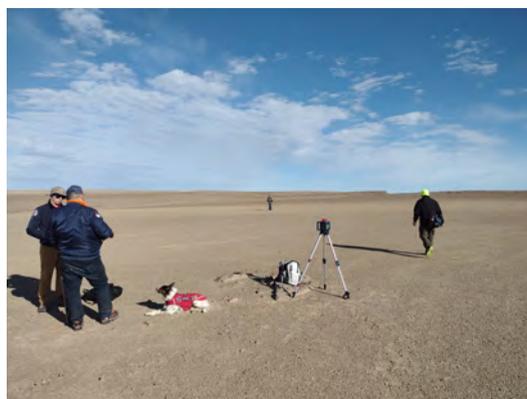
After breakfast we started our first preliminary site survey of a location North of the HMP base camp on the Von Braun planitia on foot. The first site that we examined was located approximately at (75.456560, 89.887960), and is shown in figure 1. As we had forgotten to bring the measuring tape we were only able to make approximate measurements of the ground slope at the site. We set up the laser leveling system next to a small outcrop of rock that would be on the western side of the ground plane if we chose to construct it here. We determined that North-South slope was roughly  $1^\circ$  (sloping down to the South), while the East-West slope was roughly  $0.6^\circ$ .

We later returned with a tape measure and measured the rough North-South slope at Site 1, and it appears to be within the specification at 0.9 degrees (sloping downwards to the south). The approximate East-West slope was 0.6 degrees (sloping downwards to the west). These slopes seem to be fairly consistent over ground plane sized (50x25m) sized area. In this location ground is a mixture of fine clay and dime-to-quarter sized gravel. There are some loose stones that could be fairly easily scraped away or excavated and removed. There doesn't appear to be any major outcrops of bedrock, and there are no large boulders within 100m. No point on the horizon appears to exceed 15 degrees in any direction. We measured the ground conductivity with the METER group probes in a small 3-4 inch deep hole, and obtained readings of (0.038mS/cm and 0.054mS/cm on each probe), which is low but not unexpected. This site is within line-of-site of base camp, about 1.5km away, and is relatively easy to traverse on the ATVs over a fairly smooth path.

Figure 1: Location of the first preliminary site survey on the Von Braun planitia.

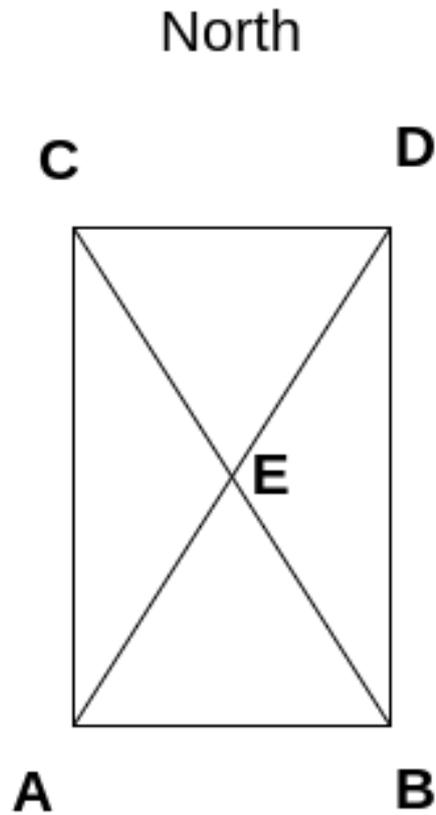
Figure 3: The ground plane layout with corner labels.

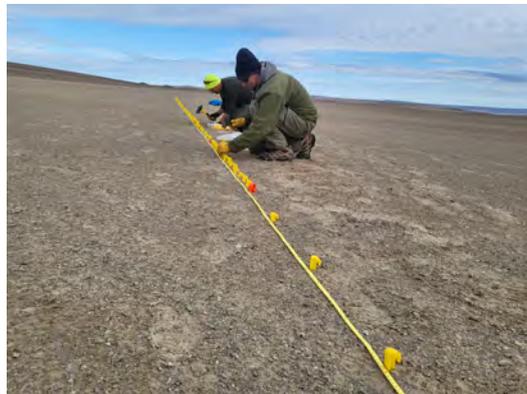
Figure 4: The installation of the ground plane support pegs.

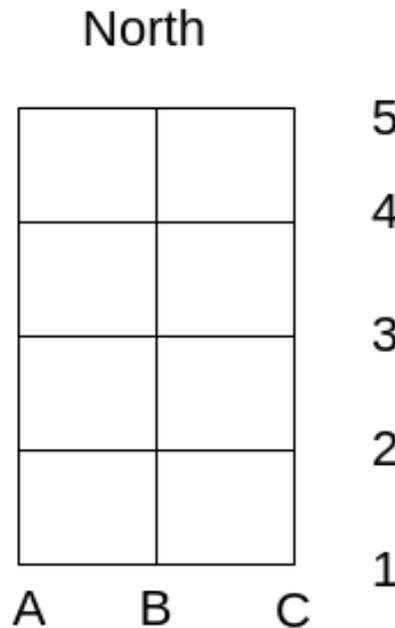
Following the completion of the ground plane a series of height measurements were taking on a grid over the ground plane. This was done using the laser leveling system. Figure 5, shows the grid, and the alpha-numerical location labels, while table 4 lists height of the laser plane above the ground at each grid point. Note that a larger height indicates that the ground is lower in that location. To get the relative height of each point in the grid subtract it from the height of the laser itself (point B3 – 1.060m). The East-West/North-South distances between each pair of adjacent grid points are 12.5m.

Figure 5: Grid points of height measurements on ground plane. Grid spacing is 12.5 m.

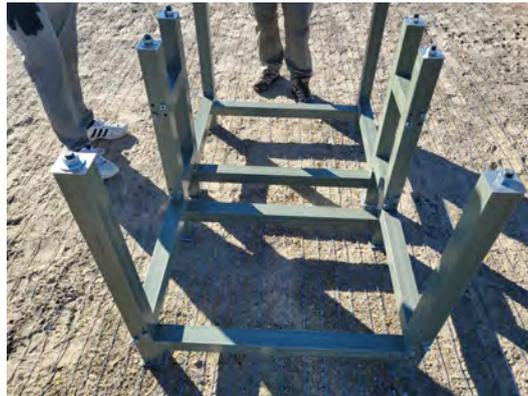
The antenna frame was carried out to the center of the ground plane (marked with a peg placed at the intersection of the diagonals), and the frame was oriented such that each corner leg was approximately equidistant with the nearest diagonal (marked with surveyor string) as shown in figure 6. Next, the antenna panels were carried out and mounted on the frame. The spacing of the panels was adjusted until the central distance between the two panels was approximately 1.3in, as shown in figure 7. The FieldFox VNA was connected, and the fiber and DC power cables were passed through the tuning pipes, which were then attached to the antenna panels.

Figure 6: The location of the antenna support frame.

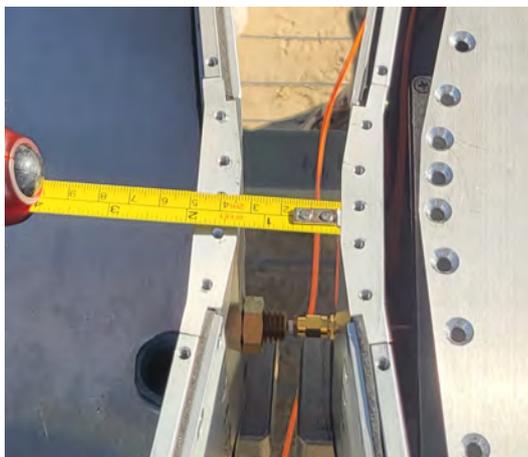
Figure 7: The spacing of the antenna panels.

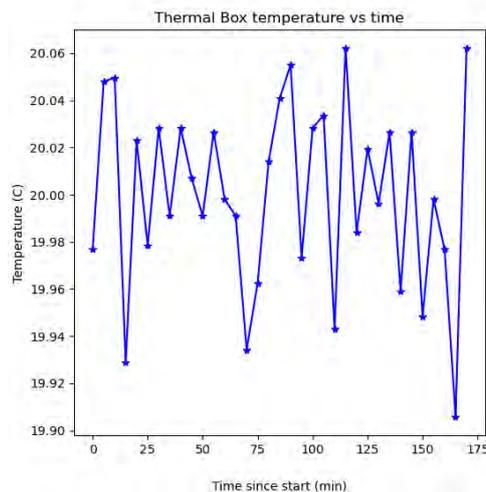
It started raining shortly after returning to base camp, around 10am and continued until about 2:00pm. We returned at 12:00PM to collect the VNA calibration data, and to start the spec-cal script. A quick examination of the temperature log for the morning run, showed that 20C was maintained stably (during the day, with thick cloud cover, and approximately 12C outside temperature). The temperature for the first  $\sim 3$  hours is shown in figure 11. We noticed two breaks in the ground plane wires (at a soldered joint), these were repaired by loosening wires slightly at the pegs and twisting the broken connection tightly back together.

Figure 11: The temperature of the front-end box, short interval.

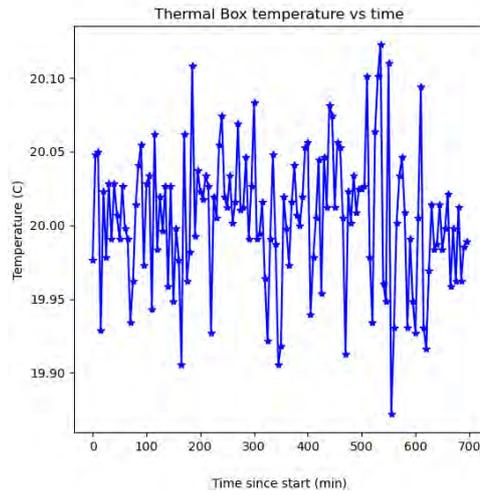
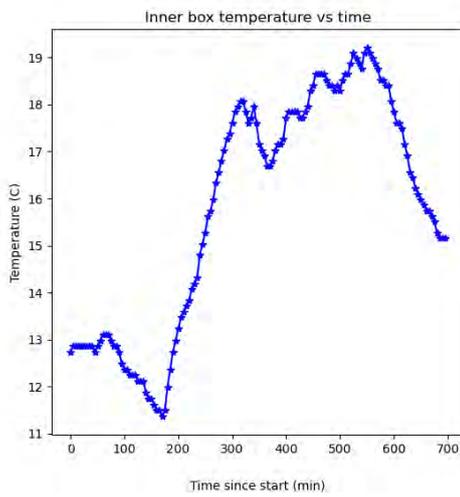
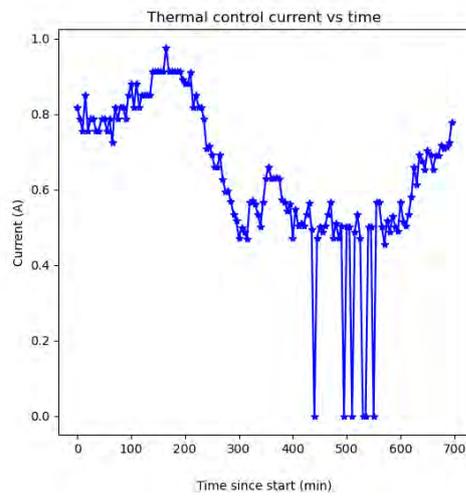
We went out to refresh the battery at 9:00PM CDT, and collected some data from the VNA calibration, and some of the (incomplete) spectrum calibration. A quick look at the thermal state of the system during the date showed that it appears to be stable at 20C for relatively long periods (see figure 12a).

(a) The temperature of the thermal (front-end) box, long interval.

(b) The temperature of the inner (back-end electronics) box. (c) The current draw on the thermal control system.

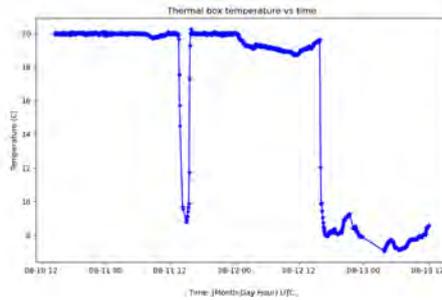
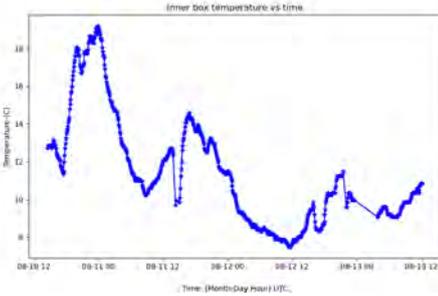
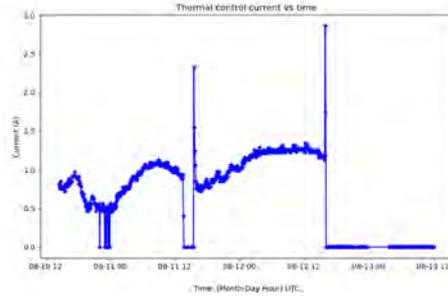
(a) The temperature of the thermal (front-end) box.

(b) The temperature of the inner (back-end electronics) box. (c) The current draw on the thermal control system.

After consulting with Alan and sending him the pr59 register values he noticed that the low temperature alarm value (register 72) was set to 10C, which is much too high for this environment. After the fog cleared, we returned to the system and modified pr59 to allow us to set the value of register 72. We changed it from 10 to -40, and the system immediately cleared the low temperature alarm and began regulating the system to the set-point of 10C. We re-started sky-data acquisition and plan to repeat the VNA cal in 36 hours, and will re-do the spec-cal on Aug 15th after verifying the system is stable at 10C.

A temperature logs up until this morning are shown in 13a.

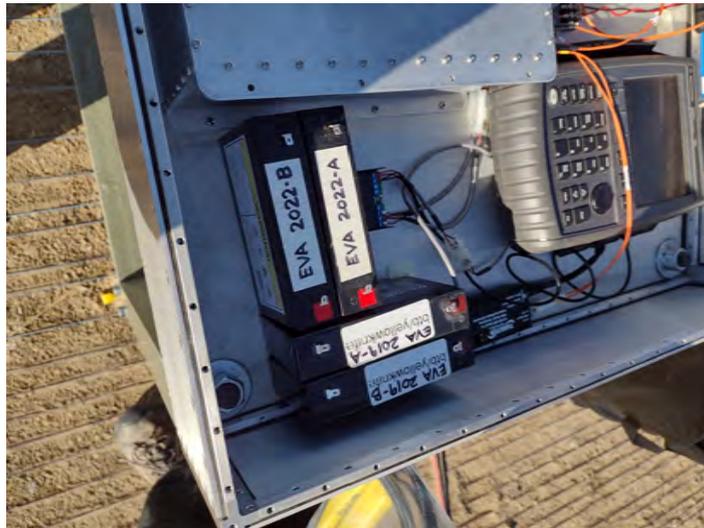
Today, starting around 11:40AM we conducted a test to rule out the external power system and DC power line as a possible source of noise using a set of 4 gel-cell 6V VRLA batteries borrowed from the HMP staff. A harness to connect these batteries two pairs in-series, in-parallel was put together and the antenna was opened up to insert these batteries as shown in figure 16. . The DC power line was disconnected and completely removed from the ground plane, while the remaining short connection below the antenna was tucked up into the pipes/box underneath the antenna, with the panel partly closed, as much as the connector would allow, as shown in figure 17. Once the batteries were connected, the antenna panel was screwed down and data acquisition was started.

Figure 16: The internal 6V VRLA batteries used for the internal battery test.

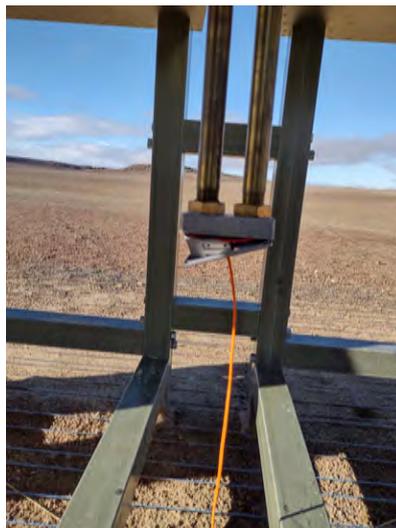
Figure 17: DC power cable disconnected and short remaining wire tucked into pipes/box.

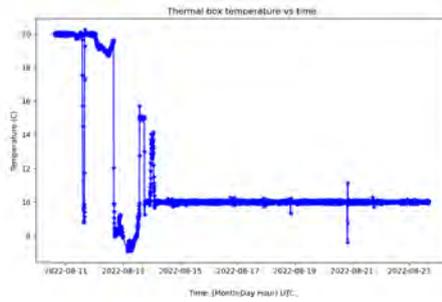
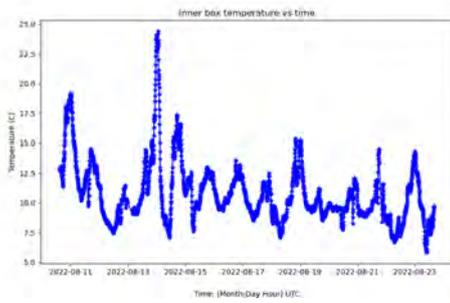
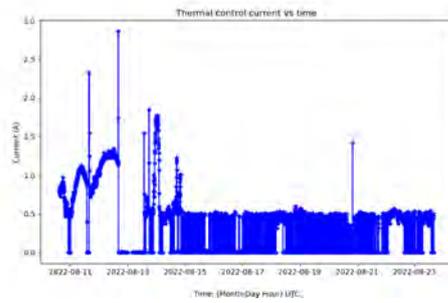
Today, the system was dismantled with the ground plane being left in place. Before disassembly, the VNA-calibration script was run to perform the antenna S11 measurement for the last time. The prefix for these VNA measurements is 2022.235.14. One final soil conductivity measurement was taken, which showed that the soil conductivity had no appreciable changes and was still in the range of 0.02-0.04mS/cm. The complete temperature logs were also copied and show the system was stable once the pr59 issues were resolved as shown in figure 19a.

(a) The temperature of the thermal (front-end) box.

(b) The temperature of the inner (back-end electronics) box. (c) The current draw on the thermal control system.
