**MASSACHUSETTS INSTITUTE OF TECHNOLOGY**  
**HAYSTACK OBSERVATORY**  
**WESTFORD, MASSACHUSETTS 01886**  
 January 9, 2014

To: EDGES Group  
 From: Alan E.E. Rogers  
 Subject: "Cross-check" of HP85047A/8753C VNA accuracy

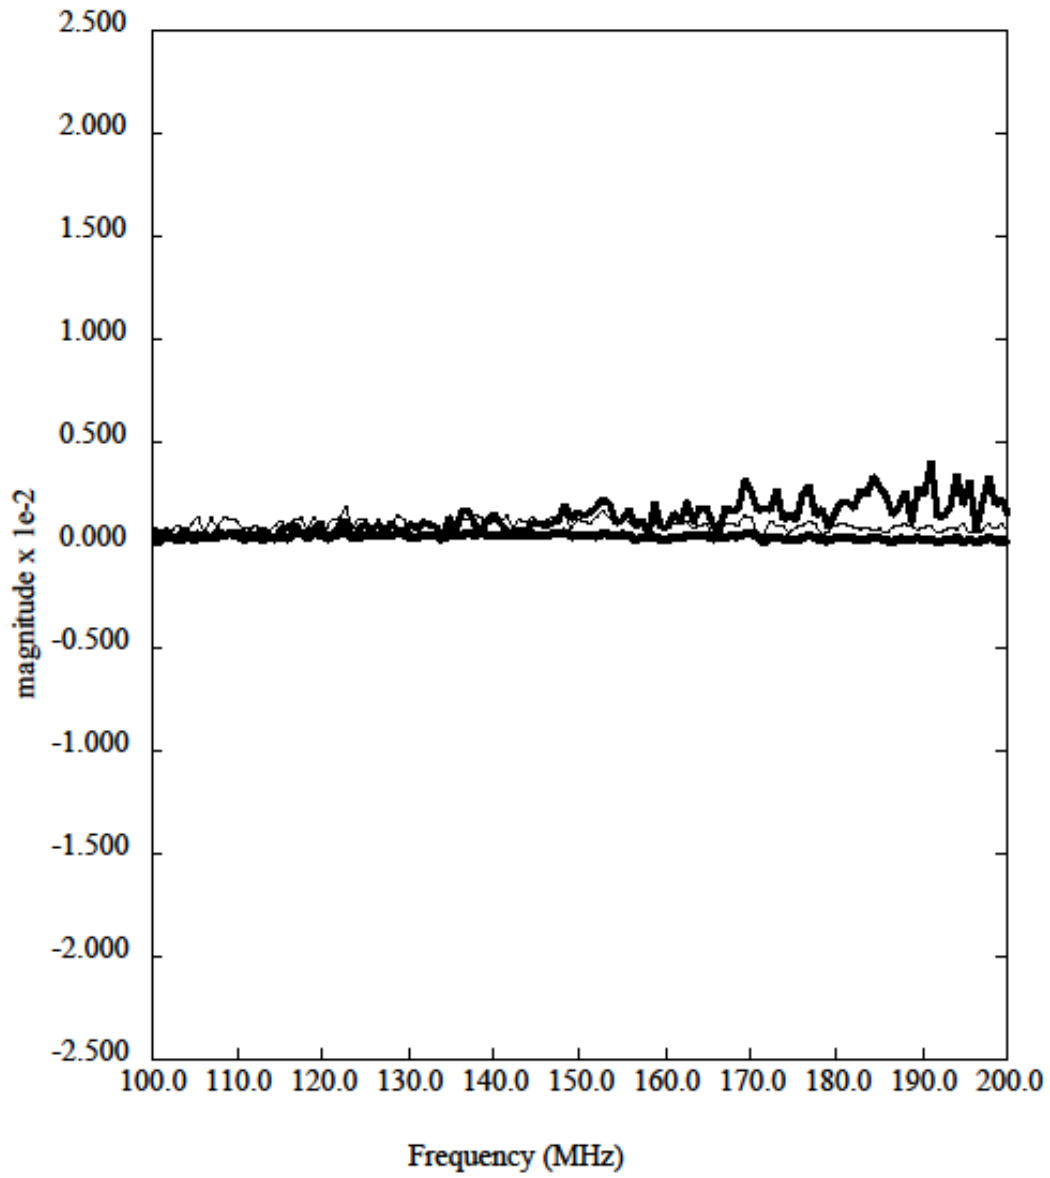
Figure 1. Check 1,2 and 3 for HP85047A/8753C from thin to thick traces.

These "check" values labelled check 1,2 and 3 vs frequency plotted in Figure 1 show that while some of the error is due to noise then is a significant departure from zero which indicate a departure from the true values of about 0.05 degrees. Initial tests gave larger values for the difference between S12S21 and SR12SR21 which indicate a significant departure from linearity or phase quadrature error but the measurements become more repeatable with smaller differences between S12S21 and SR12SR21 as extreme care was taken to ensure consistent tightening of the connections and care to avoid any bending of the cable from the VNA to the device. The frequency averaged errors of the checks were repeatable, within the noise, for several repeated tests. In addition a test was made in which the sequential order of the forward and revers test was made. In this test the magnitude of the difference and the difference in the magnitude and phases repeated illuminated the possibility of a drift in the VNA between measurements or a heating of the device and loads as an explanation of the systematics in the checks. In summary, these "cross-checks" set limits of about 0.01 dB and 0.1 degrees systematic errors in the VNA which are not correctable by SOL calibration. A test using the Agilent N5222A gave the following results:

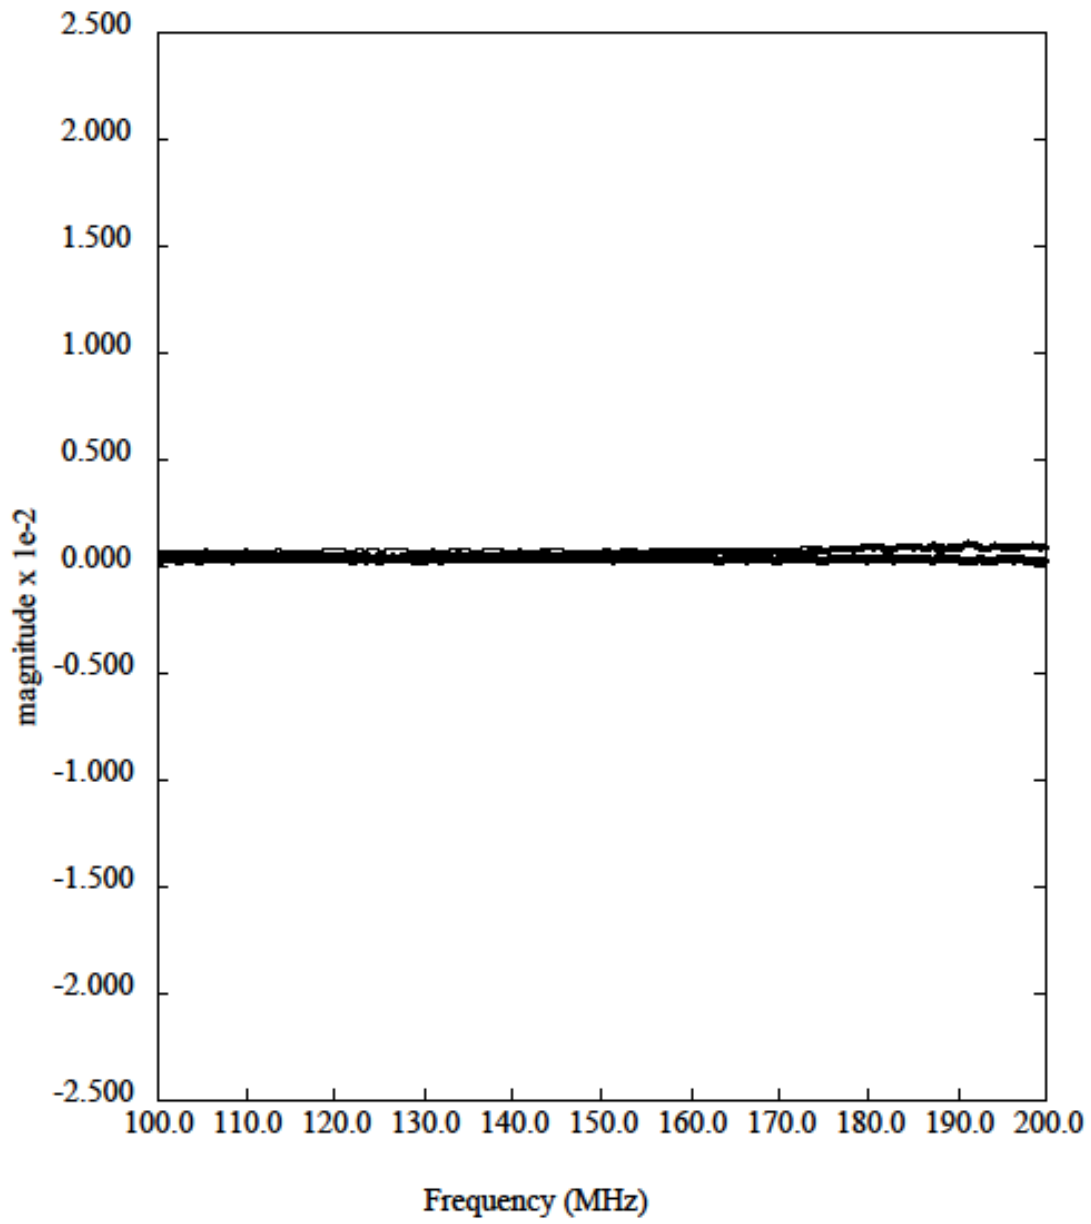
Figure 2. Result for N5222A

Which are similar, but with lower noise (see Figure 2) than the results obtained with the older HP 85047A/8753C.
