**MASSACHUSETTS INSTITUTE OF TECHNOLOGY  
HAYSTACK OBSERVATORY  
WESTFORD, MASSACHUSETTS 01886**

To: EDGES Group  
From: Alan E.E. Rogers  
Subject: EDGES-3 Thermal tests

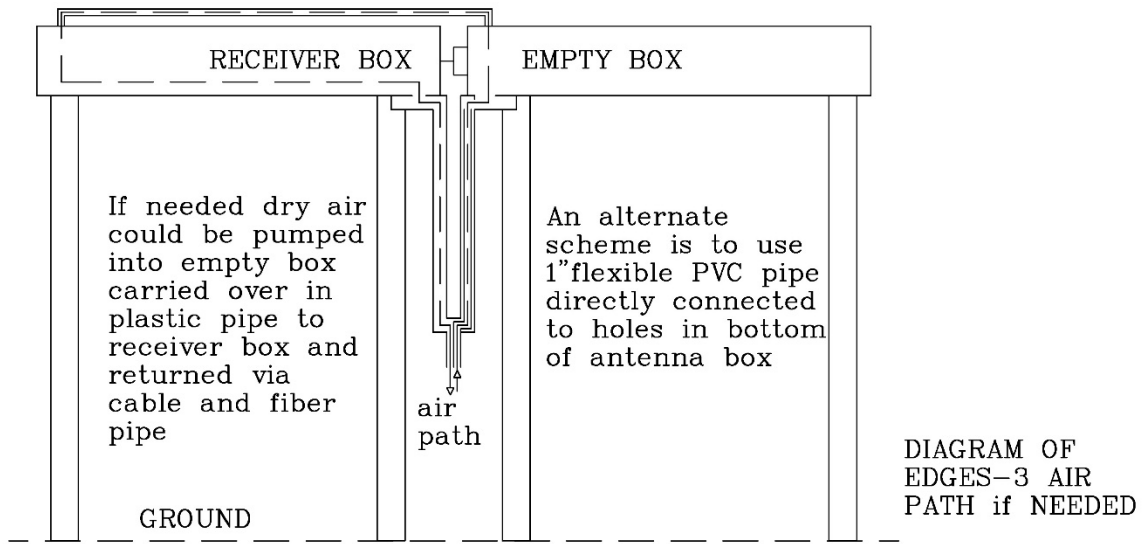
The temperature at night in the Catlow Valley region of Oregon is expected to be 15°C or lower so a rise to 35°C in the inner box should be acceptable. Raising the control temperature set by the PR59 controller to 30 or 35°C could be used, but would require calibration at these temperatures. Another way of increasing the margin would be to circulate dry air through the receiver box as shown in Figure 1. This would almost certainly be required for a more permanent installation in Western Australia.
